Technical Service Bulletin

| GROUP | NUMBER |
|---|---|
| AUTOMATIC TRANSMISSION | 17-AT-006 |
| SEPTEMBER, 2017 | SONATA (LFA) 2.0T |

AUTOMATIC TRANSAXLE SOLENOID DTC P074100, P074300, P074800, P075300, P075800, P076300, P076800, P077300 & P270900

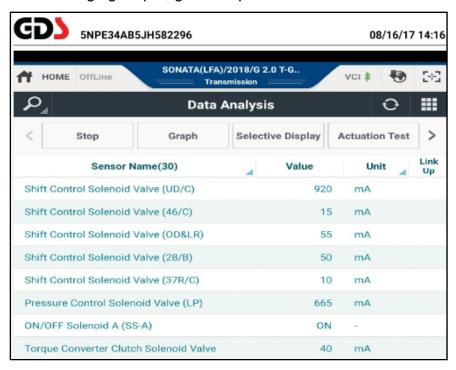
- Attach a GDS and select DTC Analysis and A/T menu. Record the DTC and description.
 Delete the DTC.
- 2. From the GDS home screen, select **Data Analysis** and **A/T** menu and the solenoid parameters shown below. If the solenoids show:
 - Continuous and changing output while driving, the wiring <u>currently</u> has no open/short circuits. Go to Step 4.
 - No continuous and changing output, go to Step 3.

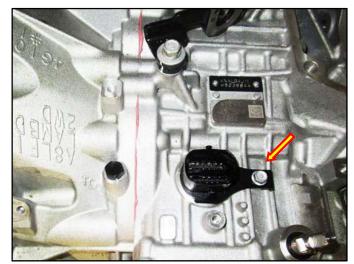
Remove the bolt that secures the tab and push the harness connector into the transmission.

Disconnect the vent hose on the top of the oil pan.

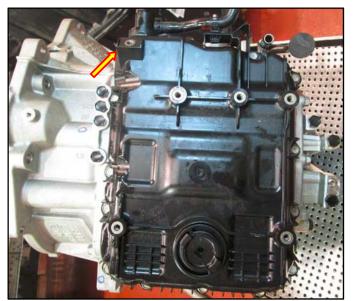
9. Remove 14 oil pan bolts and remove the pan.

Use a rubber hammer to tap the oil pan cover on a corner until the cover is loose.

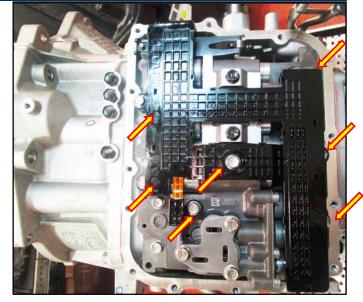
10. Remove 6 bolts to the harness and 1 bolt to the oil temperature sensor.

Pull the harness outward and move the harness out of position.

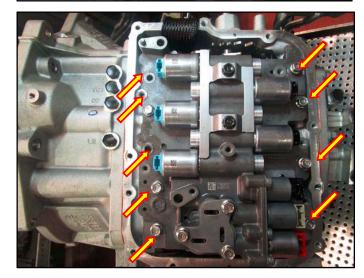
12. Remove 9 valve body bolts in order from the outermost bolts to the innermost bolts.

Remove the valve body.

Place the valve body on a clean paper towel. Placing the valve body on a rag may cause lint to enter the valve body.

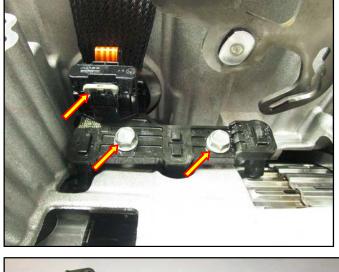
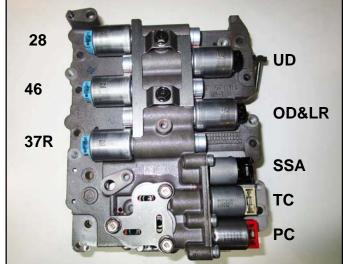
14. Refer to the DTC recorded in Step 1 and replace the related solenoid.

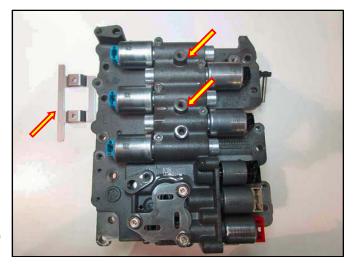
15. For 28, 46 and 37R solenoids:

- Remove two bolts to the upper solenoid support. Remove the support.
- Use a magnet to remove the pin for the solenoid to be replaced.
- Remove the solenoid and install a new solenoid.
- Reinstall the pin.
- Reinstall the support and tighten to specification.

Torque: 7~9 lb.ft (1.0~1.2 kgf. m/10~12 N.m)

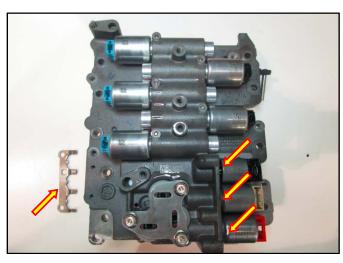
16. For UD, OD&LR, SSA, TC and PC solenoids:

- Use a 5mm hex socket and remove 3 Allen bolts that secure the solenoid support.
 Remove the support.
- Remove the solenoid and install a new solenoid.
- Reinstall the support and tighten the Allen bolts.
- 17. Confirm two O-rings are installed correctly in the case.

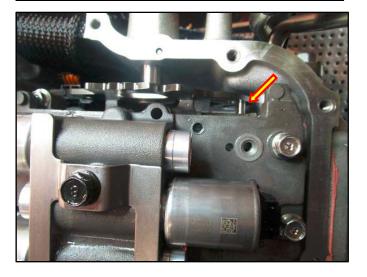
18. Align the manual shaft to the shift lever and install the valve body.

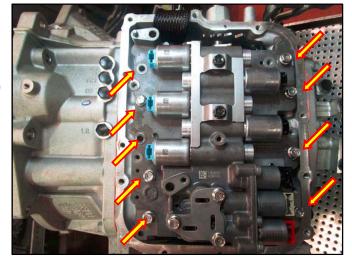
19. Install the valve body bolts and torque the bolts in order from the innermost bolts to the outermost bolts.

Torque: 7~9 lb.ft (1.0~1.2 kgf. m/10~12 N.m)

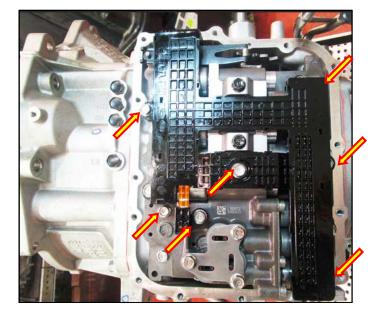
21. Reconnect the solenoid harness to the solenoids and install the temperature sensor.

Install 6 bolts to the harness and 1 bolt to the oil temperature sensor and torque to specification.

Torque: 7~9 lb.ft (1.0~1.2 kgf.m/10~12 N.m)

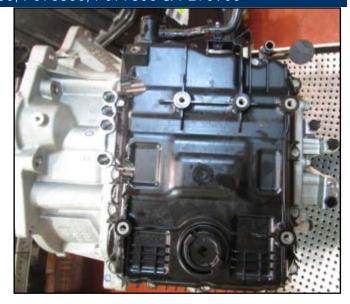
22. Install a new gasket to the oil pan and reinstall the pan.

Install 14 bolts to the pan and tighten the bolts to specification.

Torque: 6~7 lb.ft (0.9~1.0 kgf.m/8~9 N.m)

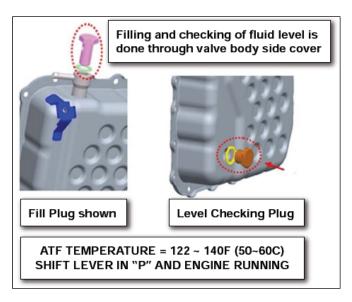
Use a funnel to add approximately 5~6 quarts

of SP4-M ATF through the fill plug opening.
Reinstall the fill plug.

Attach the GDS and select **Data Analysis**, **A/T menu** and **Oil Temperature Sensor**.

Start the engine and shift to Park. When the ATF is 122°F~140°F (50~60°C), remove the level checking plug. The level is correct when oil flows out of the level checking plug in a thin steady stream.
