# **Technical Service Bulletin**

| GROUP | NUMBER |
|---|---|
| HYBRID | 17 HC 002 |

SONATA HYBRID (LF HEV)

OIL LEAK AT ELECTRIC OIL PUMP

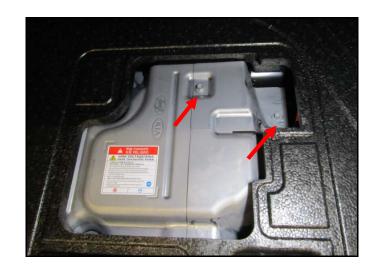
1. Remove the rear trunk cover.

Remove two bolts and remove the access cover to the safety plug.

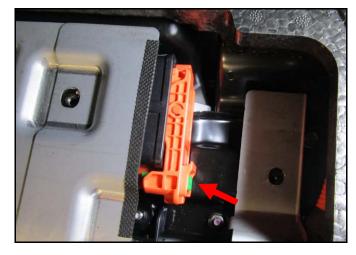
2. Put on insulation gloves.

Push the green tab forward and pull out the safety plug.

Place the safety plug on the dash so it is visible while working.

Failure to wear protective gear and perform this procedure may result in accidental injury or death.

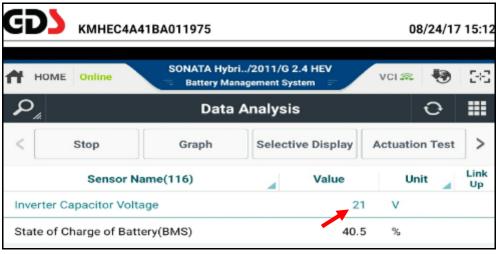
Without depressing the brake pedal, push the Start-Stop button 2 times to power the cluster.

Attach a GDS and select **Data Analysis**, **BMS** menu **Inverter Capacitor Voltage**. Confirm the **Inverter Capacitor Voltage** is less than 30V.

- If less than 30V, the system voltage is safe for the technician. Go to Step 4.
- If more than 30V, wait until the voltage is within specification. Go to Step 4.

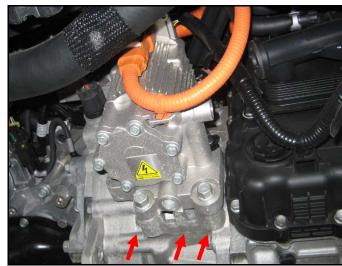
4. Locate the EOP near the oil pan.

Check for a small oil leak between the EOP and the transmission at the base of the EOP.

- If a leak is found, go to step 5.
- If no leak is found, check the engine area for the source of the leak.

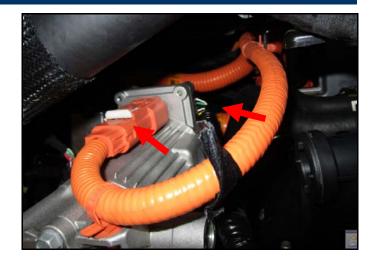
- 5. Disconnect the connectors to the EOP.
  - Orange High voltage connector:
     Pull down on the white tab and disconnect the connector.
  - Black Low voltage connector:
     Press the tab and disconnect the connector.

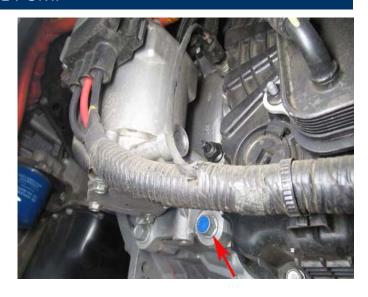
Reinstall the EOP.

Install a new bolt, P/N 45227-3D000, in the location shown by the arrow.

Reinstall two bolts and one nut.

Tighten the bolts and nut to specification.

Torque: 18~22 lb-ft (25~30 Nm)

If the new bolt is not available, apply RTV Silicon Gray, P/N 00232-19061 sealant, or equivalent, to the bolt threads.

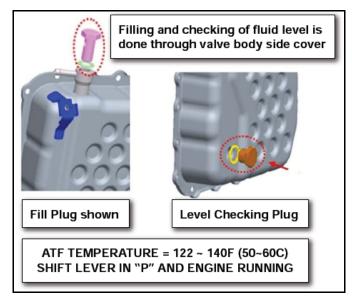
- Reconnect the connectors to the EOP and the fluid pressure switch.
   Reconnect the safety plug.
- 10. Remove the transaxle fill plug.

Use a fluid pump to add SP4-M ATF through the fill plug opening. Reinstall the fill plug.

Attach the GDS and select **Data Analysis** and **Oil Temperature Sensor**.

Start the engine and shift to Park. When the ATF is 122°F~140°F (50~60°C), remove the level checking plug. The level is correct when oil flows out of the level checking plug in a thin steady stream.

Collect and dispose of any excess fluid in accordance with local regulations.
