# **Technical Service Bulletin**

SEPTEMBER, 2017 SONATA HYBRID (YF HEV)

SUBJECT: OIL LEAK AT ELECTRIC OIL PUMP

This TSB supersedes 11-AT-019 to update the Parts Information and Service Procedure.

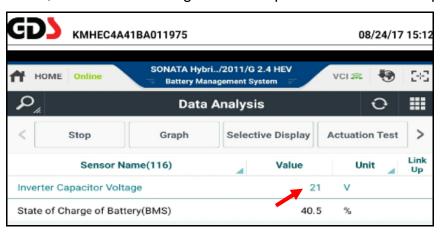
2. Without depressing the brake pedal, push the Start-Stop button 2 times to power the cluster.

Attach a GDS and select **Data Analysis**, **BMS** menu **Inverter Capacitor Voltage**. Confirm the **Inverter Capacitor Voltage** is less than 30V.

- If less than 30V, the system voltage is safe for the technician. Go to Step 3.
- If more than 30V, wait until the voltage is within specification. Go to Step 3.

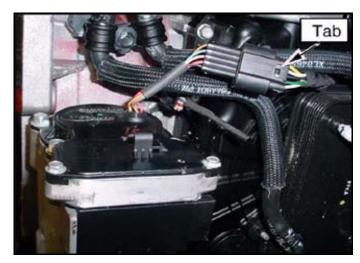
3. Squeeze the tab and disconnect the connector above the oil pump.

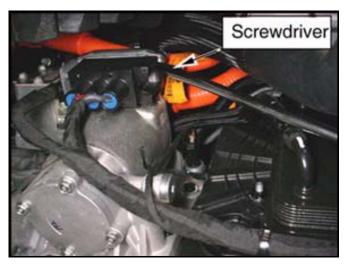
4. Use a screwdriver to push the gray tab to the left and remove the connector.

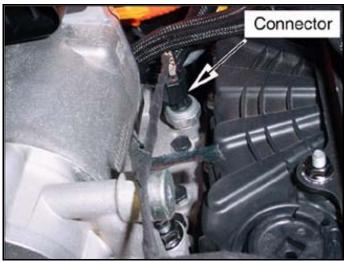
5. Squeeze the tab and remove the connector for the fluid pressure switch.

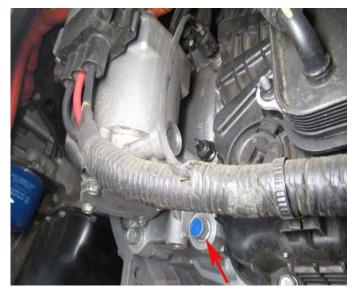
9. Reinstall the EOP.

Install a new bolt, P/N 45227-3D000, in the location shown by the arrow.

Reinstall two bolts and one nut.

Tighten the bolts and nut to specification.

Torque: 18~22 lb-ft (25~30 Nm)

If the new bolt is not available, apply RTV Silicon Gray, P/N 00232-19061, or equivalent, to the bolt threads.

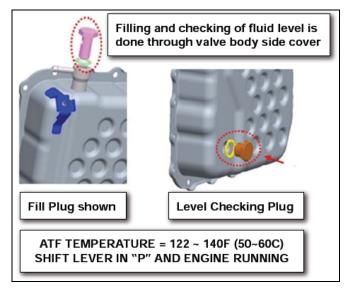
- Reconnect the connectors to the EOP and the fluid pressure switch.
   Reconnect the safety plug.
- 11. Remove the transaxle fill plug.

Use a fluid pump to add SP4-M ATF through the fill plug opening. Reinstall the fill plug.

Attach the GDS and select **Data Analysis** and **Oil Temperature Sensor**.

Start the engine and shift to Park. When the ATF is 122°F~140°F (50~60°C), remove the level checking plug. The level is correct when oil flows out of the level checking plug in a thin steady stream.
