EM17-003

2013 JX35 AND 2014 – 2017 QX60; RADIATOR SHROUD AND COOLING FAN ASSEMBLY REPLACEMENT PROCEDURE

APPLIED VEHICLES: 2013 JX (L50)
 2014 – 2017 QX60 (L50)

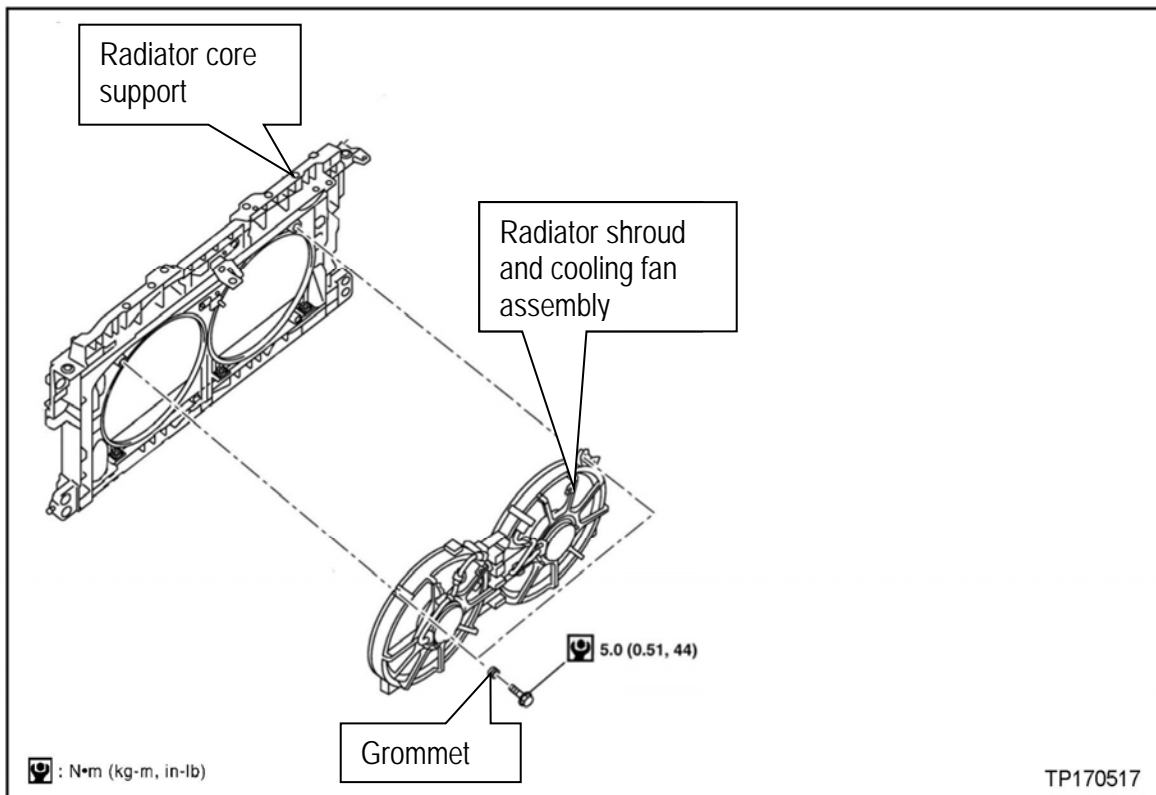
Figure 1

When replacing the radiator shroud and cooling fan assembly for any reason, the engine coolant, air cleaner case, and air duct does not need to be removed as part of the procedure. Use this SERVICE PROCEDURE (in place of the ESM) and the CLAIMS INFORMATION in this bulletin. The ESM will be updated at a later date.

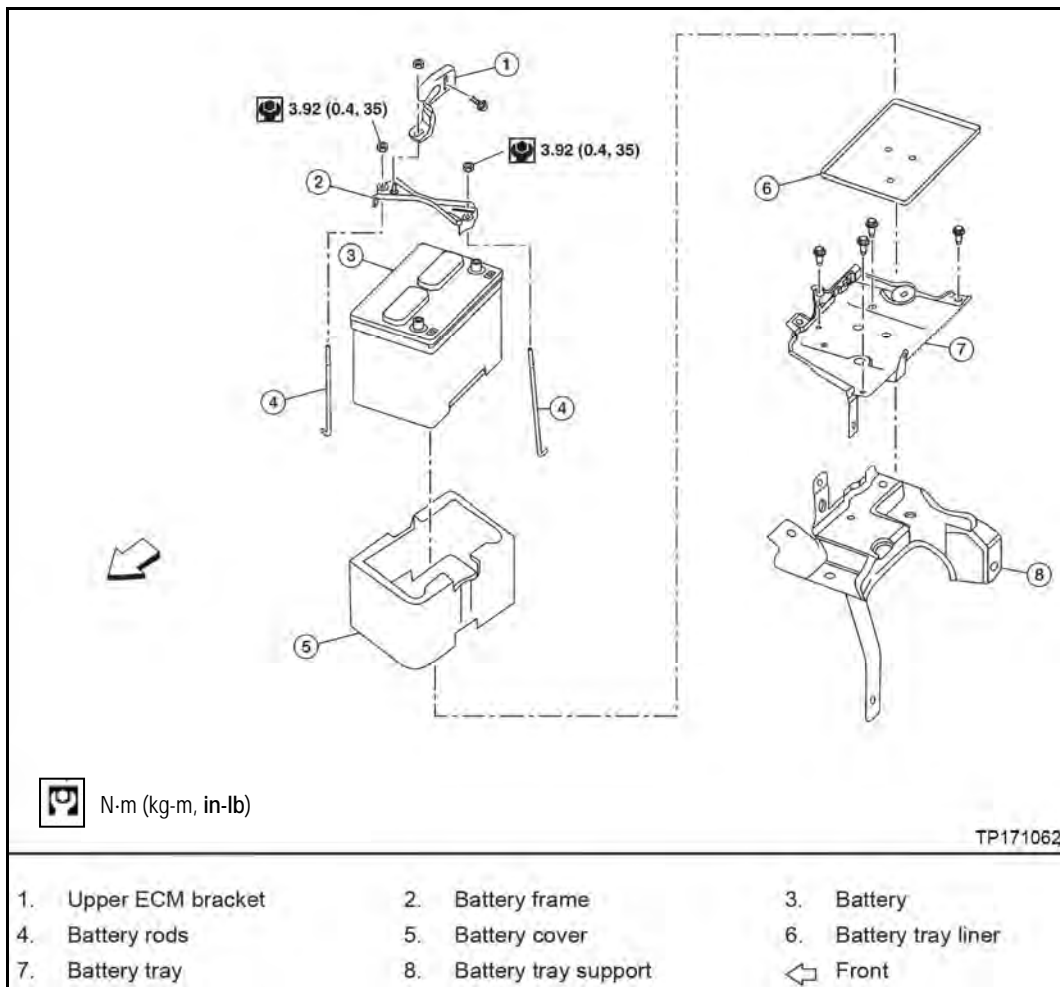
Figure 2

5. Disconnect battery negative terminal.
6. Remove cover on battery positive terminal.
7. Disconnect battery positive terminal.
8. Remove battery frame nuts.
9. Remove battery cover.
10. Remove battery.
11. Remove battery tray liner.

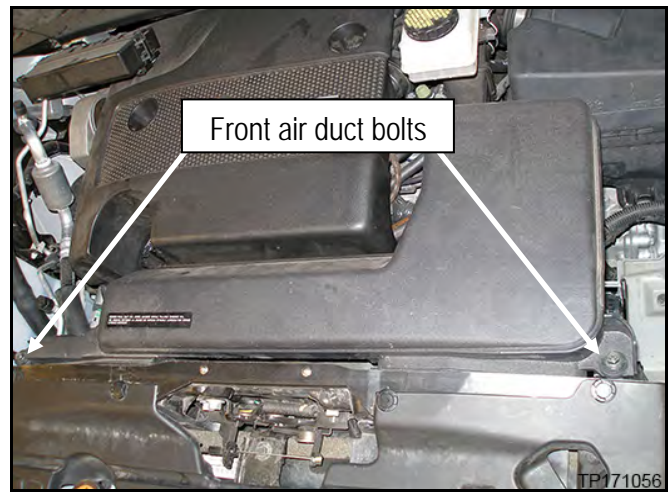
Figure 3

12. Remove 2 bolts securing the front air duct.

13. Remove the front air duct.

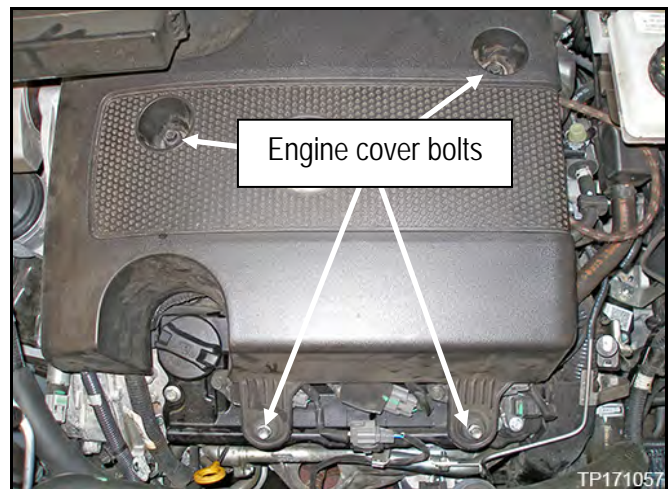
Figure 4

NOTE: Step 14 is for 2013 - 2016 model years only.

14. Remove 4 bolts securing the engine cover and remove the cover.

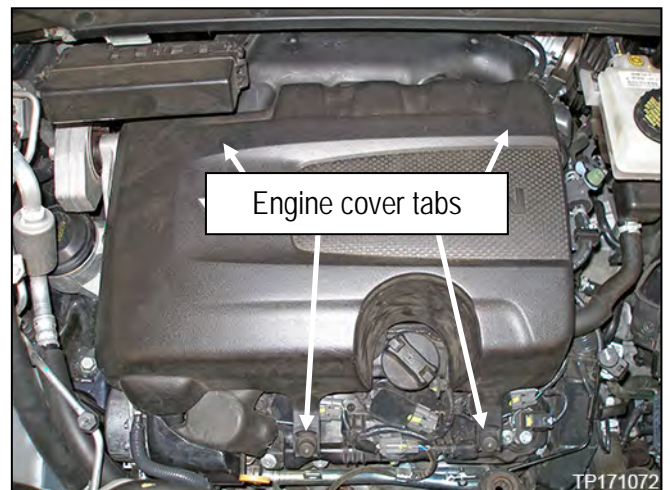
Figure 5

NOTE: Step 15 is for 2017 model year only.

15. Gently lift the engine cover to release the 4 tabs and remove the cover.

NOTE: The 2 rearward tabs are under the engine cover and cannot be seen.

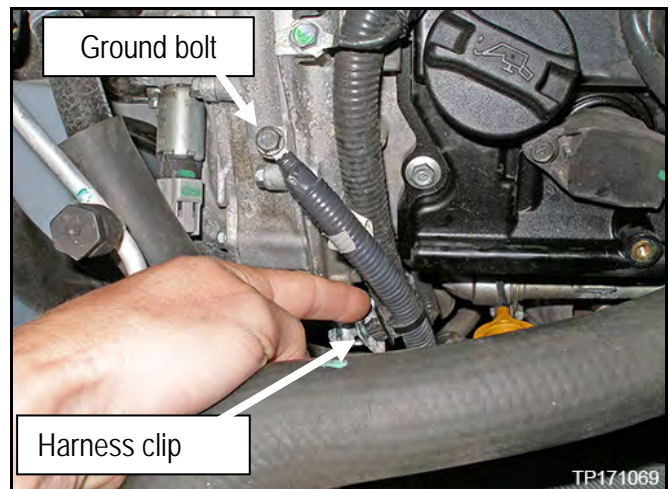
Figure 6

16. Remove ground bolt.

NOTE: 2013-2016 model years shown. 2017 model year is similar.

17. Disconnect harness clip.

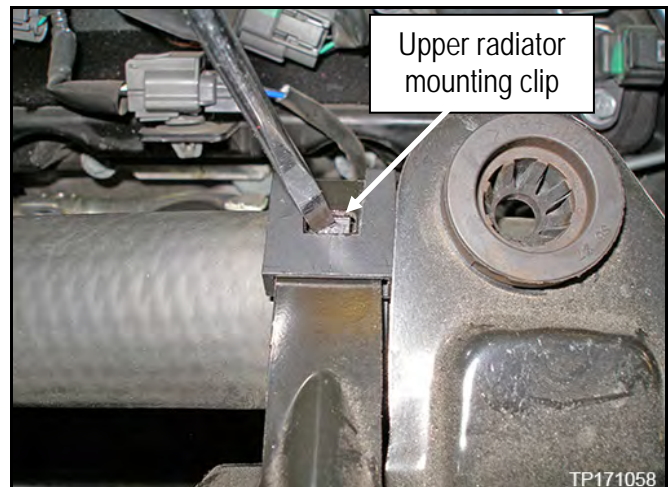
Figure 7

18. Disconnect clip securing upper radiator hose to radiator shroud.

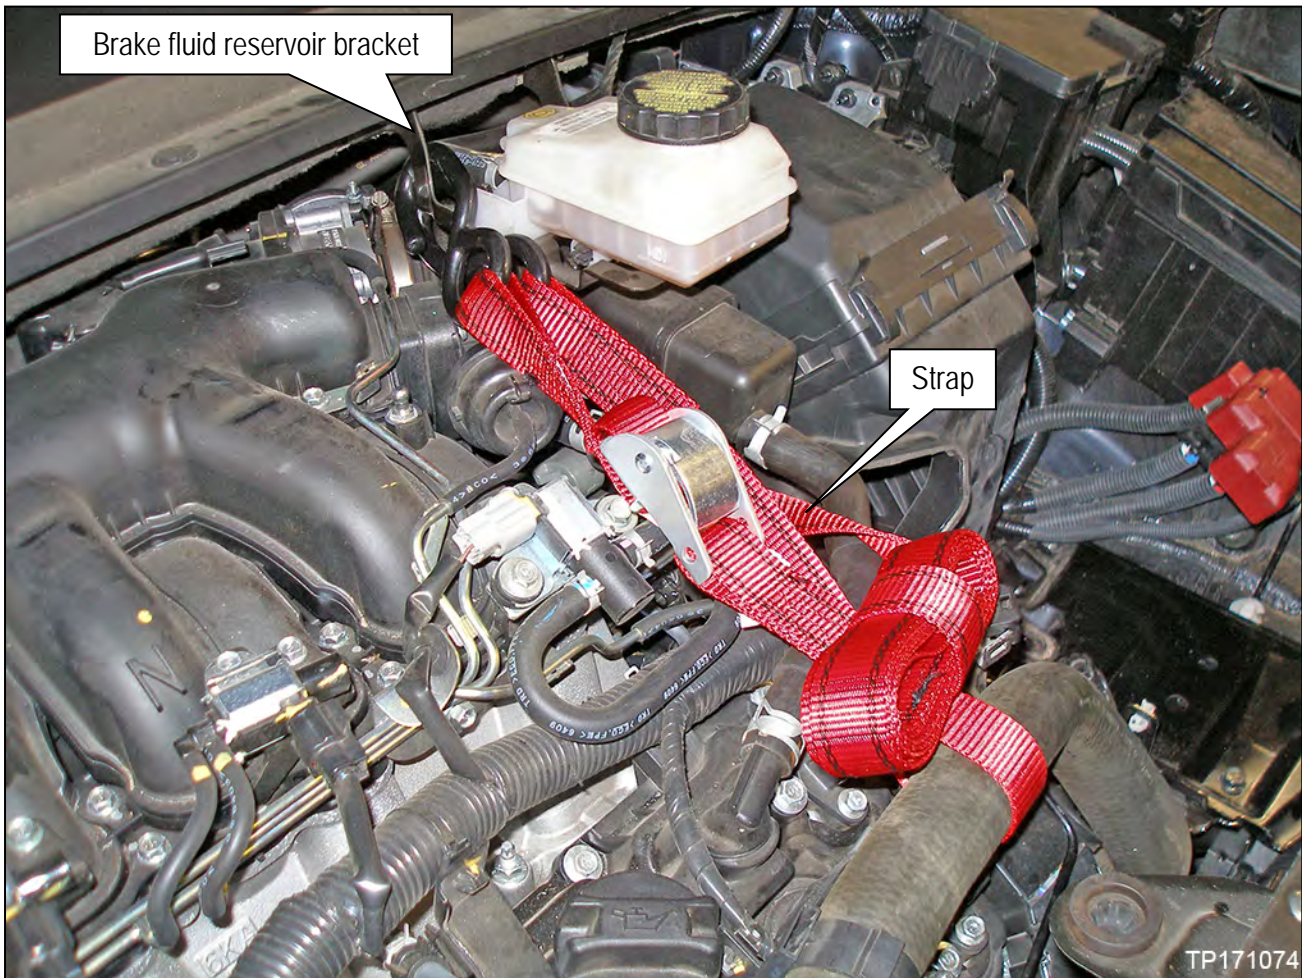
Figure 8

19. Temporarily secure upper radiator hose away from radiator shroud.

- Use a suitable strap to secure radiator hose.

NOTE: Secure the strap to the brake fluid reservoir bracket as shown in Figures 8 and 9.

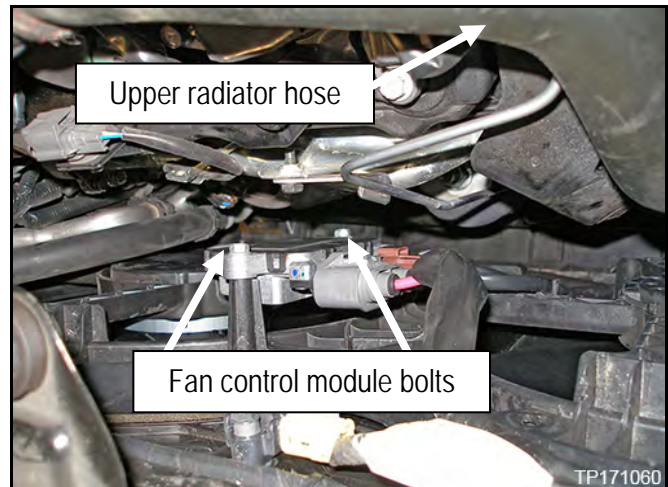
Figure 10

20. Remove the fan control module as follows;

- a. Disconnect the 3 electrical connectors on the fan control module.
- b. Remove the 2 bolts securing the fan control module to the radiator shroud.
- c. Remove the fan control module from the radiator shroud.

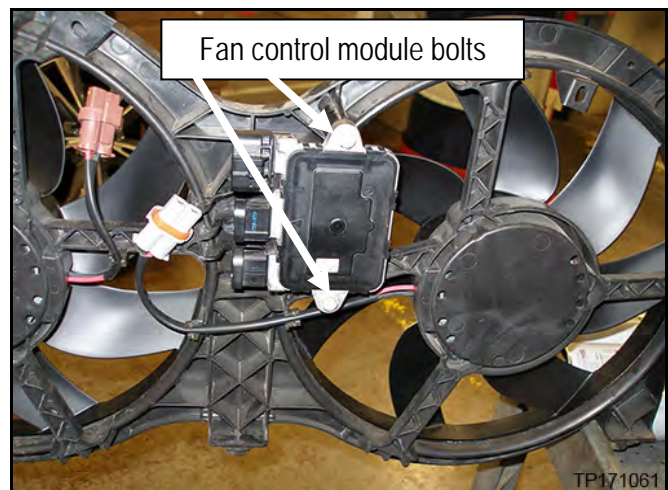
NOTE: Refer to Figure 11 for fan control module location (radiator shroud and cooling fan assembly removed from vehicle for clarification).

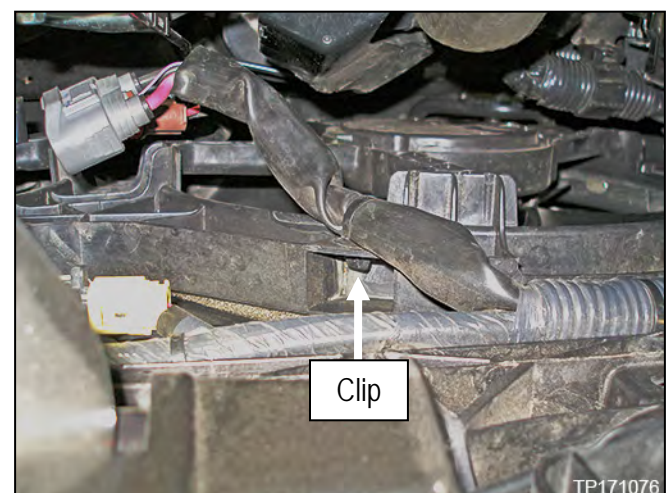
Figure 12

21. Release the fan control module harness clip from the radiator shroud and cooling fan assembly.

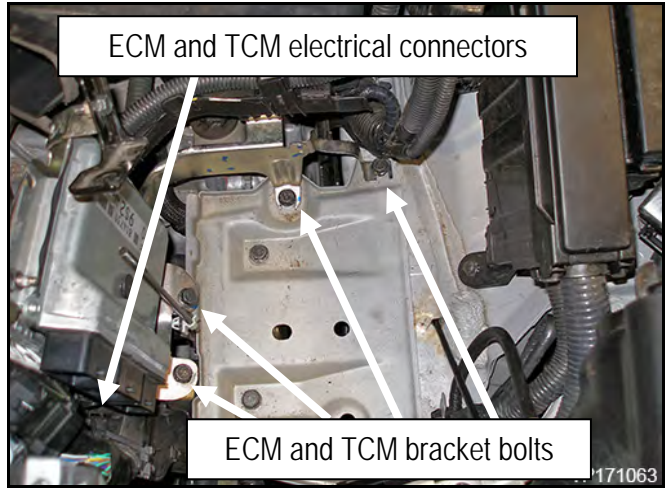
Figure 13

NOTE: Steps 22 and 23 are for 2013 - 2016 model years only.

22. Disconnect the ECM and TCM electrical connectors.

23. Remove the 4 ECM and TCM bracket bolts.

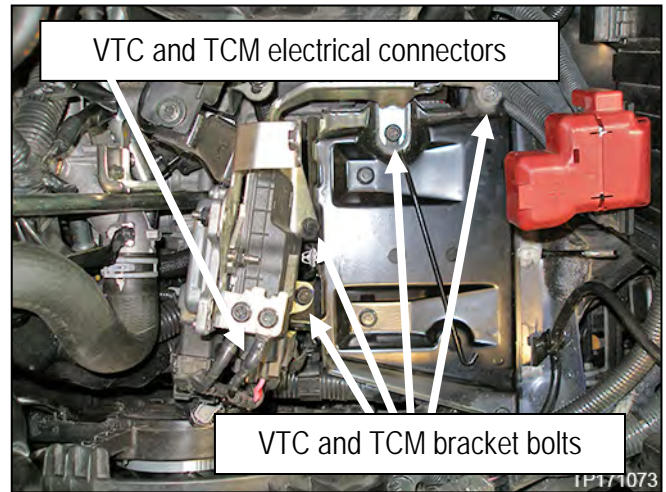
Figure 14

NOTE: Steps 24 and 25 are for 2017 model year only.

24. Disconnect the VTC module and TCM electrical connectors.

25. Remove the 4 VTC and TCM bracket bolts.

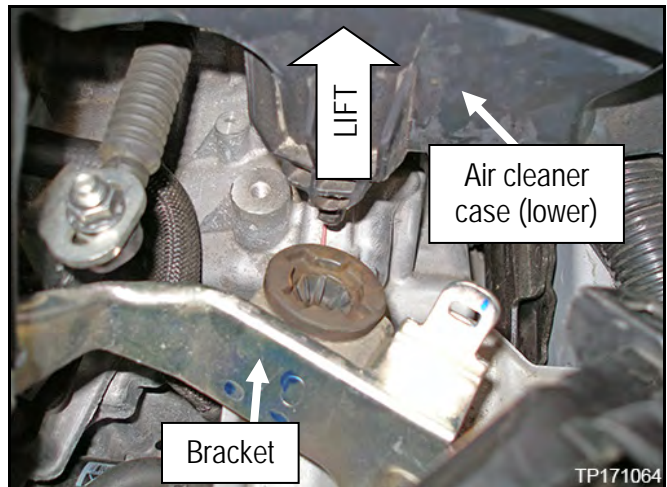
Figure 15

26. Lift up on air cleaner case (lower) to release the bracket.

NOTE: 2013-2016 model years shown. 2017 model year is similar.

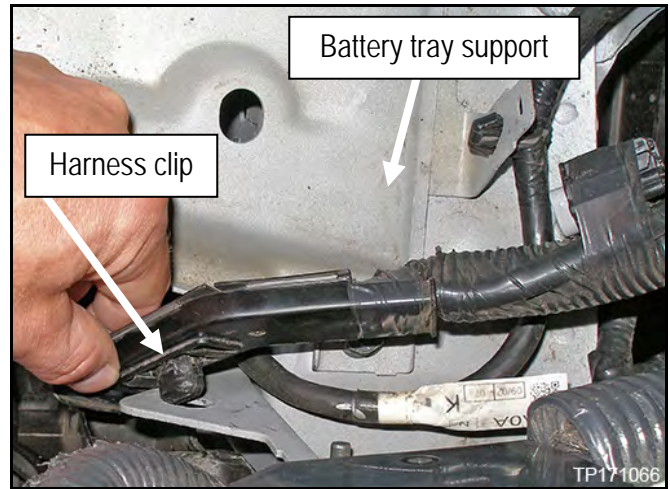
Figure 16

NOTE: Step 27 is for 2013 - 2016 model years only.

27. Release the driver's side harness clip from the battery tray support.

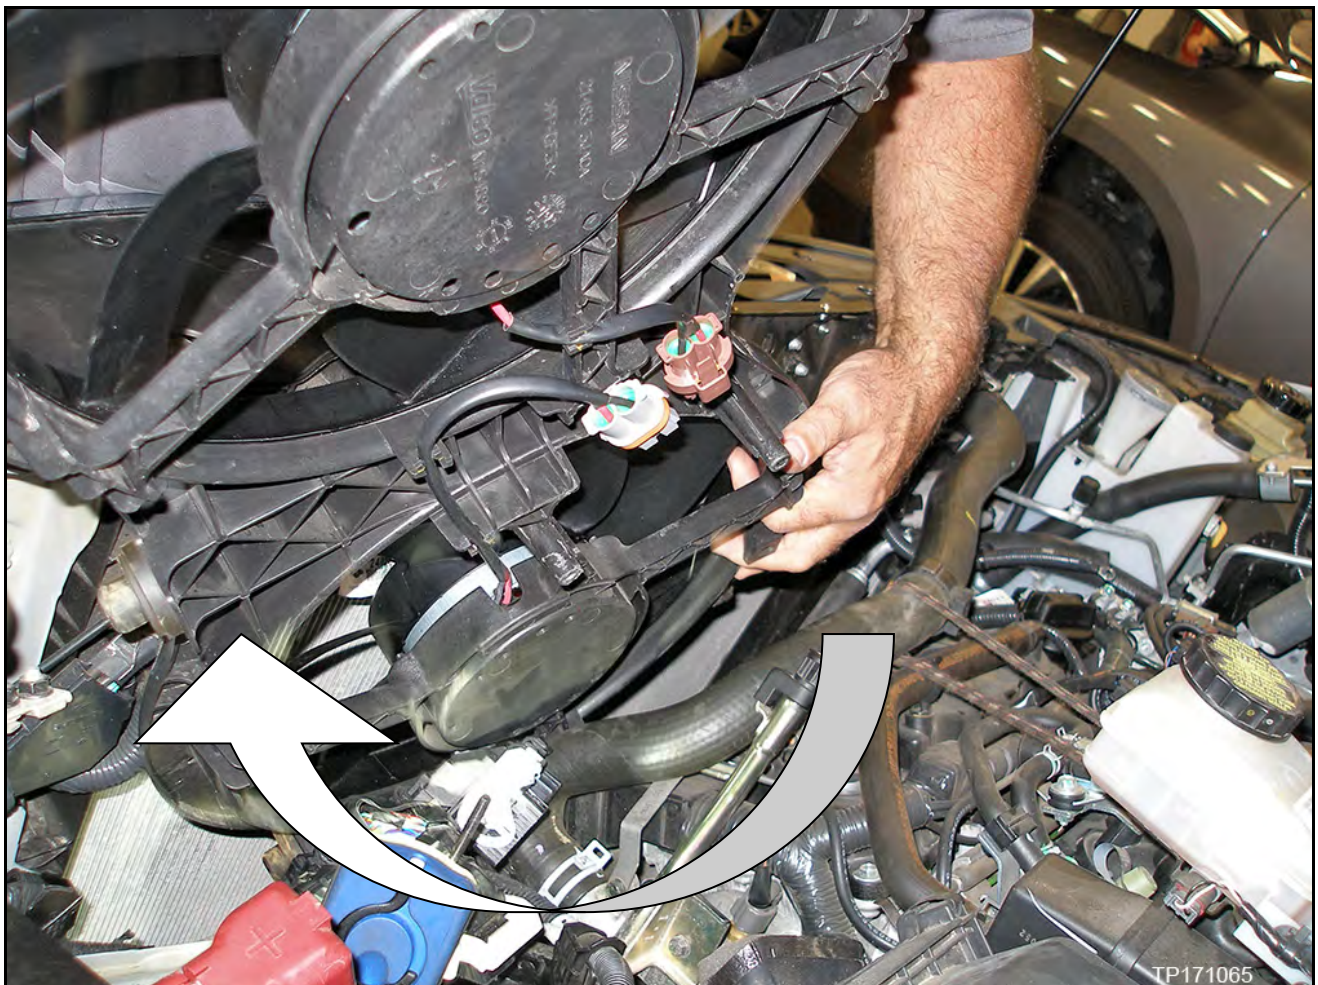
Figure 17

28. Remove the radiator shroud and cooling fan assembly mounting bolts (refer to Figure 18 on the next page for bolt locations).
29. Remove the radiator shroud and cooling fan assembly.
 - Start from the driver's side and lift the assembly out of the engine compartment.
