# SERVICE BULLETIN

Classification: BT16-028b	Reference: NTB17-017b	Date: September 12, 2017
------------------------------	--------------------------	-----------------------------

## 2016-2017 MAXIMA; NOISE HEARD WHEN LEANING BACK IN A FRONT SEAT

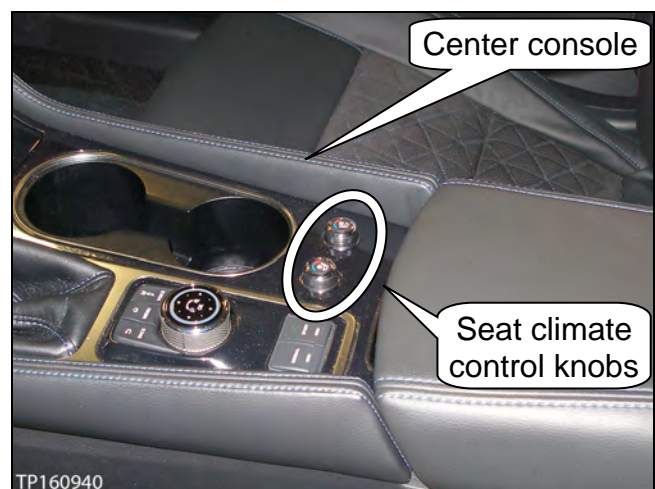
Figure 1

1. Determine if the noisy seat is equipped with climate control (see Figure 1).

- Look for control knobs located on the center console.

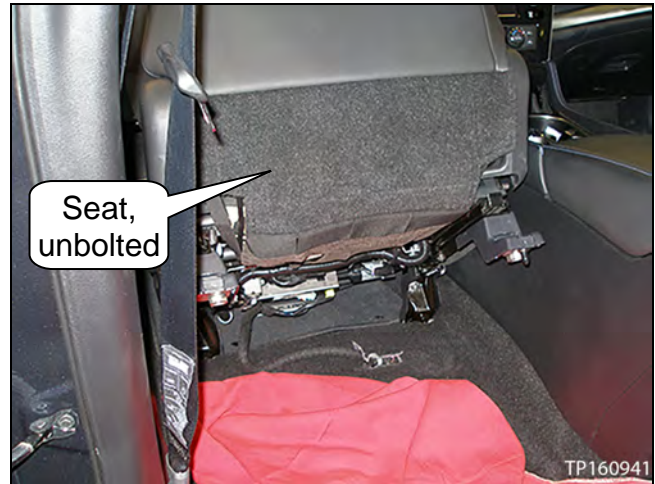
Figure 2

1. Unbolt the noisy climate controlled seat, and then tilt fore or aft. (see Figure 2).

- Driver seat shown, passenger seat similar.
- The headrest may need to be removed to allow seat tilting.
- When moving the seat fore and aft (to access the bolts), make sure the seat tracks stay “in sync” with each other.
- Do not disconnect any seat electrical connectors.

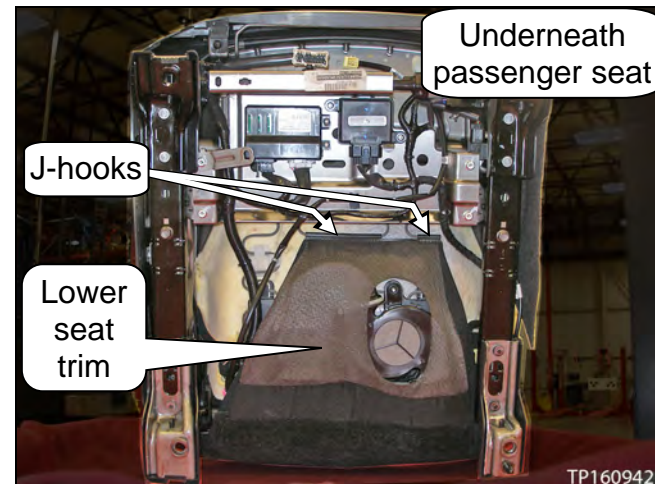
1. Climate controlled passenger seat: Unhook the J-hooks (see Figure 3).

- Figure 3 shows a typical climate controlled passenger seat. Your vehicle’s seat configuration may differ slightly.
- Remember which seat spring loops the J-hooks hook onto.

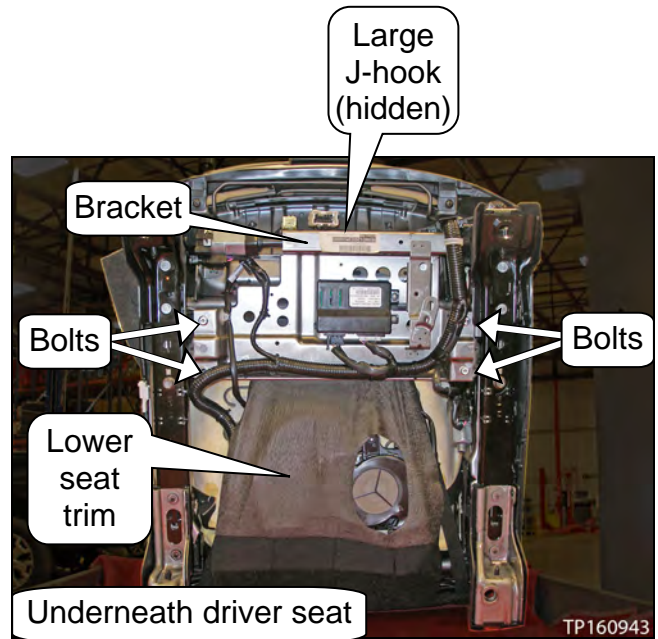
1. Climate controlled driver seat: Remove the four (4) bolts. See Figure 4.

**NOTE:** Figure 4 shows a typical climate controlled driver seat. Your vehicle's seat configuration may differ slightly.

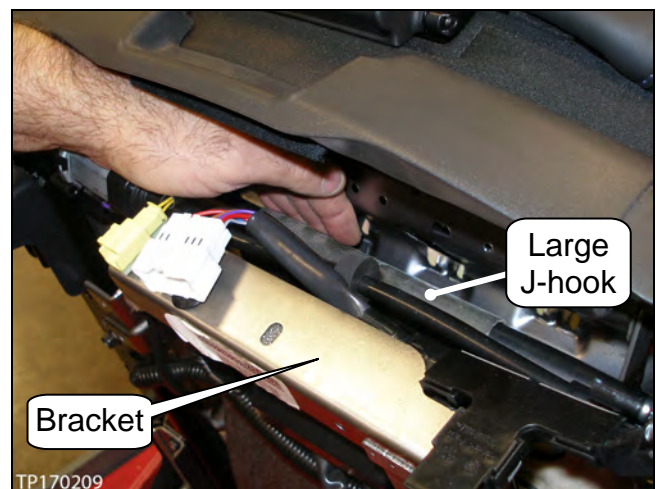
Figure 5

2. Reach in above the bracket, and then unhook the large J-hook to release the bottom seat trim (see Figure 5).
3. Pull out the large J-hook and lower seat trim from under the seat.
4. Go to page 7, **All Seats**.

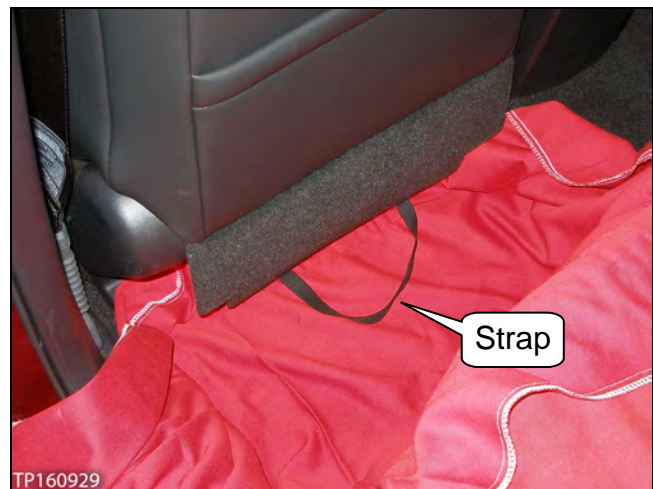
- For easier viewing, a non-climate controlled seat has been unbolted (see Figure 6). Non-climate controlled seats do not need to be unbolted or removed to perform this service procedure.
- Driver and passenger non-climate controlled seats are similar underneath. Your vehicle's seat configuration may differ slightly.

2. Reach under the seat to locate the elastic strap, and then unfasten it (see Figure 6 and 7).

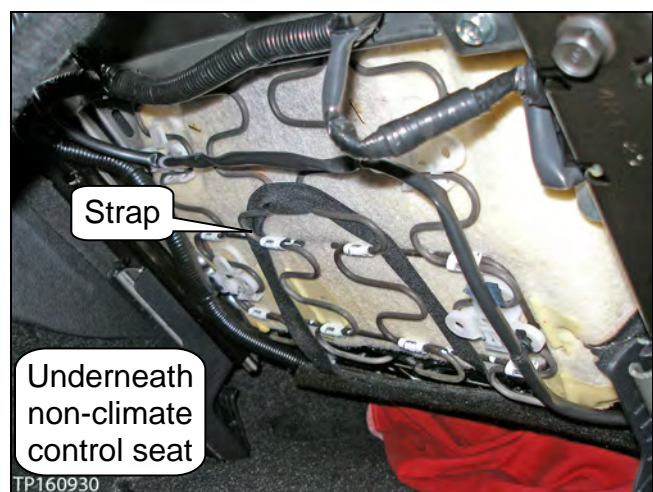
- The seat is unbolted in Figure 7, only to show where the elastic strap is fastened.
- Non-climate controlled seats: **Do not unbolt/remove the seat.**
- Figure 7 shows a typical non-climate controlled seat. Your vehicle's seat configuration may differ slightly.

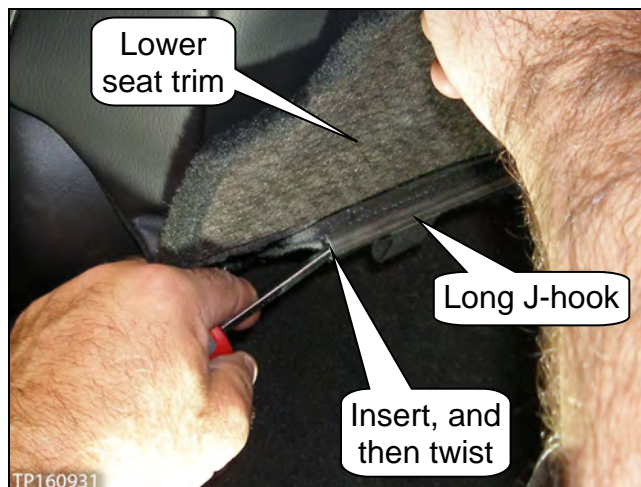
Figure 8

- Lift the lower seat trim to access the long J-hook (see Figure 8).
- a. To start separating, insert a screwdriver or other suitable tool, and then twist (see Figure 8).
- b. With the long J-hook partially unfastened, pull it apart the rest of the way.

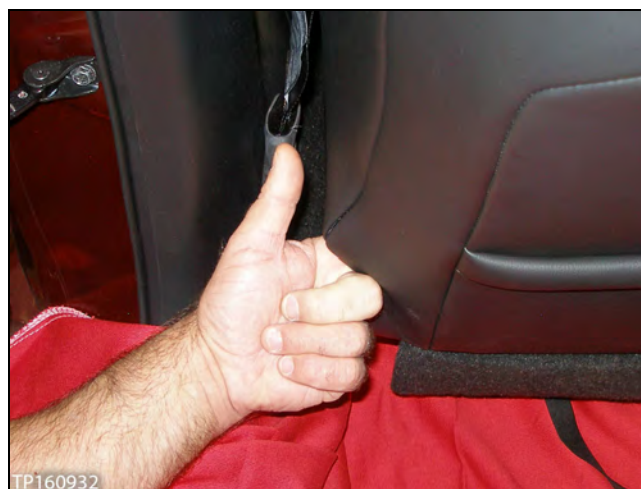
### 2. Reach up under the seatback trim to access the zipper, and then pull it out from inside the seat (see Figure 9 and 10).

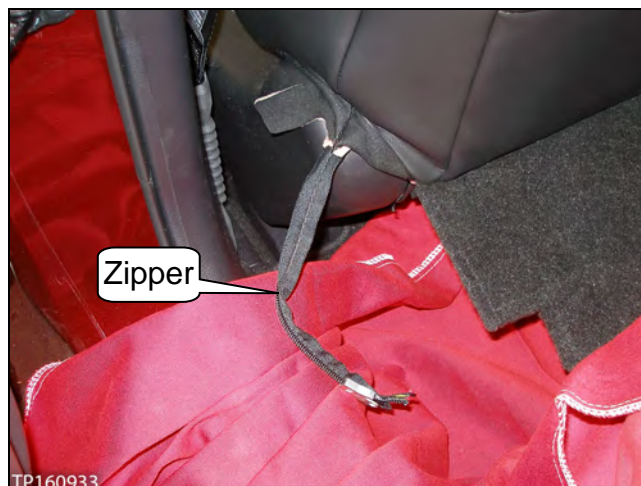
Figure 10

- Pull out the zipper on the outside of the seat, closest to the “B” pillar (see Figure 10).

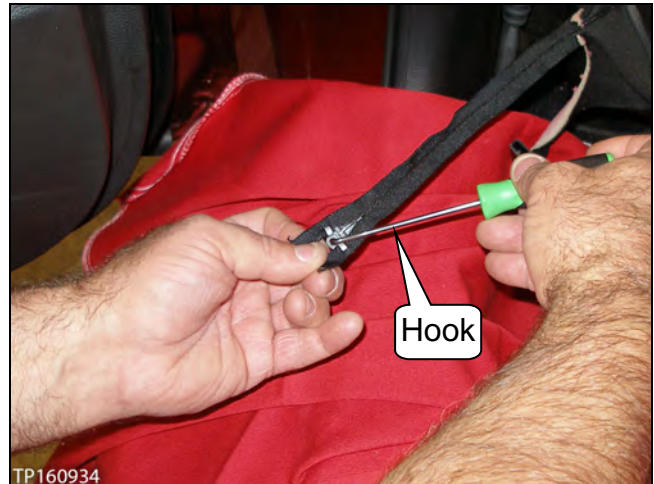
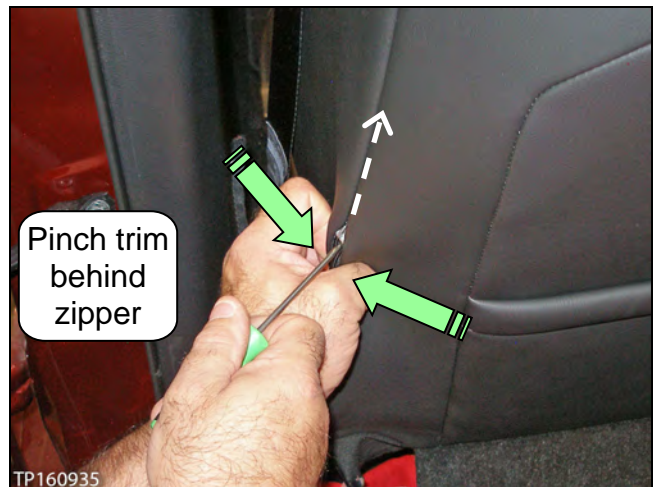
3. Carefully unzip the zipper all the way up.
  - Use a suitable tool to pull the zipper.
  - Pinch the trim together behind the zipper as it is being pulled upward (to relieve tension on the zipper).
  - See Figure 11 and 12.

- Be careful when unzipping. The zipper may come undone if forced or operated aggressively.
- If the zipper comes apart, the seat assembly will need to be replaced.

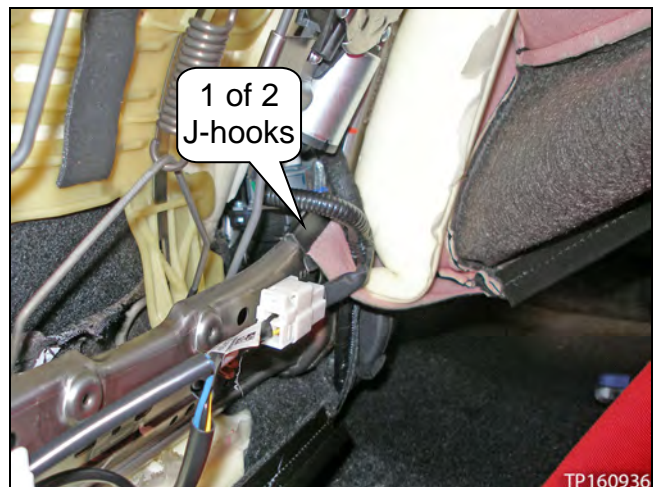
4. Unhook both J-hooks from the seatback frame (see Figure 13).
  - Figure 13 shows the inner J-hook. The outer J-hook is not shown.
5. Unzip the second zipper.
  - Unzip the second zipper the same way as stated in step 3.
  - The **CAUTION** and **IMPORTANT** notes in step 3 also apply here.

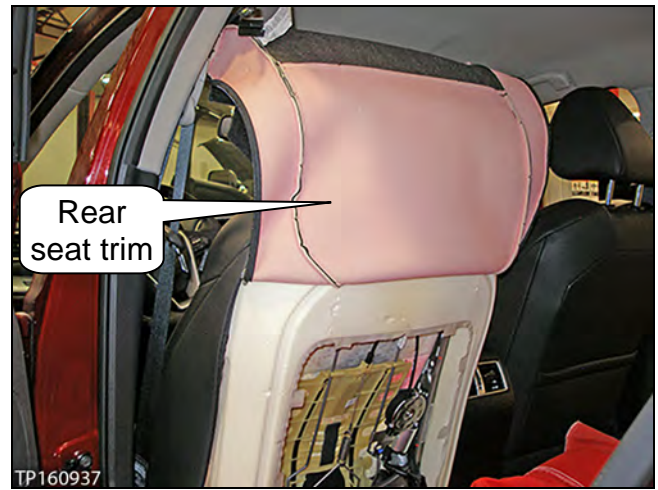
Figure 14

6. Drape the rear seat trim over the top of the seatback (see Figure 14).

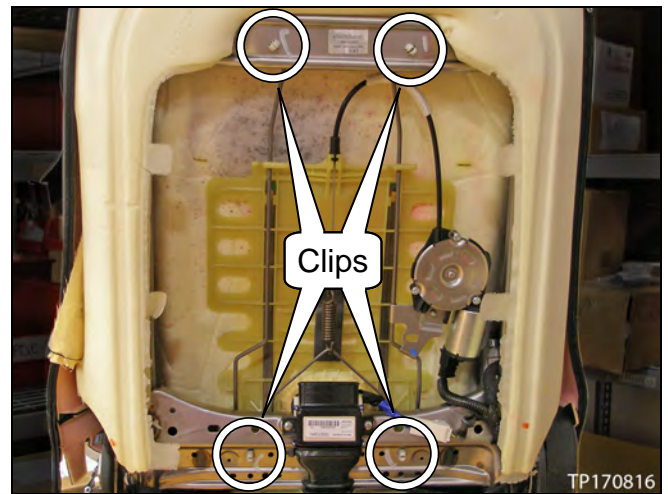
Figure 15

7. Unfasten the four (4) clips.
  - Clips are circled in Figure 15.

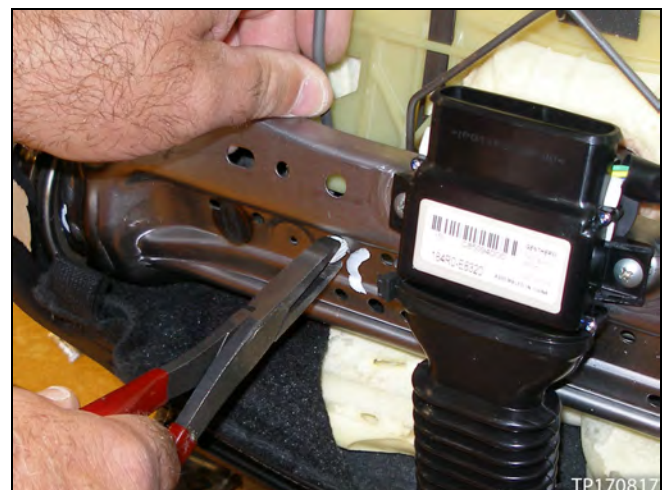
Figure 16

- Unfasten the clips by pinching, and then pushing through (see Figure 16).

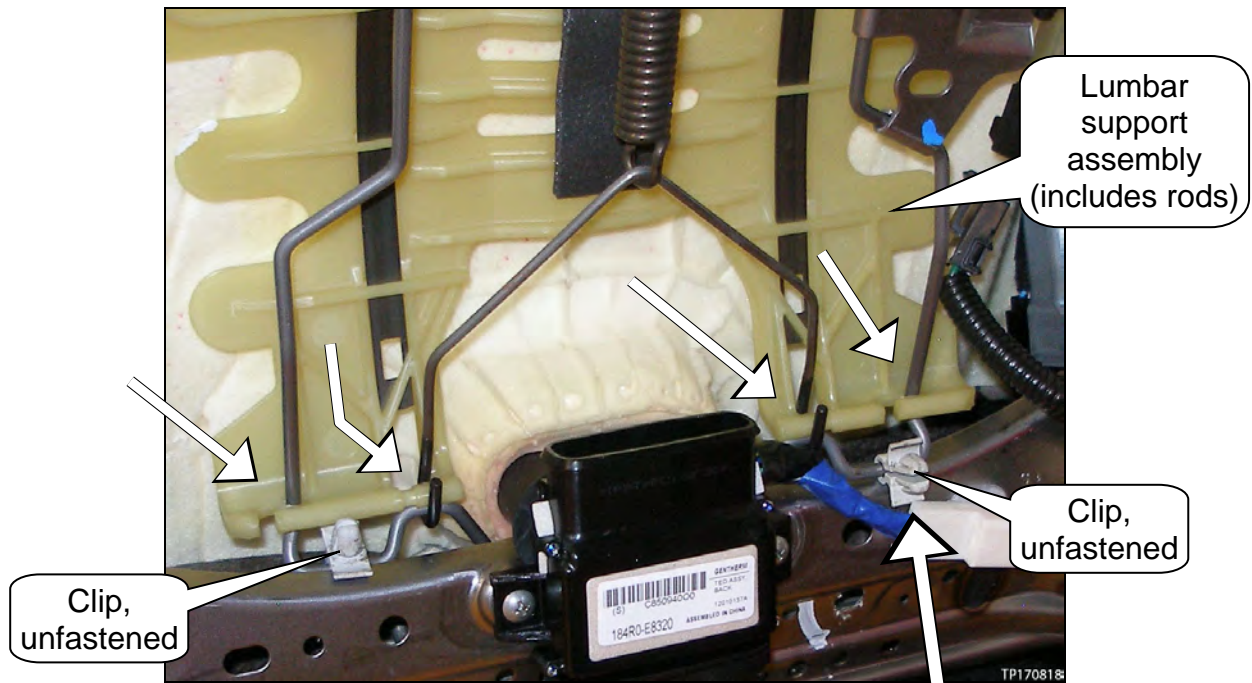
8. Lift the lumbar support assembly (see Figure 17 below).

**NOTE:** In steps later on in this bulletin, grease will be applied to specific areas of the lumbar support assembly. The arrows in Figure 17 show some of these areas.

9. Remove the two (2) lower clips from the rods (see Figure 17 and 18).

- For warranty repairs, Nissan Window Regulator Grease must be used. For customer pay repairs, Nissan Window Regulator Grease or an equivalent is recommended.
- Only the areas shown need to be greased, not the whole length of the rods.
  - See page 10 Figure 17, Figure 21 below, and page 13 Figure 22, as it applies.
- Figure 21 and 22 show a driver seat with power adjust lumbar and a non-adjustable lumbar seat, respectively. Your vehicle's seat configuration may differ slightly.
- Non-adjustable lumbar seats only: Also apply grease to the end of the return spring (see next page, Figure 22).

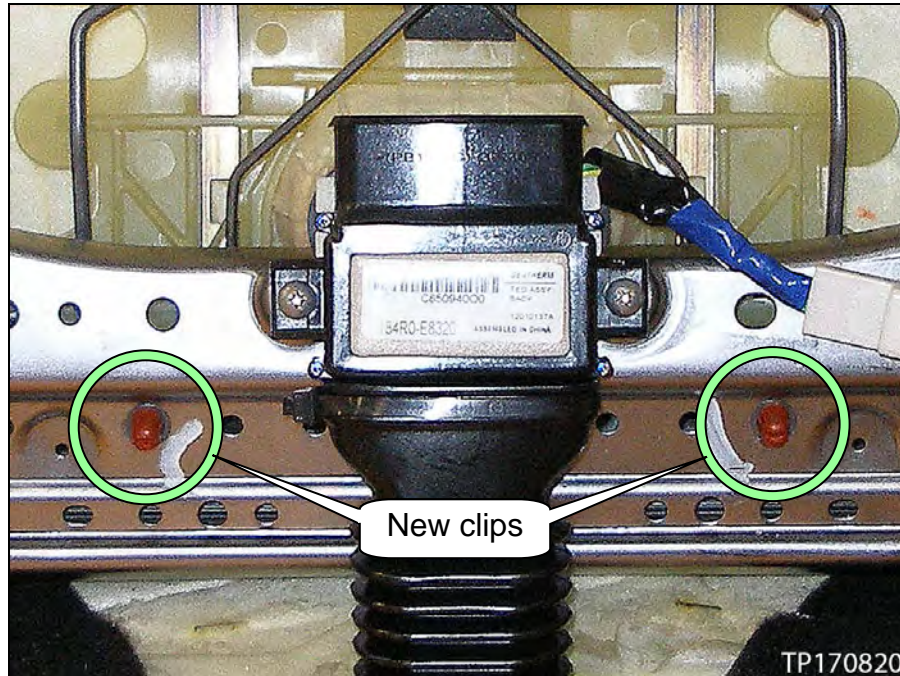
11. Reposition the lumbar support assembly, and then snap all clips into place (see Figure 19 and 20).

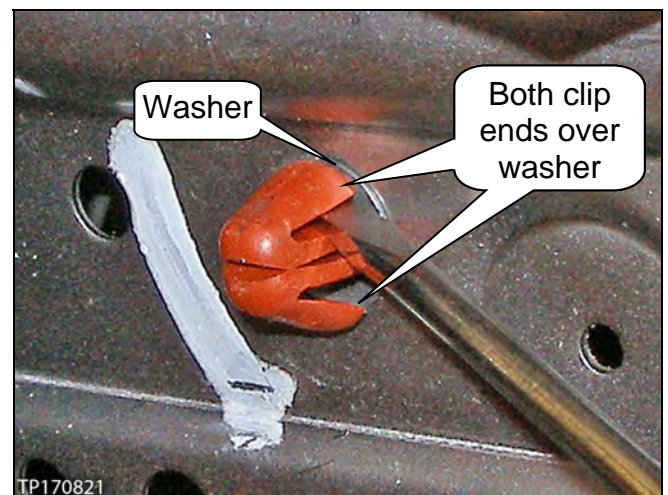
Figure 20

12. Push the new washers (see **PARTS INFORMATION**) over the tip of the new clips.

- The washer can be pushed on with a  $\frac{1}{4}$  inch drive 8 mm socket.
- Make sure the washers are under the ends of the clips (see Figure 20).
  - If needed, use a pocket screwdriver or suitable tool to spread the clip over the washer.

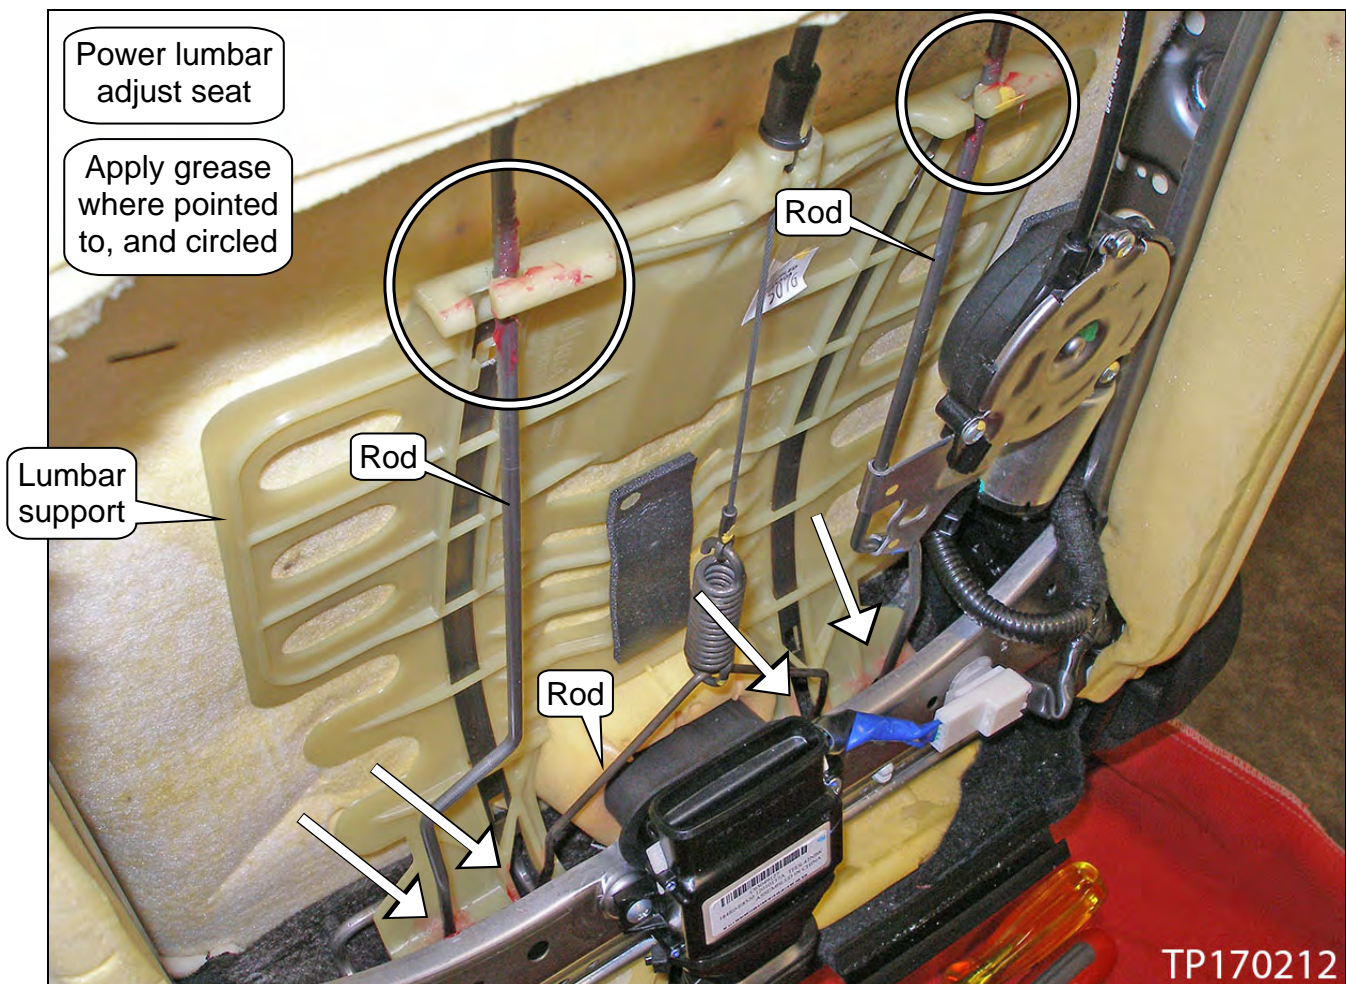
Figure 21

13. Apply a thin coating of Nissan Window Regulator Grease (see **PARTS INFORMATION**) to the rods where the lumbar support slides on.

**CAUTION:** Do not apply an excessive amount of grease as it may get on the seatback trim and stain it.

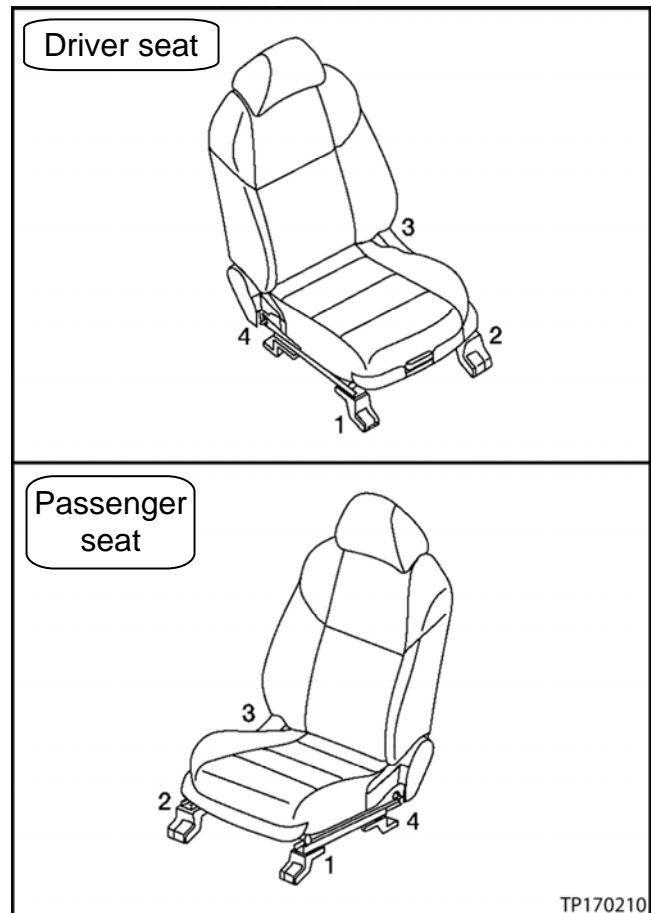
- For seats needing to be bolted in / resecured: Torque the seat bolts in the order shown in Figure 23 (as it applies).
- Seat bolts torque: 49 N•m (5.0 kg-m, **36 ft-lbs**)
