SERVICE CAMPAIGN BULLETIN

NTB17-099

VOLUNTARY SERVICE CAMPAIGN 2017 TITAN REAR HOOK BRACKETS

CAMPAIGN ID #: PC574
APPLIED VEHICLE: 2017 Titan (A61)
Does not apply to Titan XD.

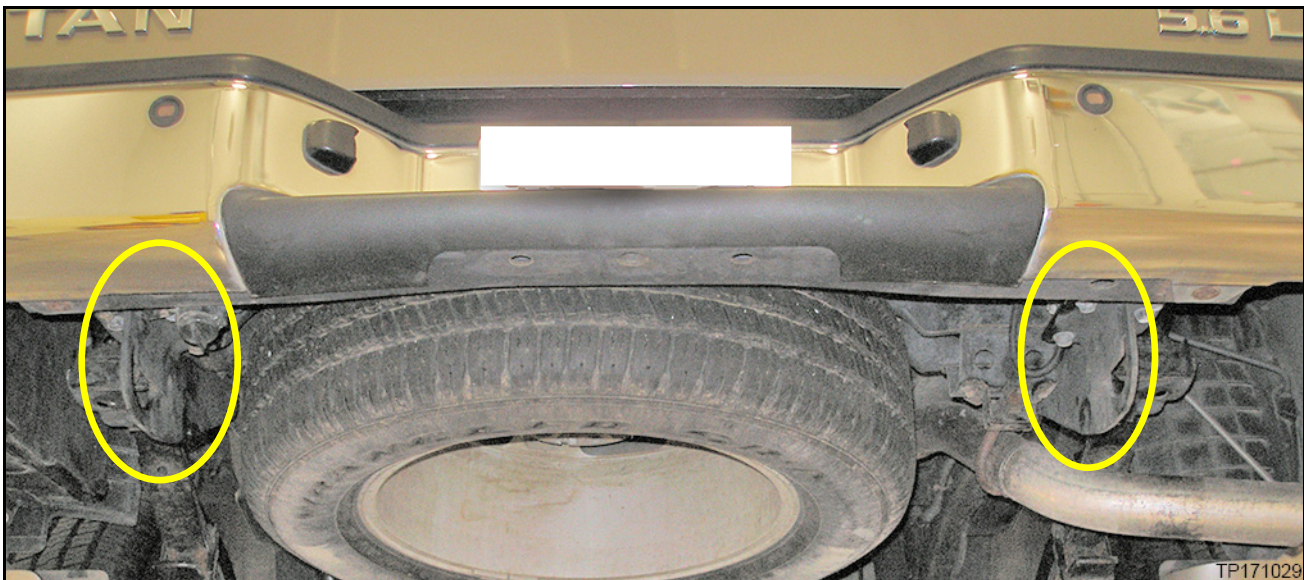
Figure 2

2. Lift the vehicle to gain access to the rear hook bracket locations.
 - Refer to the Electronic Service Manual (ESM) section GI- General Information for lifting point information.
3. Inspect for rear hook brackets in the locations shown in Figures 2 below and Figure 3 on the next page.

4. If rear hook brackets are present as shown in Figures 2, and 3 then no further action is required.
5. If rear hook brackets are missing as shown in Figures 4 and 5; then clean the debris from all rear hook bracket bolt holes (5 per side) using mild soap and water.

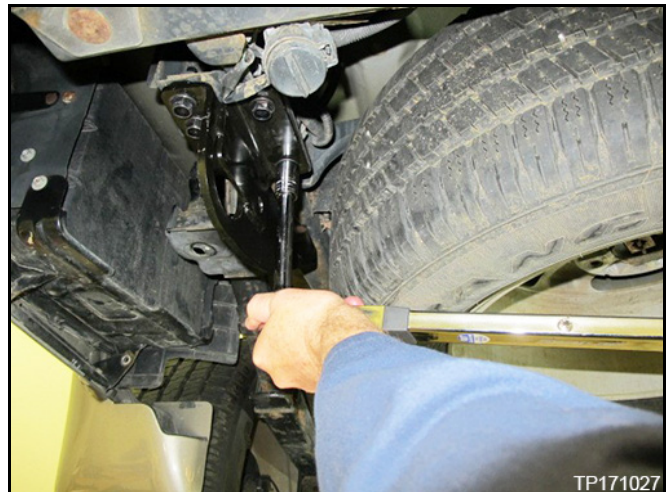
Figure 7

7. Torque the new rear hook bracket mounting bolts to;
130 N·m (13.25 kg-m, **96 ft-lb**)
