## **TECHNICAL SERVICE BULLETIN**

**SB-17-027 COE SEAT FRAME BOLT LOOSE OR  
MISSING**

**GROUP: 0-GENERAL  
BULLETIN NO: SB-17-027  
DATE: 9-28-2017  
REFERENCE: HMM-170925-J1**

**SUBJECT VEHICLES:** 13MY-16MY Cab Over Engine (COE) Trucks equipped with the magnetic suspension driver's seat.

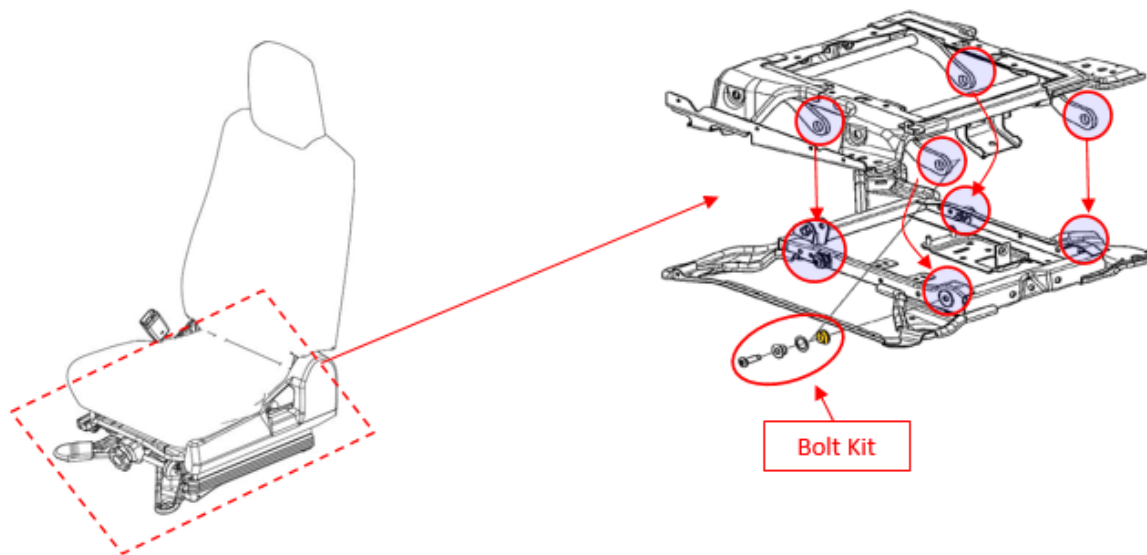
The following TSB (Technical Service Bulletin) provides replacement instruction for the magnetic suspension seat pivot bolts in the event that one or more of these bolts are found loose or missing.

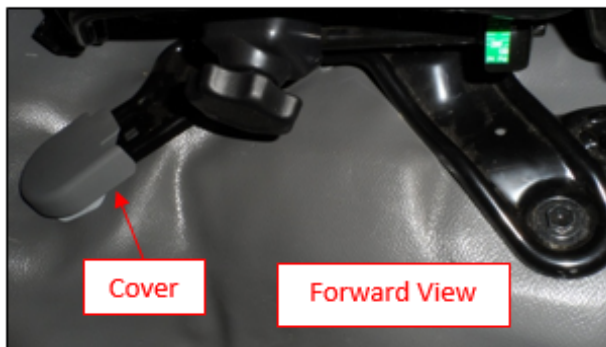
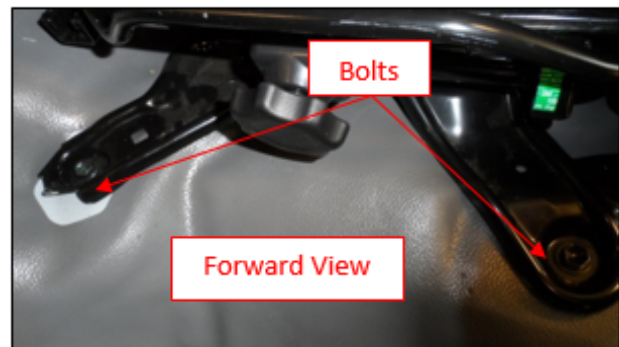
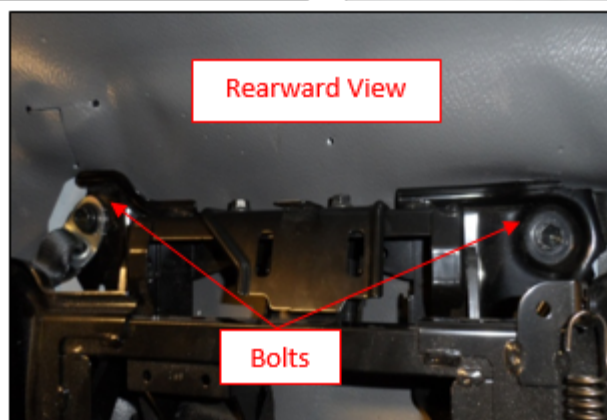
1. Remove the bolt cover from the front inboard side of the driver's seat frame. Remove the two bolts which retain the driver's seat to the floor of the vehicle and retain for reinstallation. Slide the seat to the forward position and remove the two bolts which retain the rear of the driver's seat to the floor. Remove the driver's seat from the vehicle.

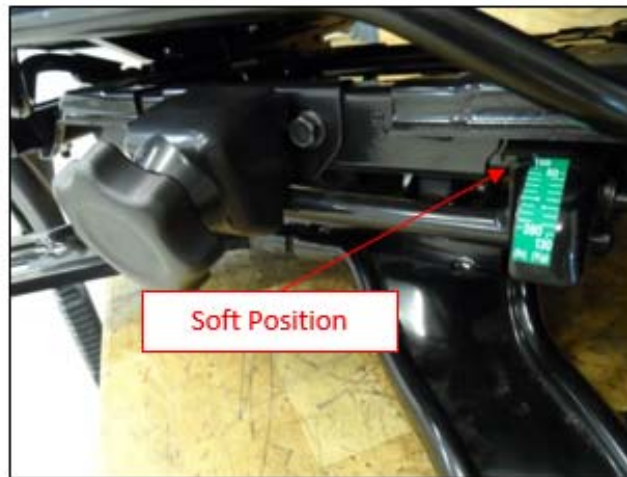
2. Place the seat on a work bench. Set the tension of the adjustment knob to the minimum/soft position.

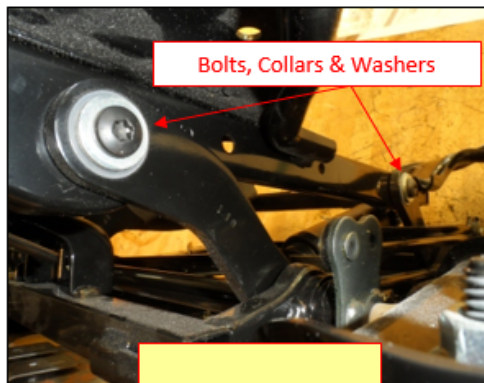
Inboard Side of Seat

3. While using care not to stain or damage the upholstery, flip the seat over on the work bench. Locate the four pivot bolts under the seat. Remove and discard the four bolt, collar, and washer combinations (unless missing). Remove and discard the 4 bushings on the back side of the seat pivot arms (unless missing).

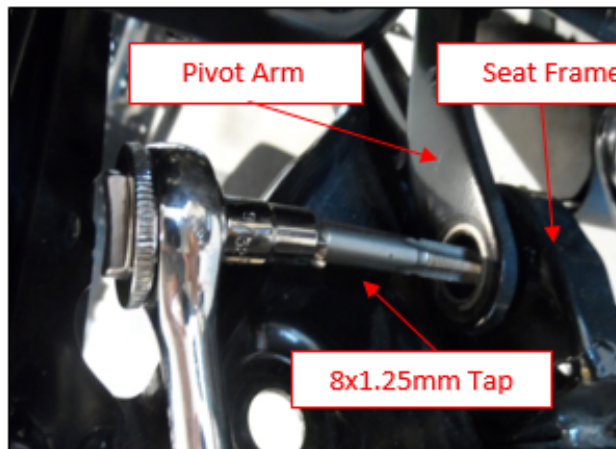
4. Clean the threads of each bolt hole using an 8x1.25mm tap.

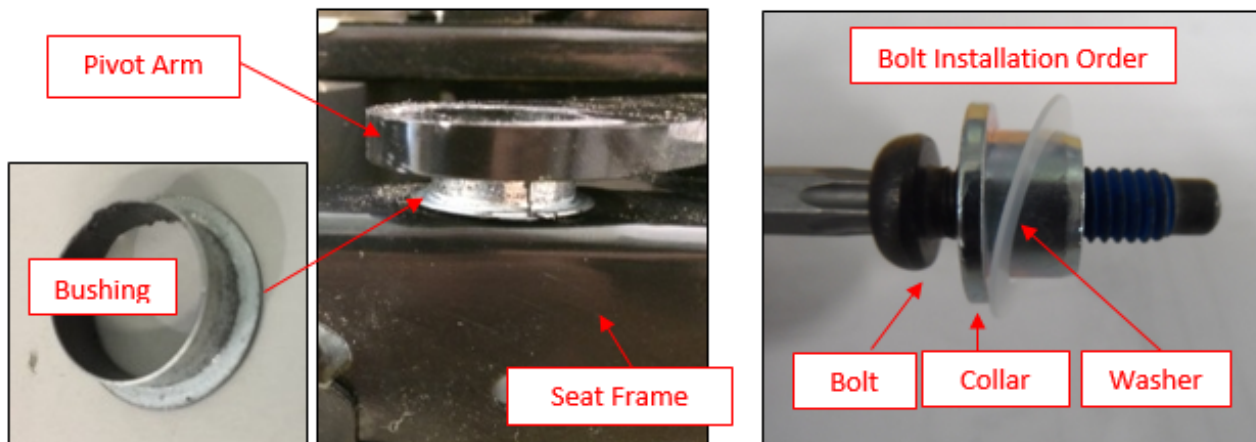
5. Install a new bushing in the back side of each pivot arm. After installing all 4 bushings, install a new bolt, collar, and washer in each pivot arm. Make certain a bushing is present in the pivot arm before installing the bolt. See the installation order photographs below. Tighten the bolt until snug using a T-40 Torx bit. The final torque will be applied in the next step.

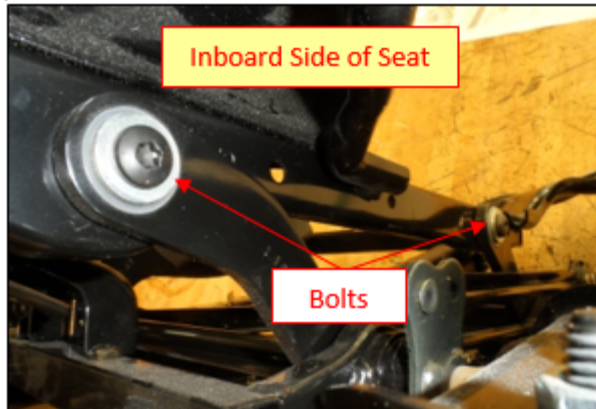
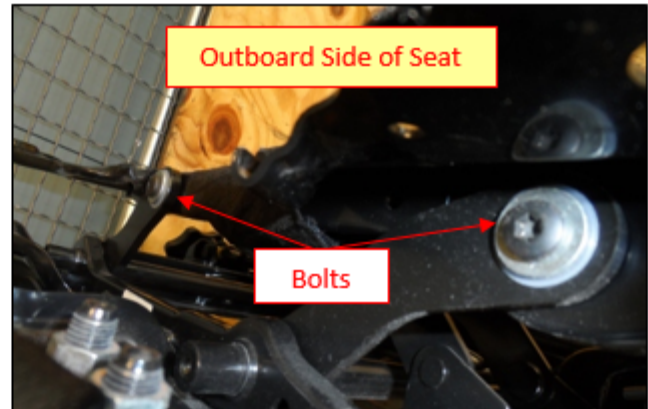
6. Tighten the four new pivot bolts to the specified torque.

**Specified Torque:** 18 lb-ft (25 Nm)

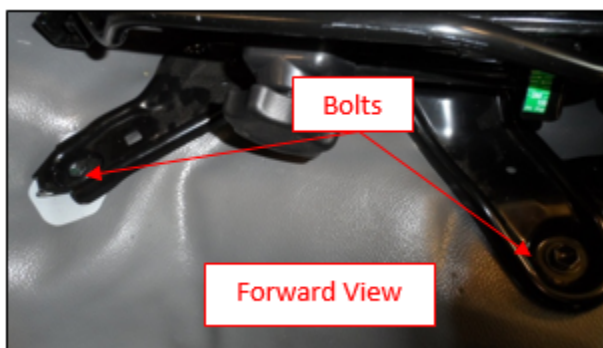
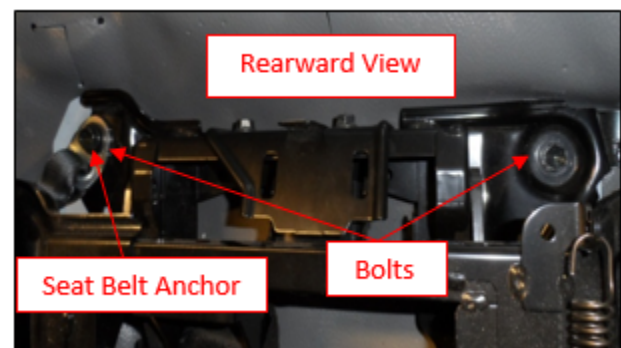
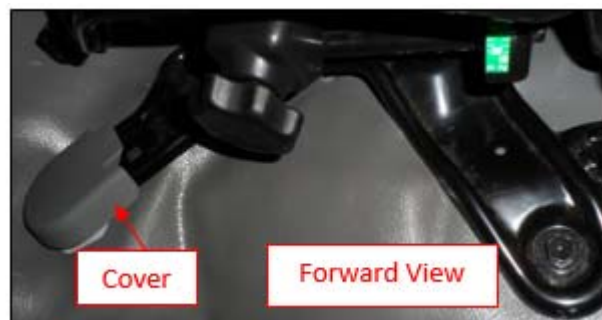
7. Position the driver's seat into the vehicle. Loosely install the four bolts which retain the driver's seat to the floor making certain that the inboard rear bolt is inserted through the seat belt anchor. See the photograph below. Tighten the four bolts to the specified torque. Reinstall the cover over the inboard front bolt once the bolts have been tightened to the specified torque.

**WARNING: NEVER** install the inboard rear seat frame bolt without first inserting it through the seat belt anchor. Failure to fasten the seat belt anchor properly may result in serious personal injury or death in the event of a collision.

**Specified Torque:** 29 lb-ft (39 Nm)
