# **Service Alert**

STOPPER PLATES FOR AIR BAG MODULE CONNECTORS HAVE BEEN ESTABLISHED AS NEW SERVICE PARTS

Service Alert No.: SA-068/17

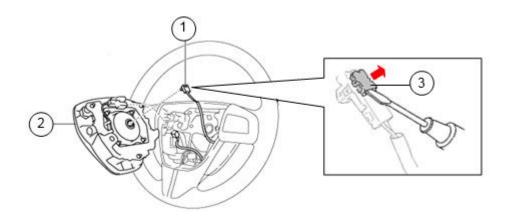
When removing the connector (1) to the air bag module (2), make sure to first lift the stopper plate (3) carefully using a flathead screwdriver (but do not remove it), and then pull out the connector.

- Pulling out the connector without lifting the stopper plate will cause damage to the connector.
- If work is not performed carefully, the stopper plate may pop off/be damaged/become lost.

In case that the stopper plate is damaged/lost during the recall work, the stopper plates have been established as new service parts. Two types of old and new stopper plates exist. The exact switching date from the old to new stopper plate is unknown. Confirm the configuration of the stopper plate used on the vehicle, then order one with the same configuration.

Part Number	GAY1 67 022	GAY2 67 022
Description	Stopper Plate (OLD TYPE)	Stopper Plate (NEW TYPE)
Configuration	OLD TYPE	NEW TYPE
