Bulletin #: HTB2017-09.14

RE: All Horton Models with aluminum attendant seat base with flip-up lid and A/C system underneath

HEV Seat Base Mounting Hardware

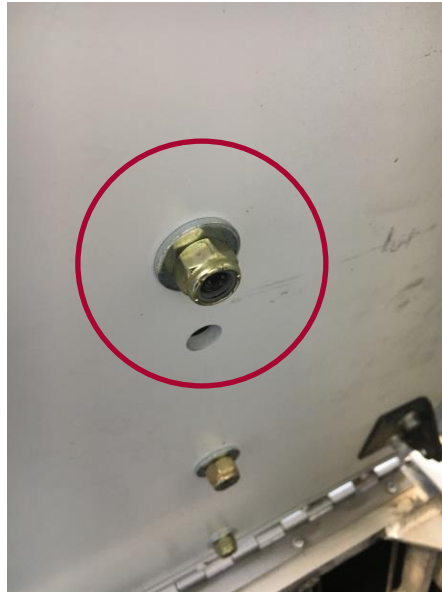
Figure 1

Horton works to continually improve our processes and quality based on feedback from dealers, the warranty team, service, assembly and suppliers. During an inspection of an A/C unit, we discovered that a shorter bolt was used to secure the attendant seat base to the flip-up plate.

After an internal investigation, it was determined that this non-conformity could be present on units built between June 26th through August 30th 2017.

- Action on delivered units, perform a visual inspection of the hardware used to secure the attendant seat. If you can see the nylon of the locking nut, the bolt needs to be replaced. The replacement bolt needs to be a **7/16" – 20 GR5 1 ½" long** and needs to be torqued down to 44 lbf-ft.

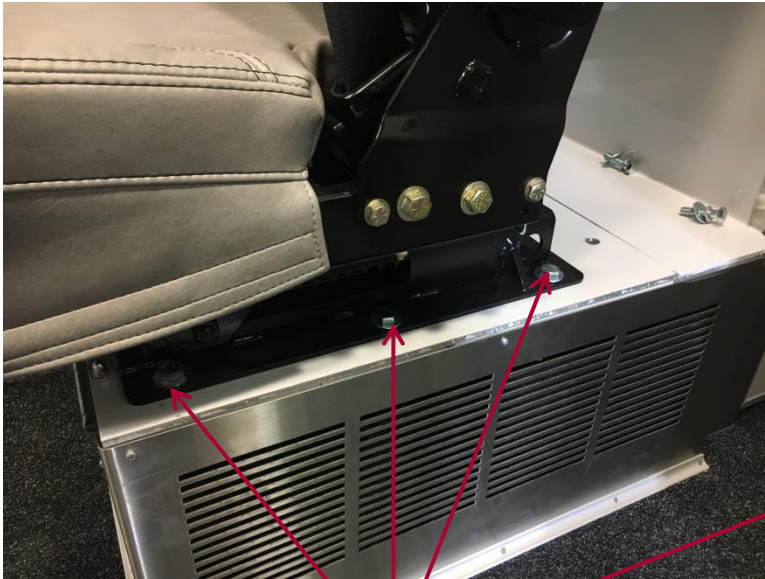
To secure the seat we use six (6) 7/16"-20 GR5 bolts torqued down to 44 lbf·ft with a nylon lock nut.

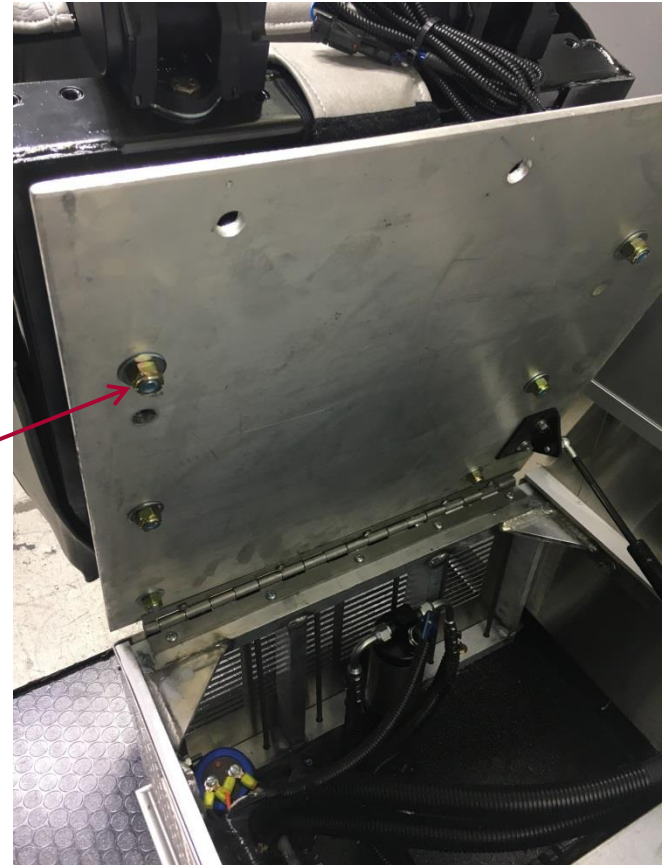
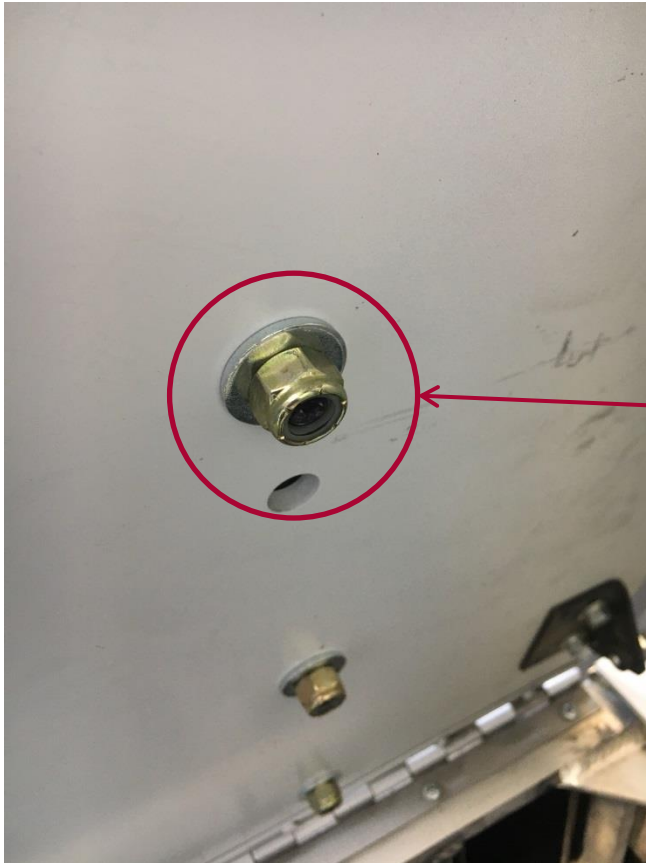
HEV Seat Base Mounting Hardware

During a period of approximately 2 month (a possibility of 75-80 units affected) the installer used a shorter bolt. The smaller bolt was properly torqued, unfortunately did not engage the locking portion of the nylon nut.

A campaign lead by QC and production identified affected units in our line and a plan is in place to switch bolts. Any unit deliver after today, September 7, 2017 will have the proper hardware.
