Technical product information

Topic	Mulsanne Flying "B" Radiator Grille Mascot - Failure to Latch And Hold
Market area	Bentley: worldwide (2WBE),Hongkong-Macau (5HK)
Brand	Bentley
Transaction No.	2048803/1
Level	EH
Status	Approval
Release date

Mulsanne

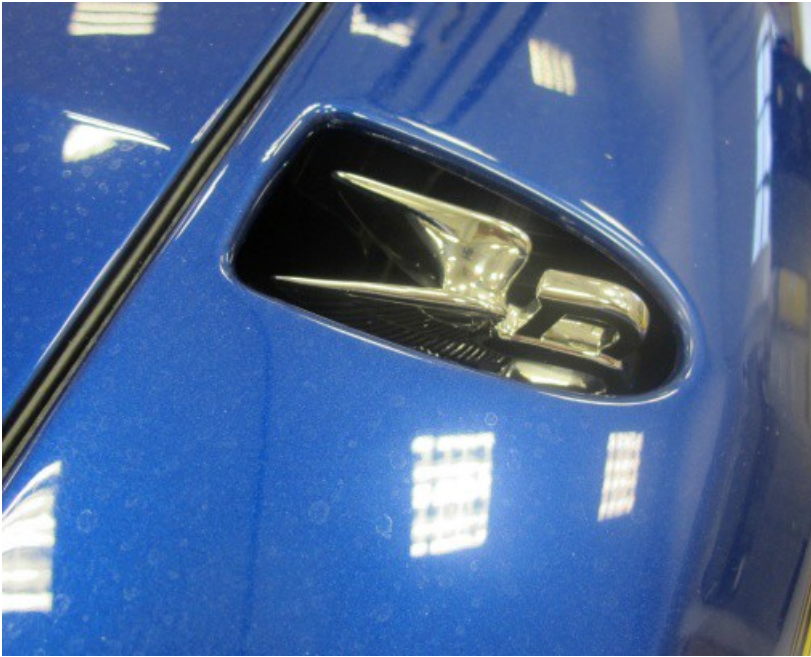
Radiator shell Mascot will not remain in the latched position.

There is a current ongoing factory investigation into radiator Mascot mechanisms that fail to latch and hold. Suspect assemblies are required for analysis by the supplier, therefore, do not attempt to rectify Mascot assemblies prior to their return.

With a confirmed complaint of a Mascot failing to latch and hold, do not attempt to repair the latching mechanism, the entire Mascot assembly should be replaced, refer to *Repair Group 66 Exterior equipment - Radiator shell - Flying "B" - To remove and fit*.

▪
Prior to Mascot mechanism removal, ensure there are no foul conditions preventing the latching components from operating correctly.
