Customer Satisfaction Program

16197 Interior Electrical Center Label and Owner's Manual Incorrect

Reference Number: N162032160

Release Date: April 2017

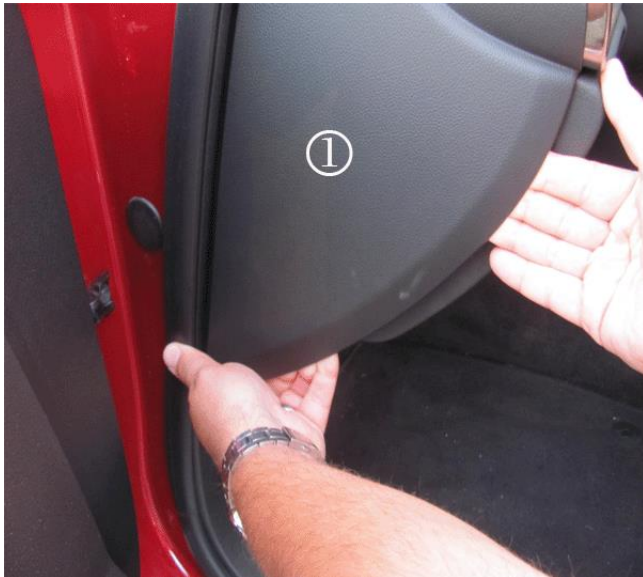
4585481

1. Remove the instrument panel outer trim cover - left side (1). Refer to *Instrument Panel Outer Trim Cover Replacement* in SI.

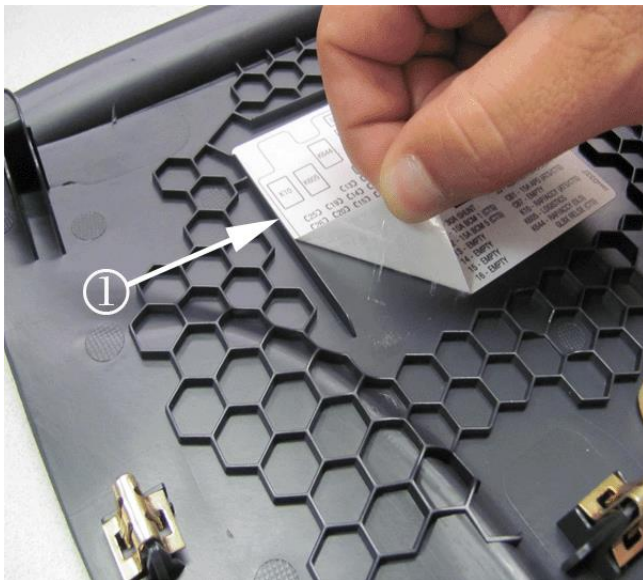
4585488

2. Remove existing label (1) and any residue using isopropyl alcohol. Dry the label surface with clean, lint free cloth. The label surface must be clean, dry and free of any contaminants. Do NOT place new label over an existing label.

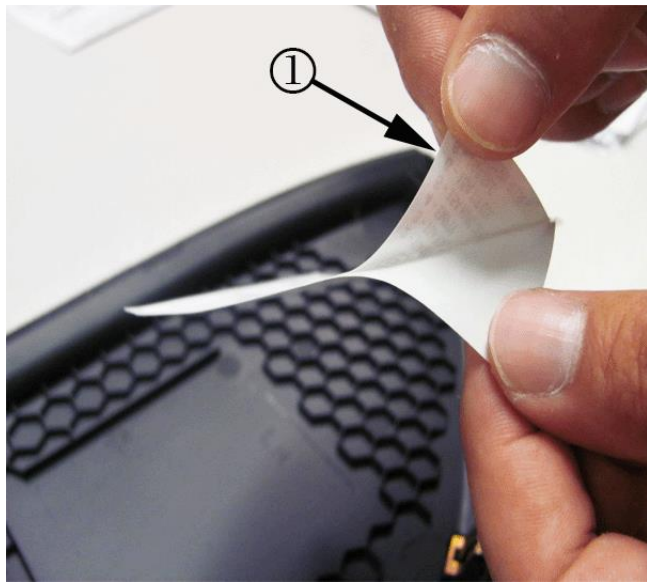
4585484

3. Firmly hold the new label (1) and peel protective liner from the back side, being careful not to touch or contaminate the adhesive with dirt or foreign matter.

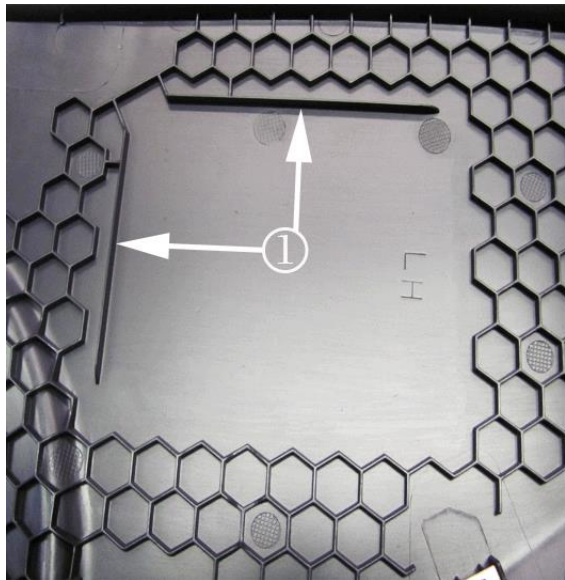
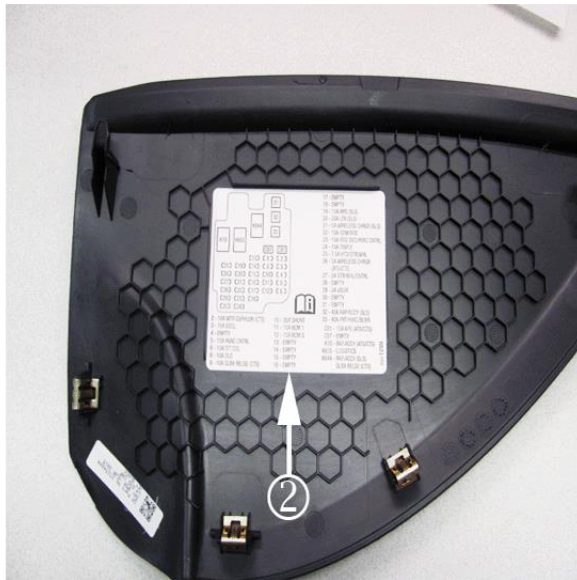
4585490

4. Using the alignment tabs (1), carefully align new label (2) to the surface. Press firmly and smooth out entire label ensuring corners are fully adhered.

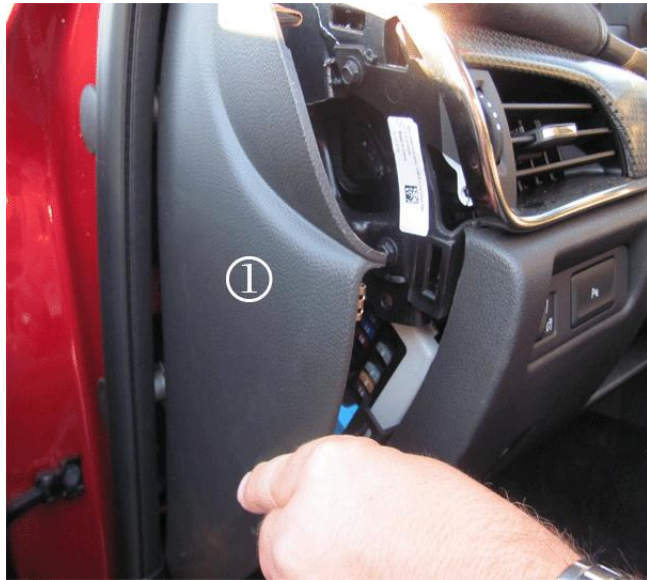
4585491

5. Install the instrument panel outer trim cover - left side (1). Refer to *Instrument Panel Outer Trim Cover Replacement* in SI.
6. Insert the updated Owner's Manual pages into the Owner's Manual.

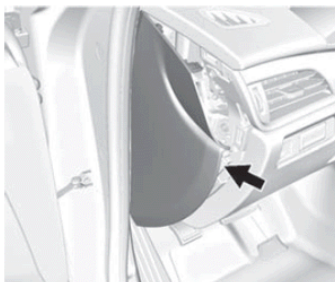
The instrument panel fuse block is in the end of the driver side of the instrument panel.

To access the fuses, remove the end panel by gently prying with a plastic tool near each clip, beginning at the point shown.

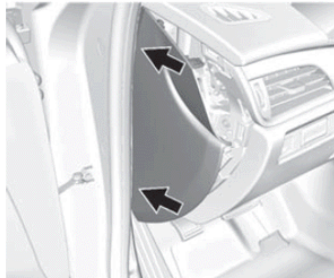
To install the end cover, insert the tabs on the back of the cover into the slots in the instrument panel at the points shown. Align the clips with the slots in the instrument panel, and press the cover into place.

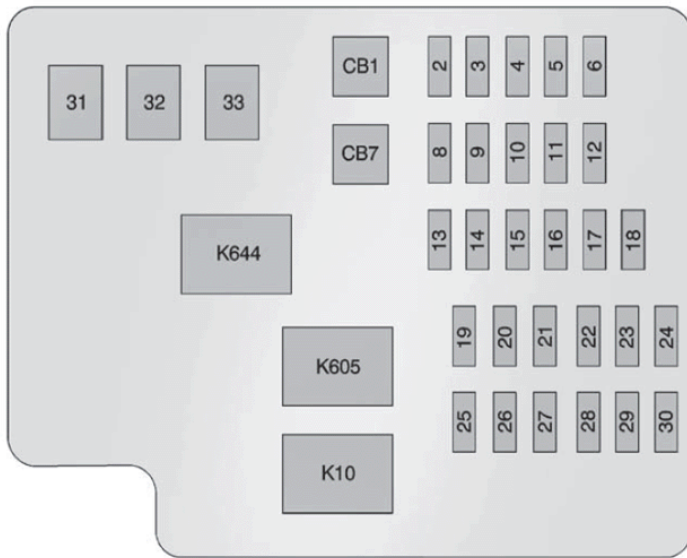
Item	Usage
2	Spare
3	Electric Steering Column Lock
4	Spare
5	Heater, Ventilation, and Air Conditioning Control
6	Tilt and Telescope Steering Column
8	Data Link Connector
9	Spare
10	Shunt
11	Spare
12	Spare
13	Spare
14	Spare
15	Spare
16	Spare

Item	Usage
17	Spare
18	Spare
19	Spare
20	Spare
21	Spare
22	Sensing Diagnostic Module/Automatic Occupant Sensing
23	Radio/DVD/Heater, Ventilation, and Air Conditioning Control
24	Display
25	Heated Steering Wheel
26	Wireless Charger
27	Steering Wheel Controls

Item	Usage
28	Spare
29	Visor
30	Spare
31	Spare
32	Spare
33	Front Heater, Ventilation, and Air Conditioning Blower
CB1	Retained Accessory Power/Accessory Power Outlet Power
CB7	Spare
K10	Retained Accessory Power/Accessory
K605	Logistics
K644	Spare

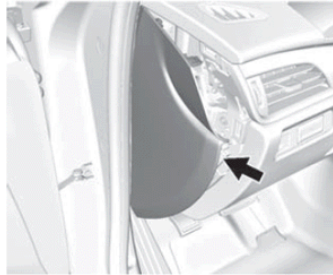
The instrument panel fuse block is in the end of the driver side of the instrument panel.

To access the fuses, remove the end panel by gently prying with a plastic tool near each clip, beginning at the point shown.

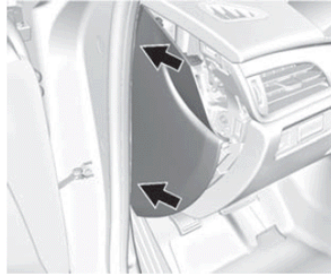
To install the end cover, insert the tabs on the back of the cover into the slots in the instrument panel at the points shown. Align the clips with the slots in the instrument panel, and press the cover into place.

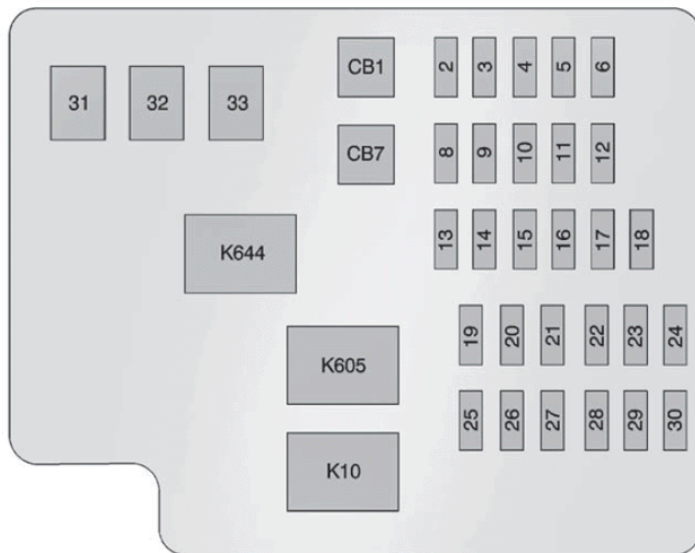
Fuses	Usage
2	Motorized cupholder
3	Electric steering column lock
4	-
5	HVAC control
6	Tilt/Telescoping steering column
8	Data link connector
9	Glove box release
10	Shunt
11	Body control module 1
12	Body control module 5
13	-
14	-
15	-
16	-

Fuses	Usage	Fuses	Usage
17	-	32	-
18	-	33	Front HVAC blower
19	-	CB1	Accessory power outlet
20	-	CB7	-
21	-	K10	Retained accessory power
22	Sensing diagnostic module/ Automatic occupant sensing	K605	Logistics
23	Radio/DVD/HVAC control	K644	Glove box release
24	Display		
25	Heated steering wheel		
26	Wireless charger		
27	Steering wheel switches		
28	-		
29	Visor		
30	-		
31	-

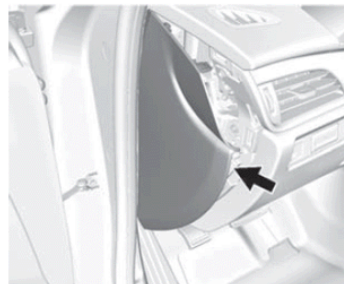
The instrument panel fuse block is in the end of the driver side of the instrument panel.

To access the fuses, remove the end panel by gently prying with a plastic tool near each clip, beginning at the point shown.

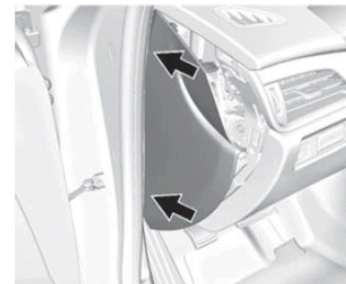
To install the end cover, insert the tabs on the back of the cover into the slots in the instrument panel at the points shown. Align the clips with the slots in the instrument panel, and press the cover into place.

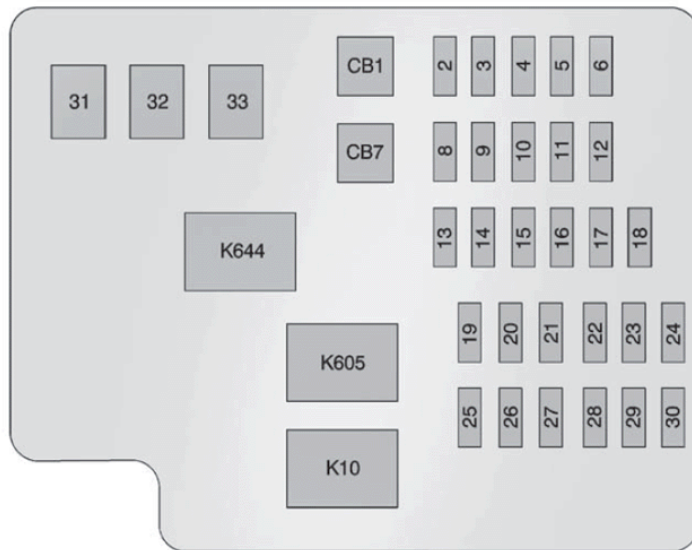
Fuses	Usage
2	Motorized cupholder
3	Electric steering column lock
4	-
5	HVAC control
6	Tilt/Telescoping steering column
8	Data link connector
9	Glove box release
10	Shunt
11	Body control module 1
12	Body control module 5
13	Body control module 6
14	-
15	Body control module 7
16	Transmission control module

Fuses	Usage	Fuses	Usage
17	-	32	-
18	-	33	Front HVAC blower
19	-	CB1	Accessory power outlet
20	-	CB7	-
21	-	K10	Retained accessory power
22	Sensing diagnostic module/ Automatic occupant sensing	K605	Logistics
23	Radio/DVD/HVAC control	K644	Retained accessory power/Glove box release
24	Display		
25	Heated steering wheel		
26	Wireless charger		
27	Steering wheel switches		
28	-		
29	Visor		
30	-		
31	-
