SERVICE BULLETIN

Classification: EC16-003c	Reference: NTB16-027c	Date: July 17, 2017
------------------------------	--------------------------	------------------------

2013 – 2017 SENTRA; MIL ON WITH DTC P0101

APPLIED VEHICLES: 2013 – 2017 Sentra (B17)

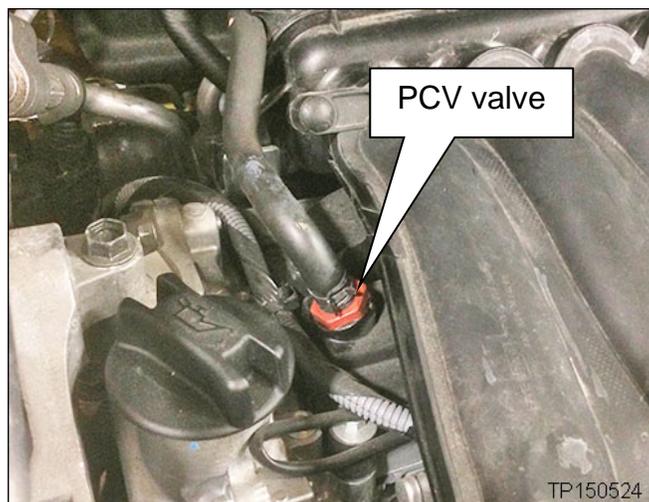
Figure 1a

If the PCV valve is orange, as shown in Figure 1a:

NOTE: The new PCV valve is “black” color.

- Replace the PCV valve.
- Refer to the Electronic Service Manual (ESM), section **EM-Engine Mechanical**, for replacement information.
- Install the new PCV valve listed in **PARTS INFORMATION**.

- DO NOT replace – continue with the **SERVICE PROCEDURE**.

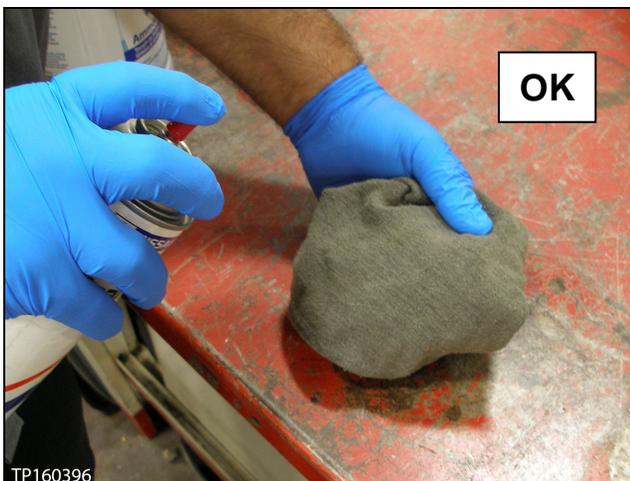
Figure 3a

3. Spray “carburetor” cleaner on a clean cloth towel.
 - Do not use a paper towel.
 - For warranty repairs, use only Nissan Genuine Low VOC Non-Chlorinated Carburetor Cleaner.
 - For non-warranty repairs, Nissan Genuine Low VOC Non-Chlorinated Carburetor Cleaner is recommended, but an equivalent “carburetor” cleaner may be used.

CAUTION: Do not spray directly on the ETC chamber. Damage may occur to the electronics of the ETC.

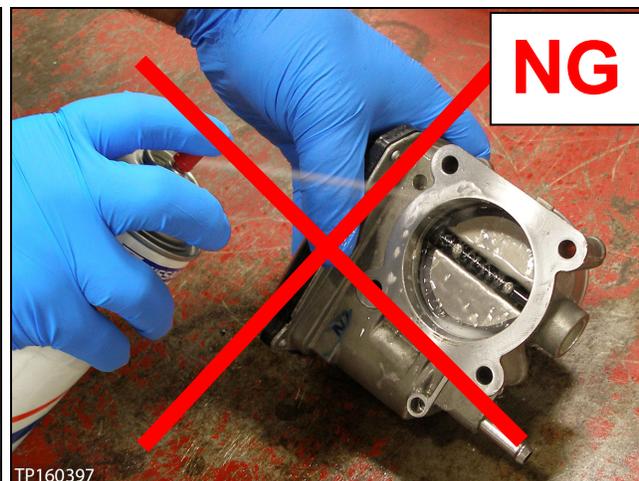
Figure 4a

4. Clean the throttle valve and chamber with the soaked cloth towel.
