Technical Service Bulletin

46 Brake pulsation diagnostic guidelines

46 17 63 2022584/7 January 12, 2017. Supersedes Technical Service Bulletin Group 46 number 15-25 dated October 20, 2015 for reasons listed below.

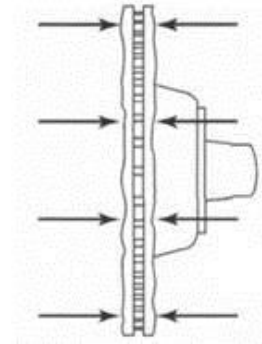
Figure 1. Example of DTV.

Disc thickness variation (DTV) is a common condition that contributes to brake pulsation (Figure 1). DTV occurs when the two braking surfaces of

the brake disc are no longer parallel to each other. This condition cannot be accurately measured with normal workshop tools. Most common conditions that create DTV include:

- Corrosion/rust build-up
- Pad material transfer
- Prolonged use of a disc with high run-out condition

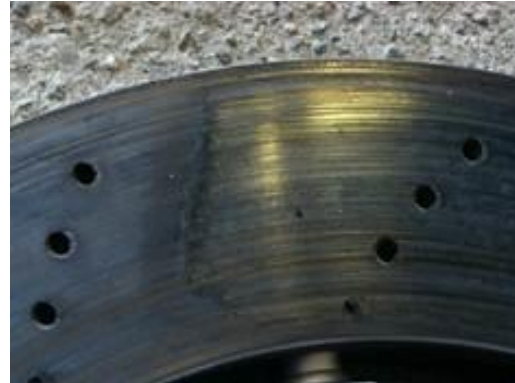
Figure 2. Deposits on the brake disc.

Condition: Brake pad material smeared on the brake disc (Figure 2). This condition can create DTV.

Common cause: An overly-aggressive driving style, which results in frequent sharp braking without proper cooling off periods.

Service: Replace brake discs and pads.

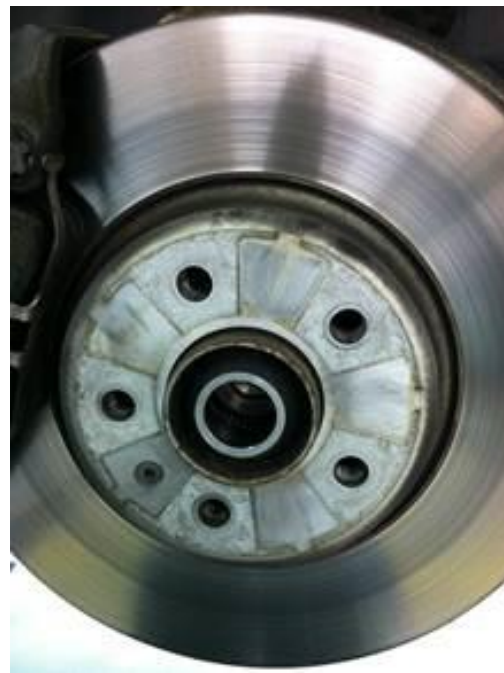
Figure 3: Brake disc with heat marks.

Condition: Blue-tempered or overheated brake discs (Figure 3).

Common cause: Failed component(s) causing constant brake application. This can also be caused by an overly-aggressive driving style, which results in frequent sharp braking without proper cooling off periods.

Service: Replace brake disc and pads.

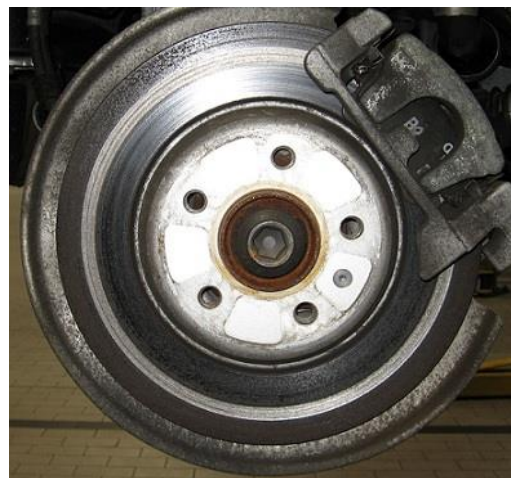
Figure 4. Corrosion/rust build-up.

Condition: Corrosion/rust build-up on the brake discs (Figure 4). This condition can create DTV.

Common causes:

- Exposure to road salt during winter months, high humidity, or moisture.
- Vehicle not being driven for prolonged periods of time.
- A gentle driving style with very light brake application may not be enough to remove build-up (such as rust or corrosion) on the brake discs and pads.

Service: With careful consideration of the traffic situation, perform 2-3 ABS stops from speeds above 50mph. Between each stop, allow the brake components to cool by driving the vehicle for more than one minute at speeds greater than 50mph. Do not perform ABS stops if brand new pads and/or discs are installed. Replace brake disc and pads if the condition is not eliminated.

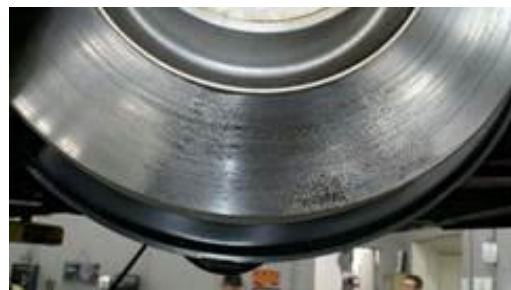
Figure 5. Pad marks on the brake disc.

Condition: Pad material transfer or corrosion marks from brake pads on the brake disc, also known as “pad marks” (Figure 5). This condition can create DTV.

Common cause: These marks can appear if the vehicle has not been driven for a prolonged period of time or if the brakes are exposed to high humidity or moisture.

Service: With careful consideration of the traffic situation, perform 2-3 ABS-stops from speeds above 50mph. Between each stop, allow the brake components to cool by driving the vehicle for more

than one minute at speeds greater than 50mph. Do not perform ABS stops if brand new pads and/or discs are installed. Replace brake disc and pads if the condition is not eliminated.

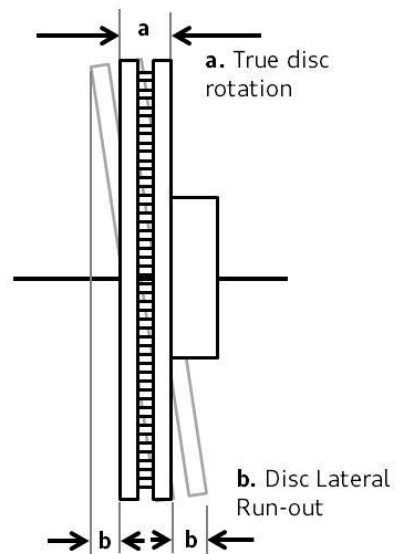
Figure 6. True disc rotation (a) and disc lateral run-out (b).

Condition: Excessive brake disc or wheel hub run-out (Figure 6). Measure according to the *Run-out Measurement Instructions* listed below.

Common causes:

- **Over-torqued or improperly-torqued wheels** (torque sticks, impact gun, etc.) can distort the brake disc and hub, causing a run-out condition. Refer to Elsa for proper torque values and procedures for the VIN.
- **Wheels that are not Audi-approved** may not have the same contact surface on the back of the wheel and may not have the correct center bore dimension, which can distort the brake disc and hub, causing a run-out condition.
- **External impact or rust build-up** between brake disc and hub.

Service: Replace brake disc(s) and/or hub(s) if measurements exceed the maximum value listed in the *Run-out Measurement Instructions*.

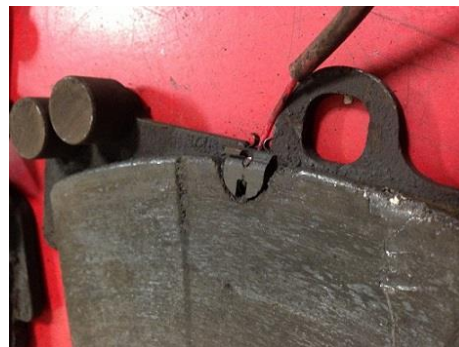
Figure 7. Worn brake pad.

Condition: Worn brake pads (Figure 7).

Common cause: As brake pads and discs reach their wear limit, their dampening characteristics are reduced.

Service: Replace worn brake pads and discs.

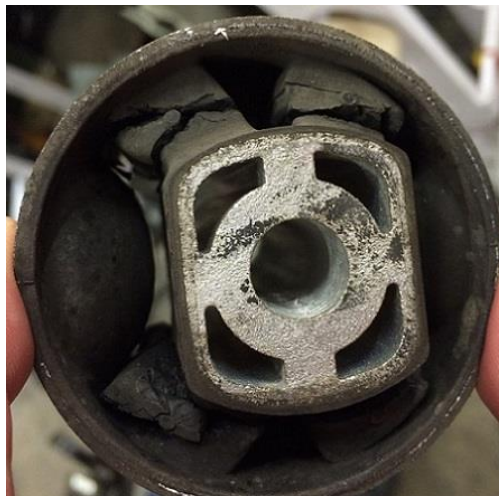
Figure 8. Damaged suspension bushing.

Condition: Faulty, damaged, or aftermarket suspension components (ball joints, links, tie rods, bushing, etc.) can significantly amplify vibration/pulsation or lead to body vibrations which only become noticeable when braking (Figure 8 and Figure 9).

Service: Diagnose these components accordingly.

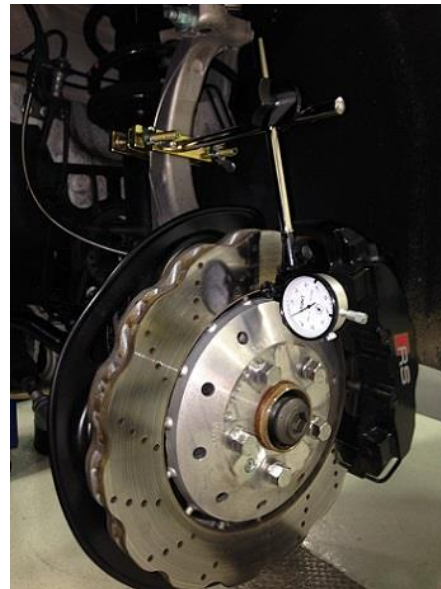
Figure 11. Example of run-out measurement tool VAS6079/1 properly secured to a solid suspension component.

- All surfaces that will be measured must be free of rust/corrosion build-up or pad material transfer.
- VAS6079/1 (or similar measurement tool) is securely attached to the vehicle (Figure 11).
- The brake disc is secured to the hub with 5 bolts.
- Axle bolt/nut is installed and properly torqued.
- Run-out measurements should be taken with all parts installed on the vehicle

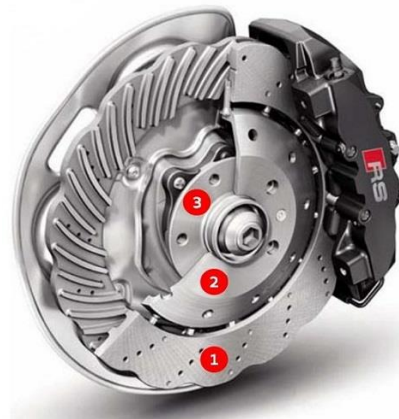
Figure 12. Run-out measurement locations: disc braking surface (1), disc hub (2), wheel hub (3).

Disc braking surface (Figure 12, point 1):

- Disc hub and wheel hub run-out impact this value.
- Maximum run-out: **0.06 mm / 0.002"**

Disc hub (center of the brake disc) (Figure 12, point 2):

- Wheel hub run-out impacts this value.
- Disc hub run-out impacts the disc braking surface run-out.
- Maximum run-out: **0.03 mm / 0.0012"**

Wheel hub (without the disc installed) (Figure 12, point 3):

- This value impacts the disc hub and disc braking surface run-out. High run-out can distort the brake disc.
- Maximum run-out: **0.02 mm / 0.0008"**
