## RECREATIONAL VEHICLE SERVICE CAMPAIGN

Service Advisory: 17-295

## SERVICE ADVISORY # 17-295

### Zinger In-Wall A/C

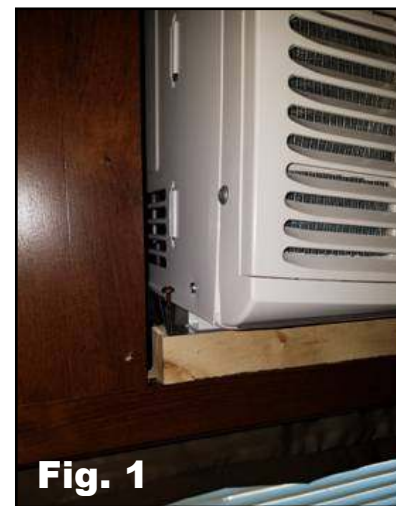
- Remove decorative padded part around A/C.
- Remove the screws holding the spacer under the front of the A/C, Figure 1.
- Remove spacer by lifting front of A/C.
- Unplug and remove A/C. **NOTE:** Have extra towels ready for any residual water in the pan of the A/C.

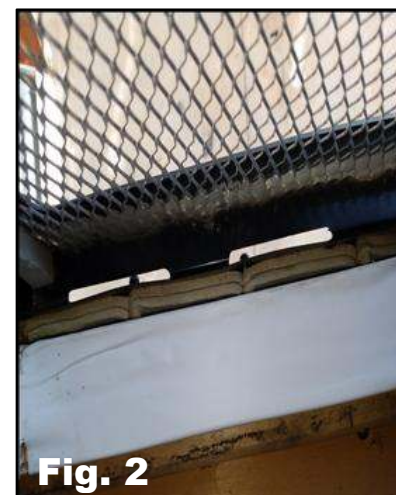
- Inspect the opening for water intrusion and remove the existing drain pan.
- The new drain pan will have to sit on the shroud and be lined up with the drain holes in the bottom of the outside shroud, Figure 2.

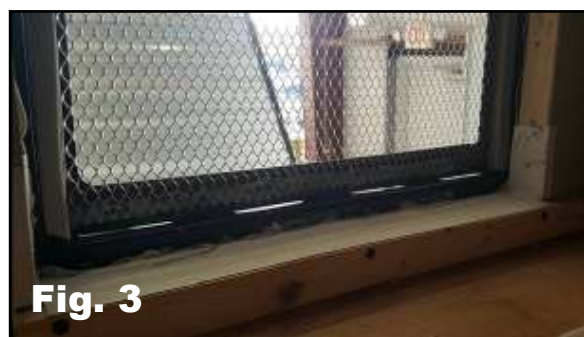
- A cleat may need to be added to the wall opening at the outside shroud to allow the new pan to sit at the proper height to drain into the holes of the shroud.
- The front of the opening may need to be cut at the top to allow for  $\frac{1}{2}$ " of slope from front to back and a new cleat (spacer) will need to be added to the front to accommodate for the  $\frac{1}{2}$ " of slope, Figure 3.

**Please Note: It will be important that there is  $\frac{1}{2}$ " fall from inside to outside to allow water to drain properly.**

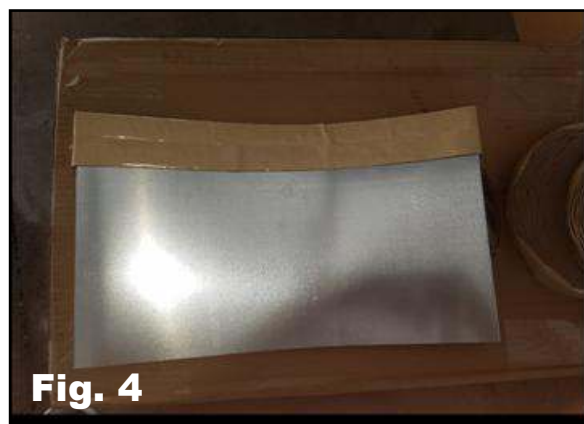
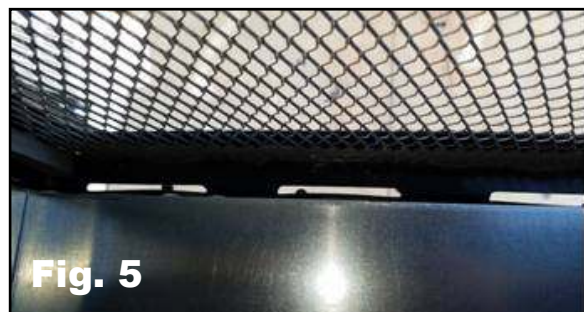
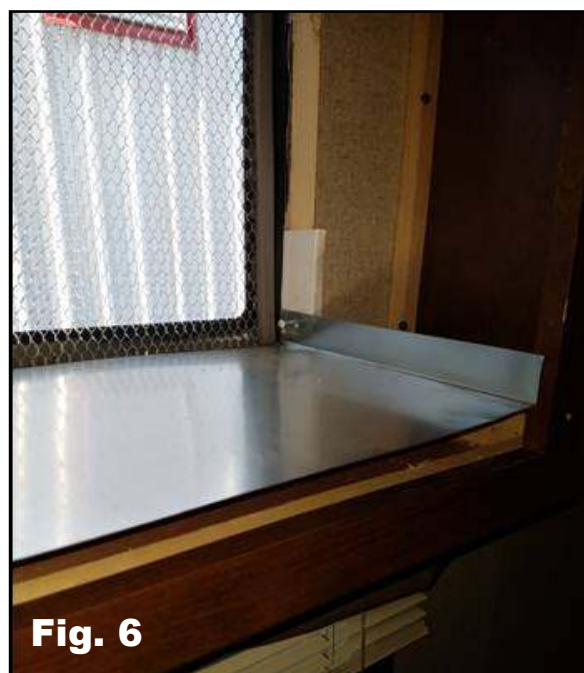
- Apply 2 strips of butyl tape  $1/8$ " x 1" next to each other, across the bottom and up the sides of the drain pan, Figure 4.
- Place the pan so that the edge lines up with the drain holes in the shroud, Figure 5.
- Add a screw on each side of the pan to hold it in place, Figure 6.
