JTBO0343NAS5

TECHNICAL BULLETIN

501-14: Handles, Locks, Latches and Entry Systems

Smart Key Handset - Lower-Level Service Repair

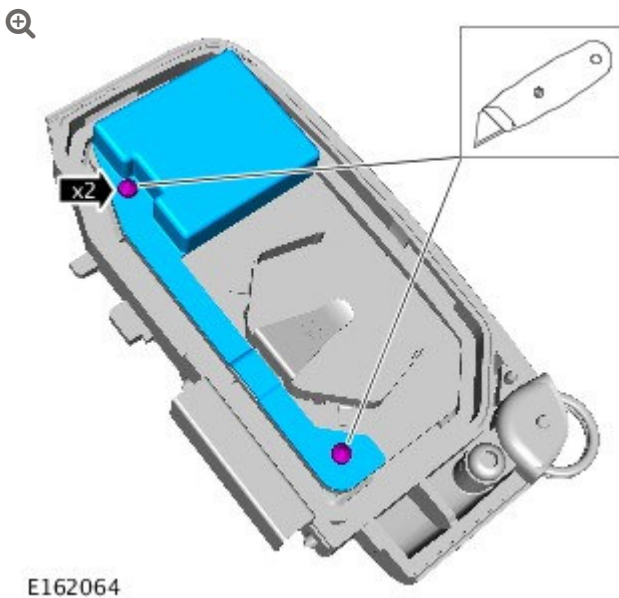
6

Make sure the Printed Circuit Board [PCB] is not damaged when removing the black anti-tamper cover. If the copper coil antenna is damaged, the unit will be unserviceable.

Use a suitable tool to cut the fixings of the black anti-tamper cover and lift away from the Printed Circuit Board (PCB).
