**MODEL:** Karma Revero**DATE:** September 2017**TITLE:** Front Door Trim Panel Blister Remedy**First Release****PRIORITY:** On Complaint**APPLICABILITY:** MY17 and MY18 Revero**MARKET REGION:** North America**PURPOSE:** Reduction of the Door Panel Blister

**TB-17-82-18**

**TITLE:** Front Door Trim Panel Blister Remedy

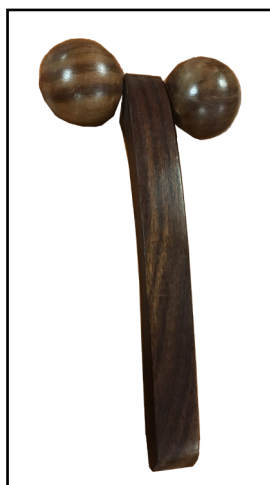
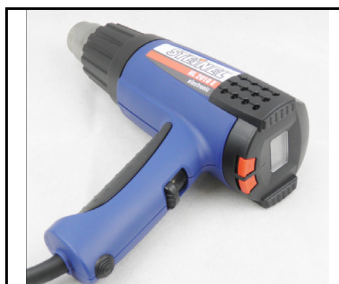
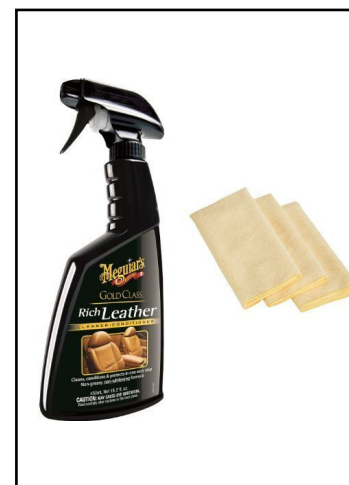
- Harness Clip Fastener Screws P/N C140330308100 – total quantity 6 (3 LH and 3 RH)
- Door Panel Clips P/N C148001800100 (TERMAX 71205) - total quantity 18 (9 per panel)
- Heat gun (capable of minimum of 400°F) as shown below for example.
- Infrared Thermometer
- Dual ball wooden roller (source locally - Karma Automotive will supply to current retailers)
- Leather cleaner (Recommended Meguiar's Gold Class Rich Leather) and a microfiber cloth
- Camera or suitable device for images

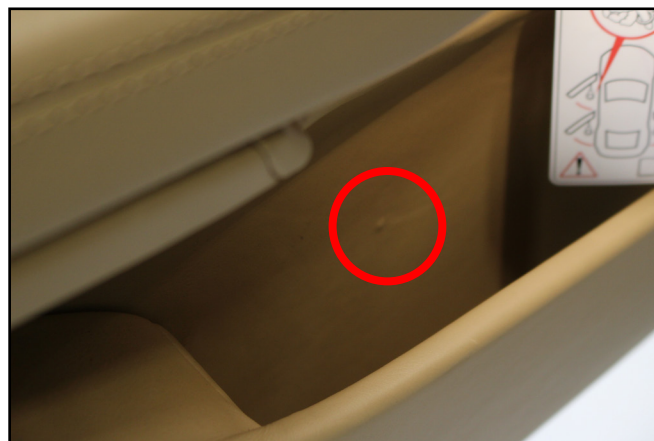
fig.1

The door panel blister will be visible above the pocket.  
As shown in the image (fig.1).

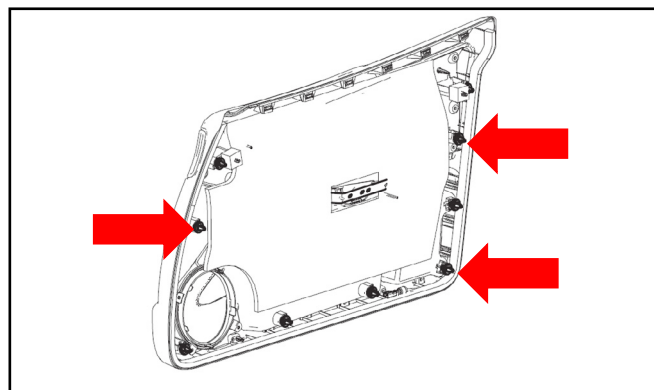
fig. 4

Using a suitable tool carefully release the clips (9) securing the door cover (fig.4). Three locations shown for example. These nine clips will be replaced with new ones.

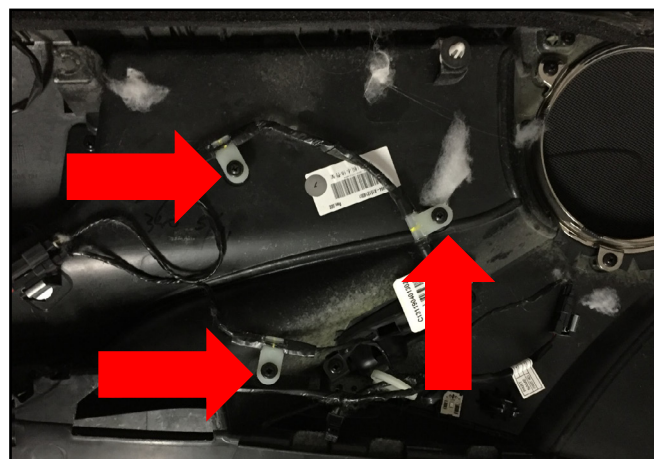
fig. 5

On the reverse side of the panel remove the three (3) screws as indicated (fig. 5).

These will be replaced with C140330308100 when the procedure is complete.

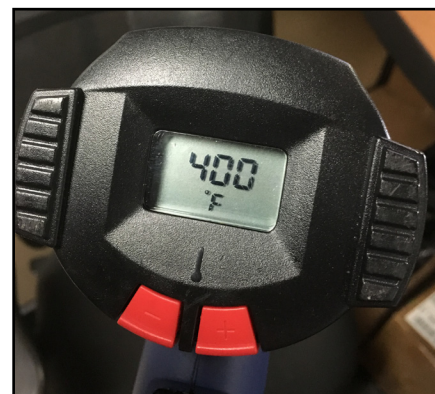
fig. 6

As mentioned in the tools required list, the heat gun should be set to 400°F (fig.6), this is the heat gun set temperature.

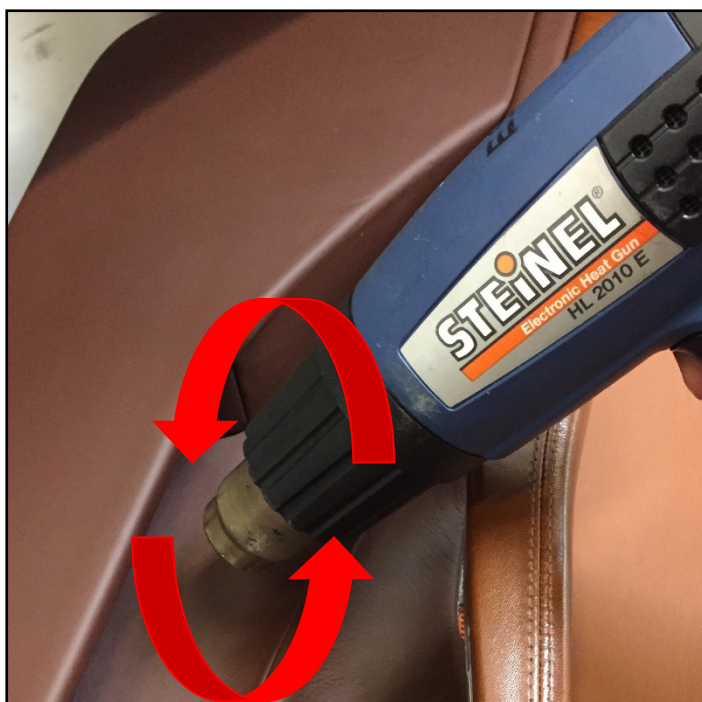
fig. 7a

Flip the door panel. Set the Heat gun temperature and place at distance 2.5 and 3 inches of the blister, not any closer to avoid burning the leather. Move the heat gun around back and forth, this will soften the plastic under side.

Heat area of blister for around 30 seconds to 1 minute before applying roller, this is to soften the surface in advance of applying pressure. Do not start rolling at same time of heating (fig. 7a and 7b).

Use the wooden ball roller to apply pressure to the surface of the blister (remove heat gun whilst you use roller). Check area to see if blister is removed. If not add heat again for 30 seconds and repeat. Repeat until the area is flat and no visible blister this may take several passes and overall time may be 7-15 minutes. A surface temperature on the leather should not exceed 300 °F so as not to discolor the leather, use the infrared thermometer to take temperature readings on the surface under the heat gun.

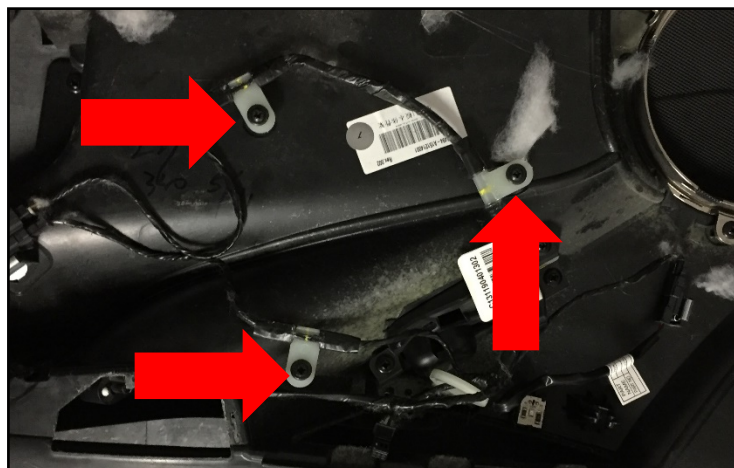
fig. 8

After the heating and rolling procedure is complete, install the new screws C140330308100 install torque 1.0NM +/- 0.2NM (fig.8).

Replace all clips for the door panel as required using C148001800100.

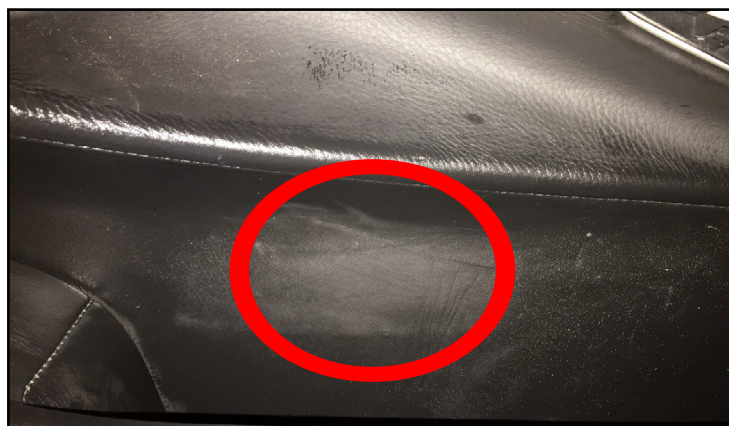
fig. 9

After completion of assembly, and no blister is seen. Clean the affected area with leather cleaner and a microfiber cloth (fig.9).

Apply Meguira's Leather conditioner to a microfiber cloth and gently clean the whole area. Ensure to wipe well and not leave a shine.
