October 12, 2017

06569 Version 1

Front Upper Seat Back Bolster Deformed

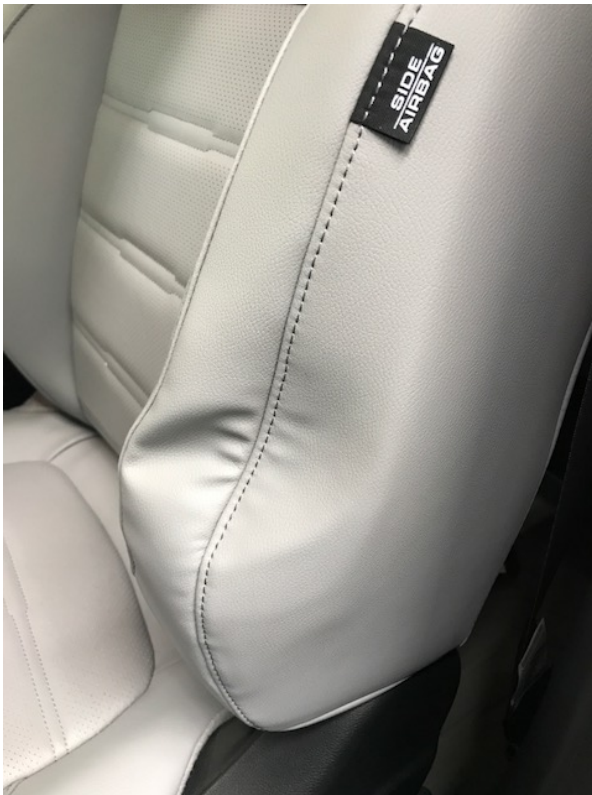
The seat pad folds under the frame, causing the seat cover material to collapse.

When a driver or front passenger enters the vehicle and rubs against the bolster, the seat foam folds and gets caught inside the seat frame.

- Install the new seat side airbag holder to the upper seat back frame.
- Inspect the seat foam and see if it is repairable (foam returns to the original shape), if it is not repairable, replace it.

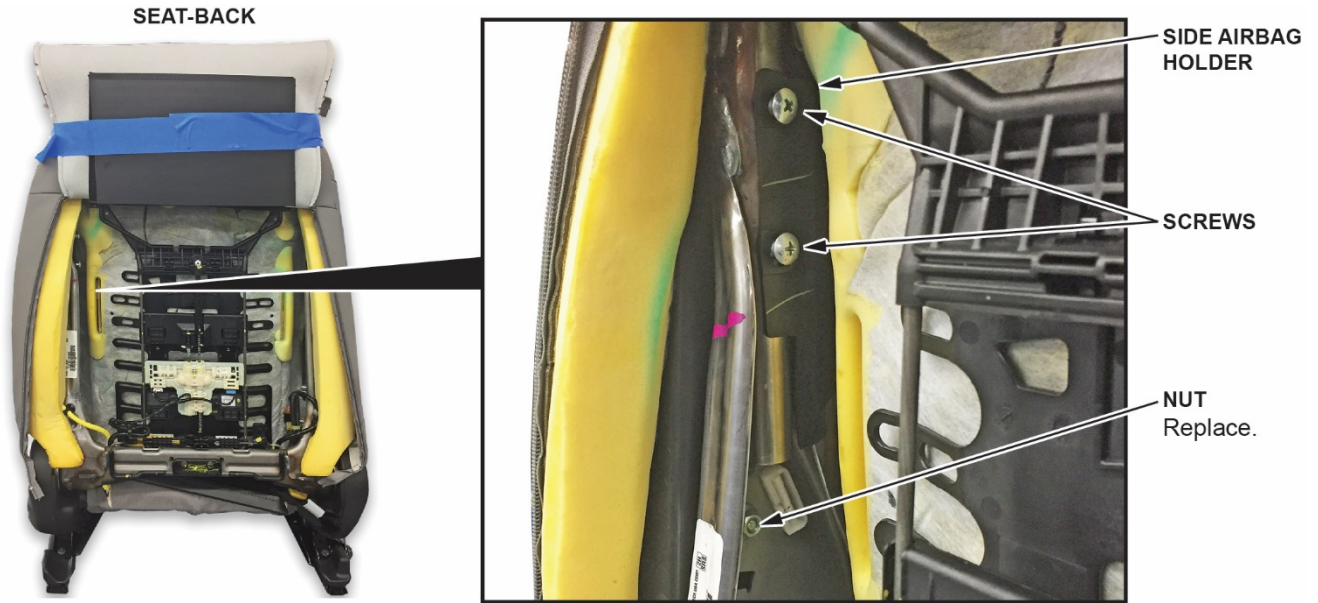
1. Remove the two screws holding the front seat side airbag holder, and the nut holding the side seat airbag.

- Driver's side seat is shown below, the passenger side is a mirror image.
- The nut holding the airbag is a must replace part, replace it when installing.

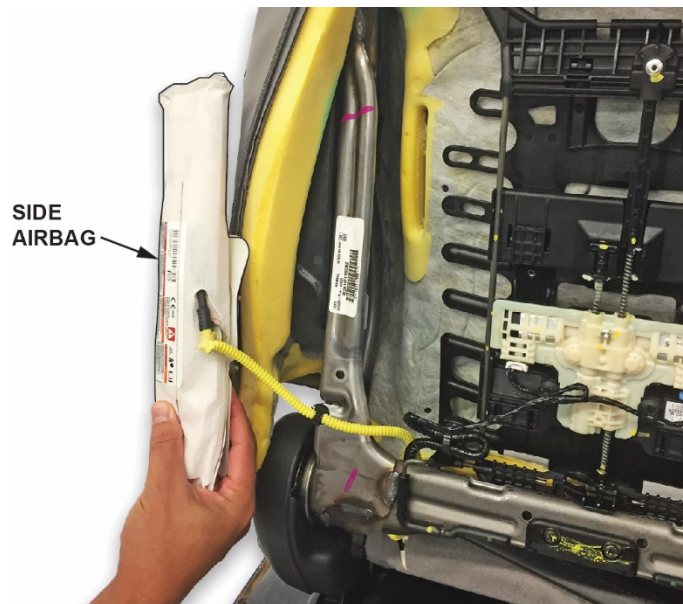
2. Remove the side airbag.

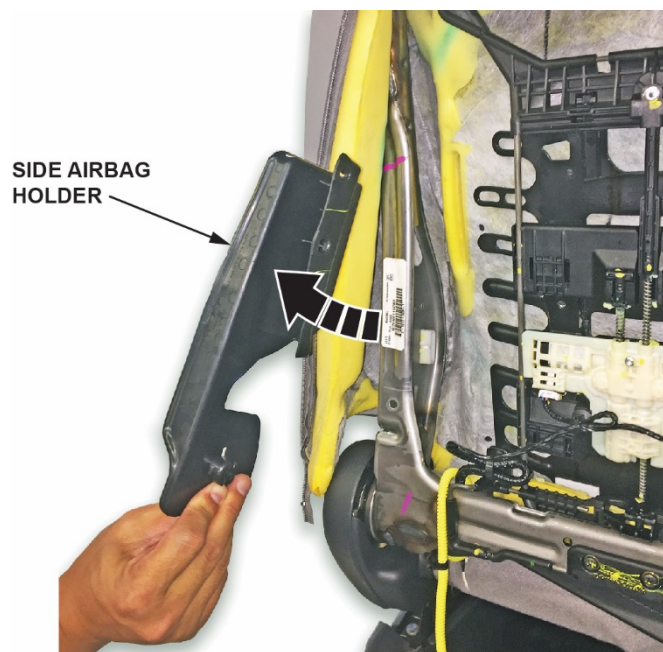
3. Remove the front seat side airbag holder.

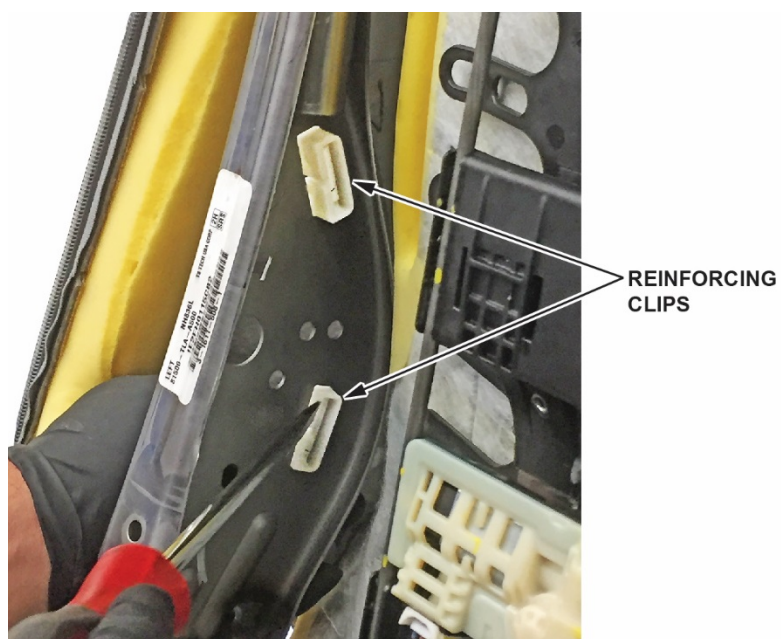
4. *CR-V only*: Remove the two reinforcing clips.

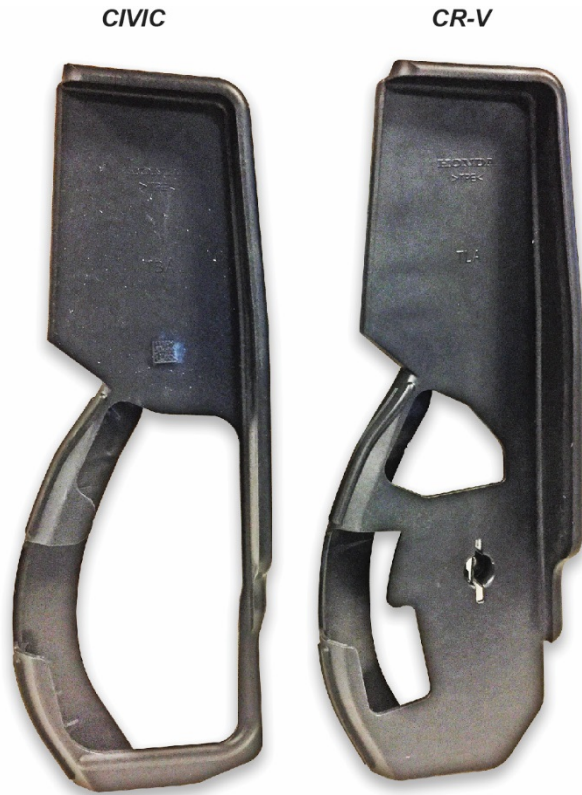
5. Install the counter-measure front seat side airbag holder.

NOTE: The counter-measure part is different according to the model you are working on.

NOTE: Do not forget to replace the airbag nut with a new one. Torque it to 6.3 N•m (4.6 lb-ft)
