## Odor like crayon or vinegar entering the passenger compartment through the ventilation system (USA)

| Topic number | LI00.00-P-066036 |

# W/X 166 – Sealing bodyshell openings

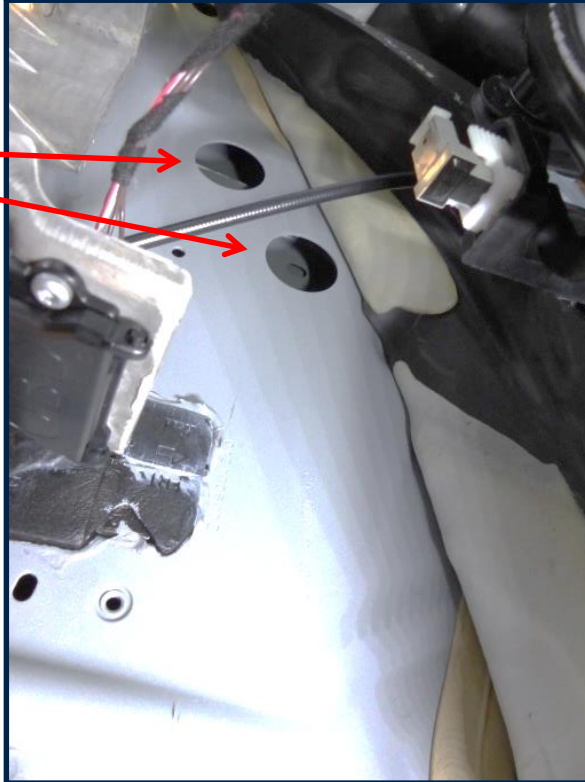
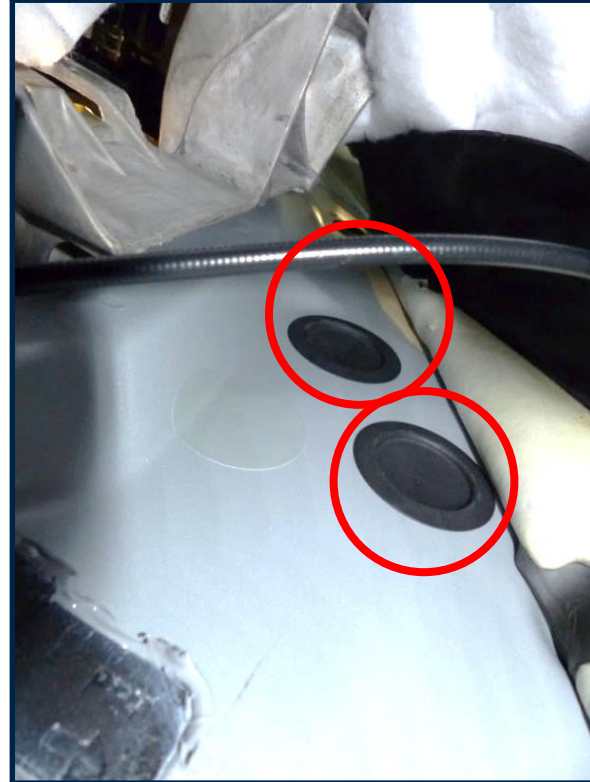
Fault location  
A-pillar, top, inside

Bodyshell holes open

Bodyshell holes sealed

**Note:** Perform task on left- and right-hand sides

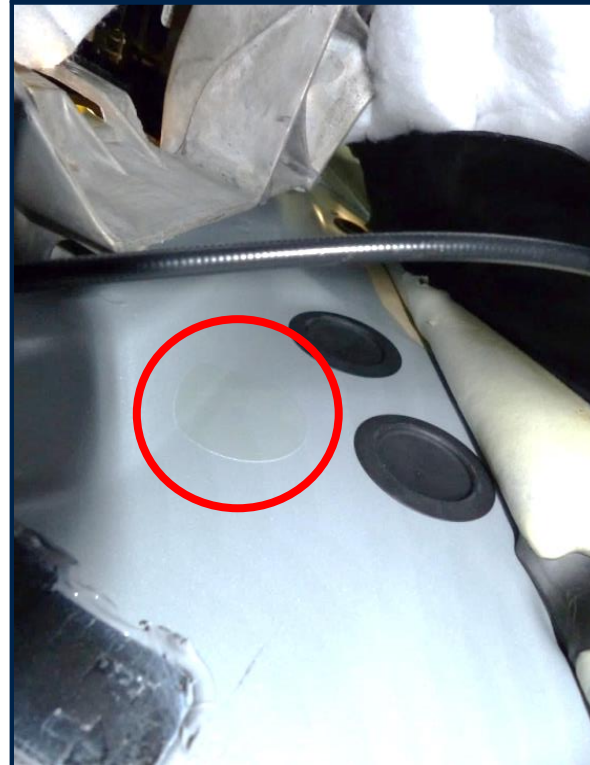
Fault location  
A-pillar, center, inside

Bodyshell holes open

Bodyshell holes sealed

**Note:** Perform task on left- and right-hand sides

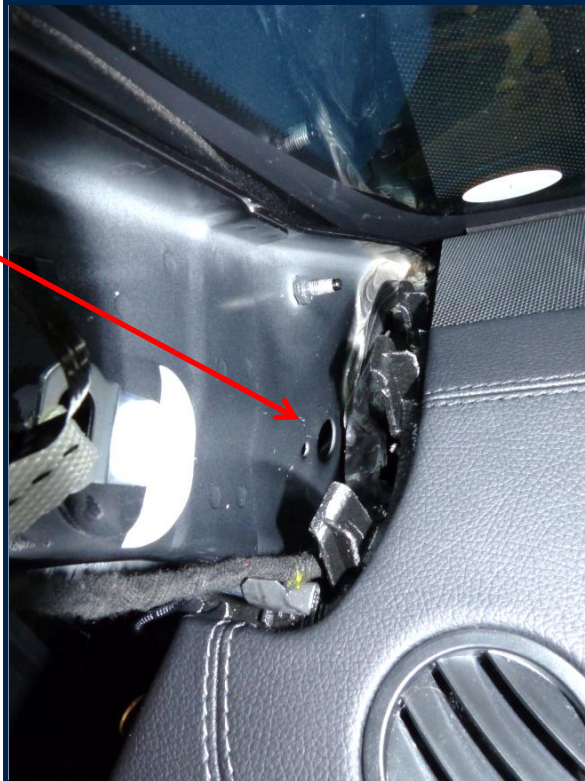
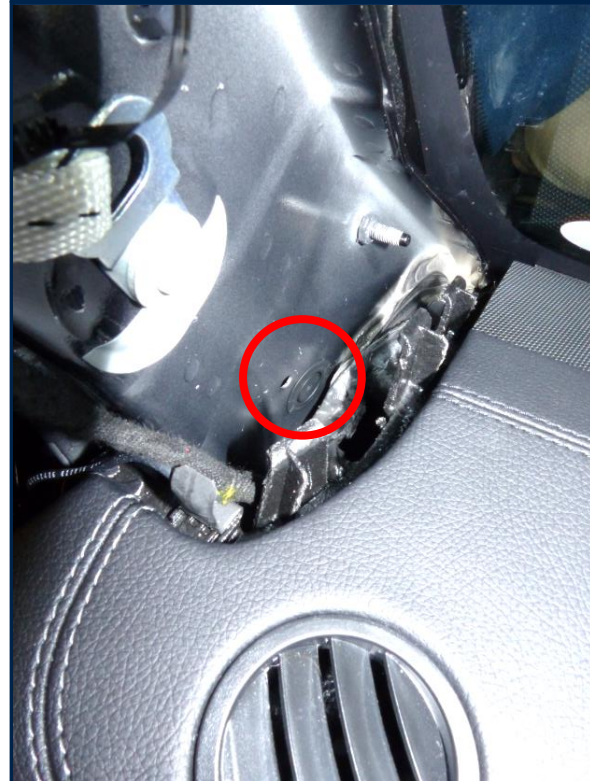
Bodyshell holes open

Bodyshell holes sealed

**Note:** Perform task on left- and right-hand sides.

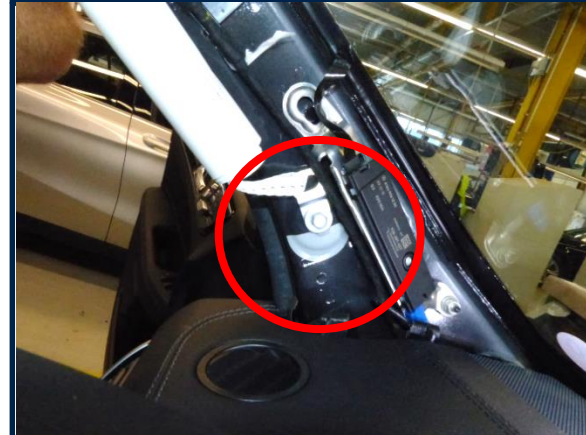
Bodyshell holes open

Bodyshell holes sealed

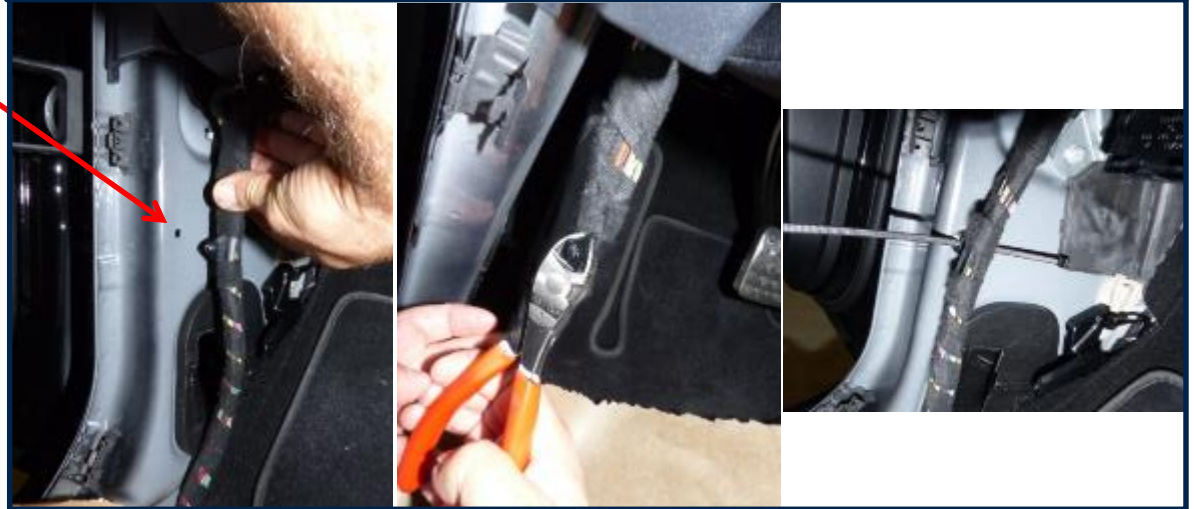
Bodyshell holes sealed

**Note:** Perform task on left-hand side. Check right-hand side (depending on equipment variant). Remove seal (black) of the plastic clip (orange) and install onto the cable strap to seal. Disconnect the cable fastening fixture from the cable harness (e.g. using side cutting pliers) and fasten with the prepared cable strap

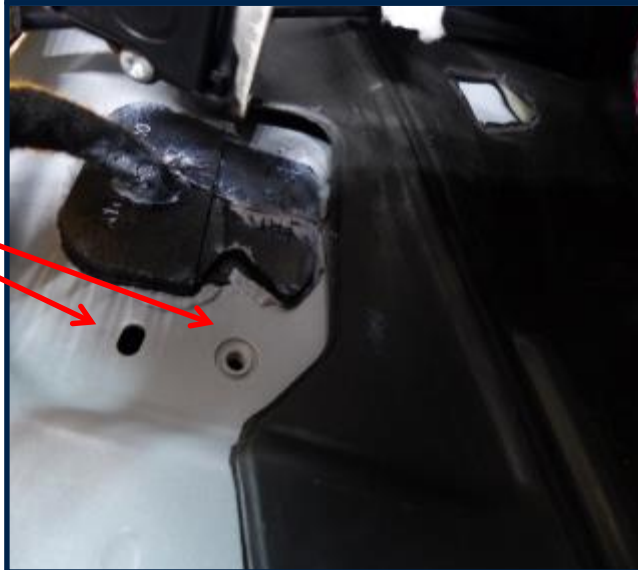
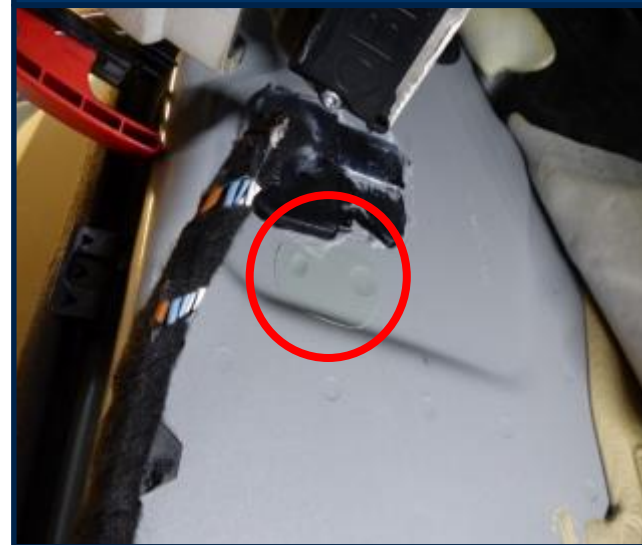
Bodyshell holes open

Bodyshell holes sealed

**Note:** Perform task on left- and right-hand sides. Adapt adhesive tape.

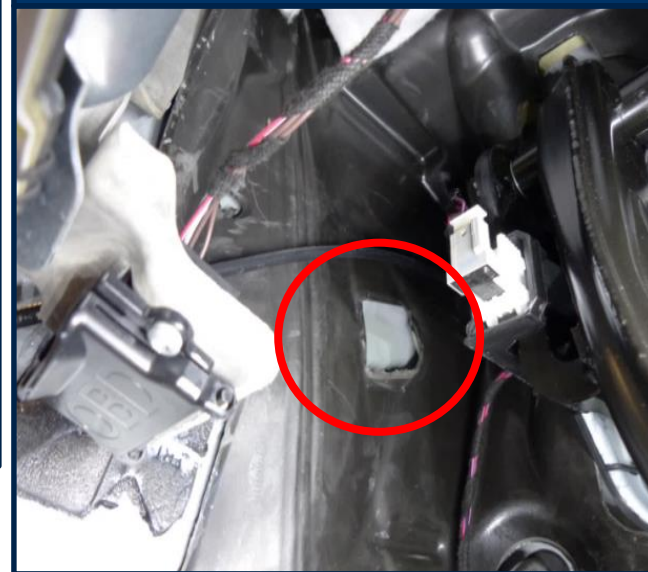
Bodyshell holes open

Bodyshell holes sealed

**Note:** Perform task on left- and right-hand sides (undo damping if necessary)

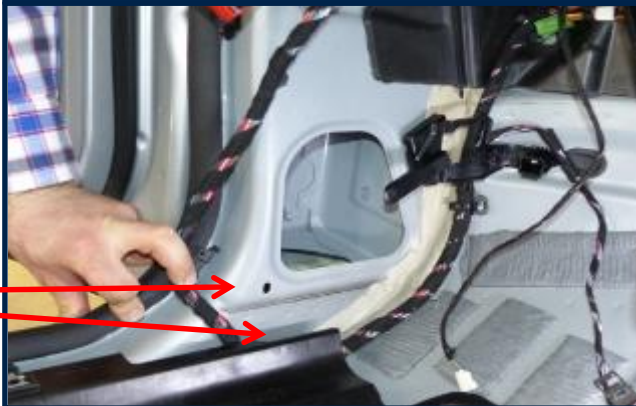
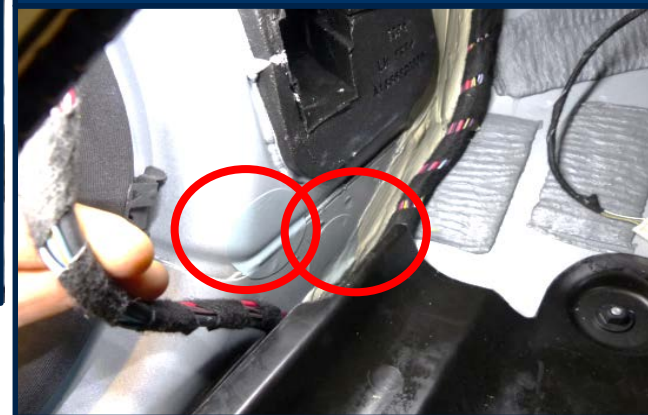
Bodyshell holes open

Bodyshell holes sealed

**Note:** Perform task on left- and right-hand sides

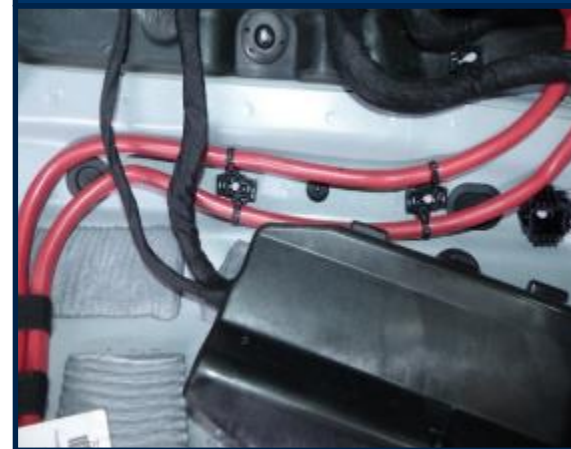
Fault location  
Bulkhead/pedal floor

Bodyshell hole sealed

**Note:** Perform measure on the right-hand side for left-hand-drive vehicles.

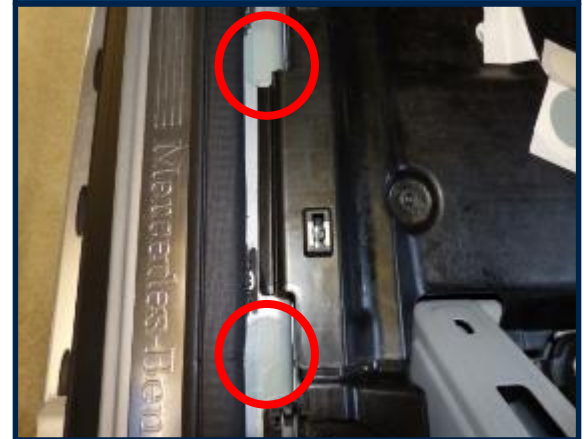
Fault location  
Longitudinal member, inside,  
front

Bodyshell holes sealed

**Note:** Perform task on left- and right-hand sides. Bodyshell openings may or may not be present depending on the production year.

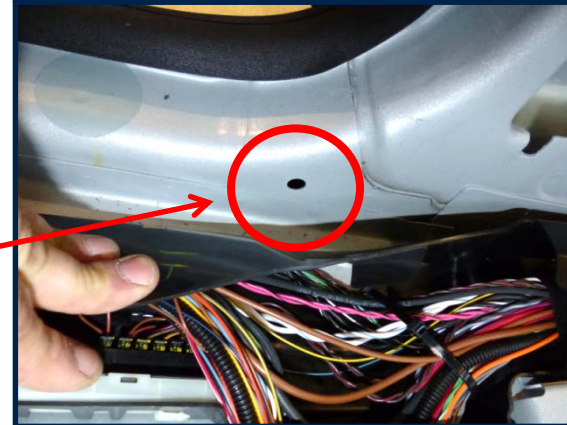
Fault location  
B-pillar, bottom, inside

Bodyshell holes open

Bodyshell holes sealed

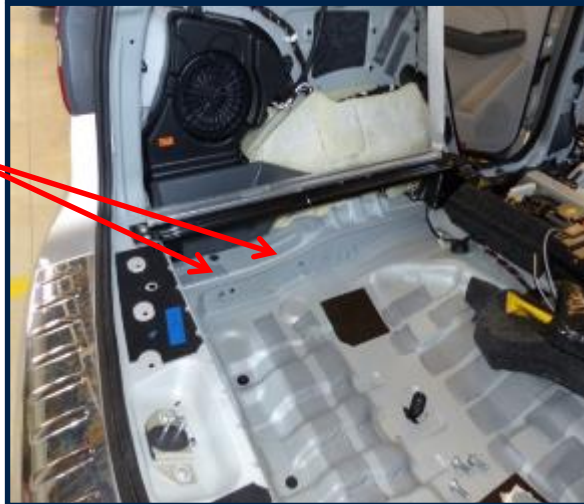
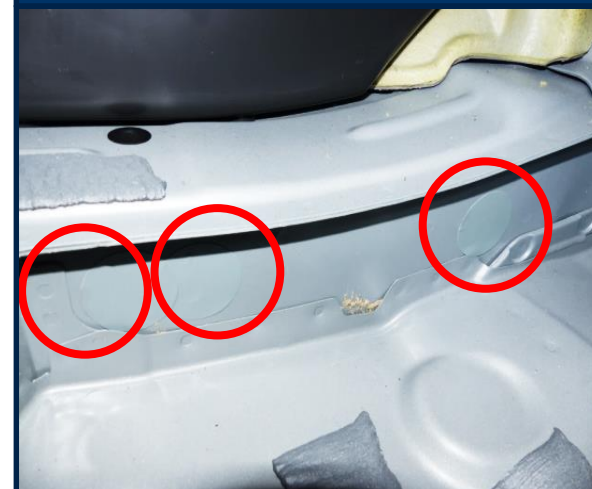
Bodyshell holes open

Bodyshell holes sealed

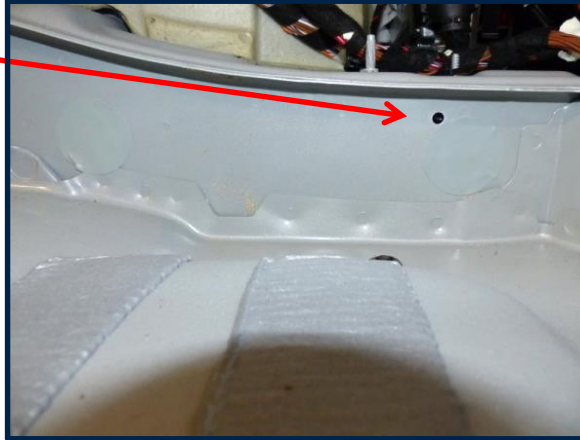
Bodyshell holes open

Bodyshell holes sealed

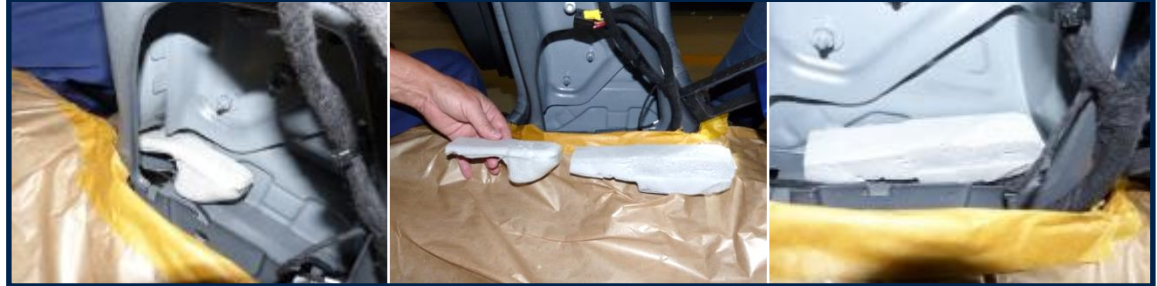
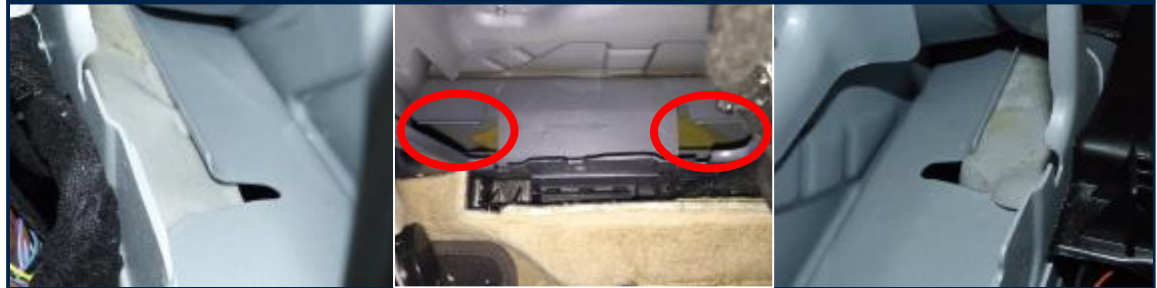
Install foam piece

Foam piece installed

**Note:** Perform task on left- and right-hand sides. Depicted on left-hand side of vehicle. The foam pieces should fill the bodyshell openings in the longitudinal member.

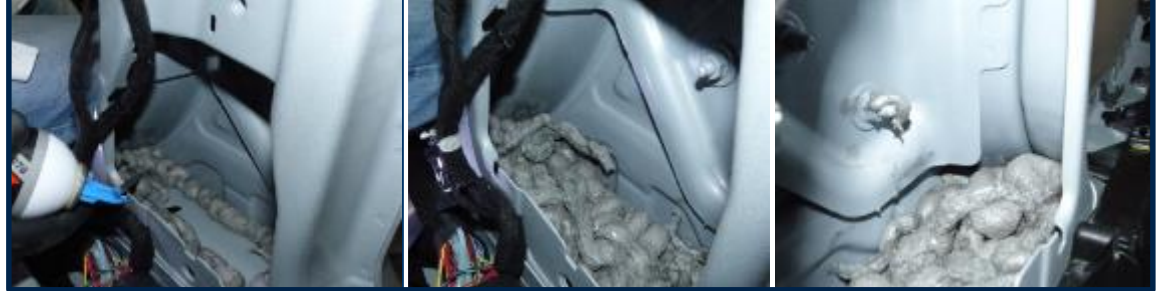
Apply acoustic foam to entire surface

Foam piece installed

**Note:** Ensure that the entire surface in the foot of the B-pillar is coated with acoustic foam, then install the new left-hand foam piece A166 682 87 00. **Caution:** It must be ensured that the function of the seat belt is not compromised after the foam has been applied and the foam piece has been installed. Recommendation: Wear protective gloves.

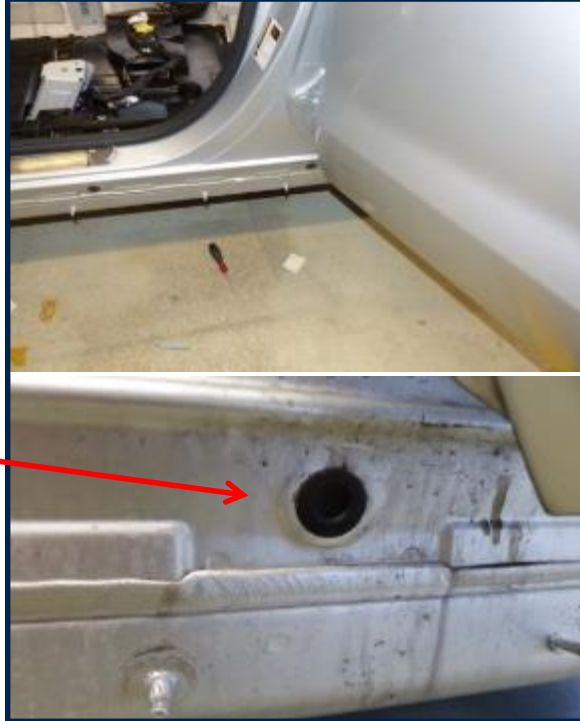
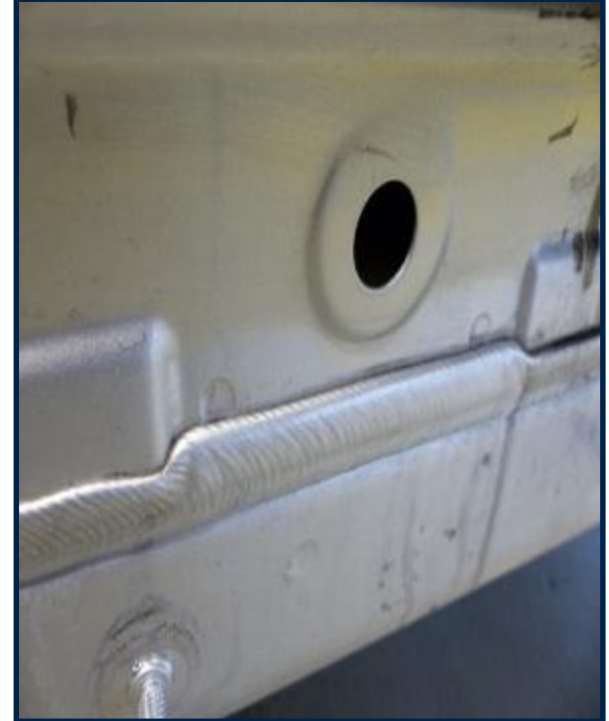
Area to be worked on

Bodyshell hole open

**Note:** Perform task on left- and right-hand sides. Expansion plug is located under the longitudinal member panel or the running board. For details, see next slide.

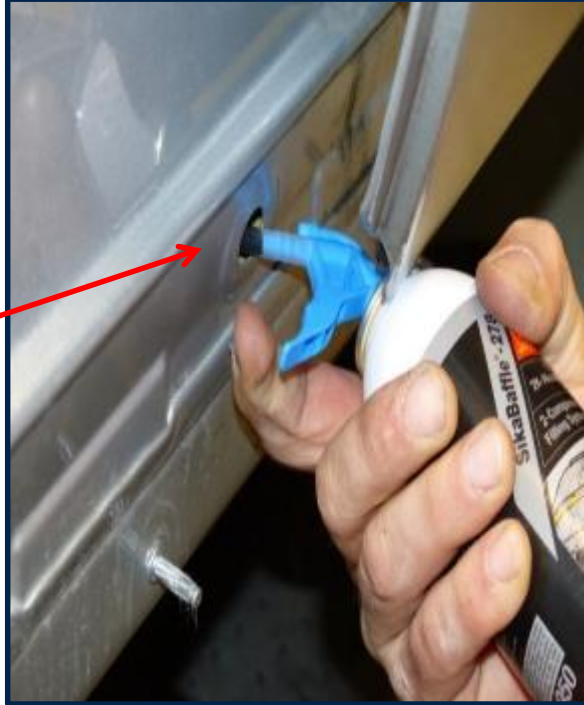
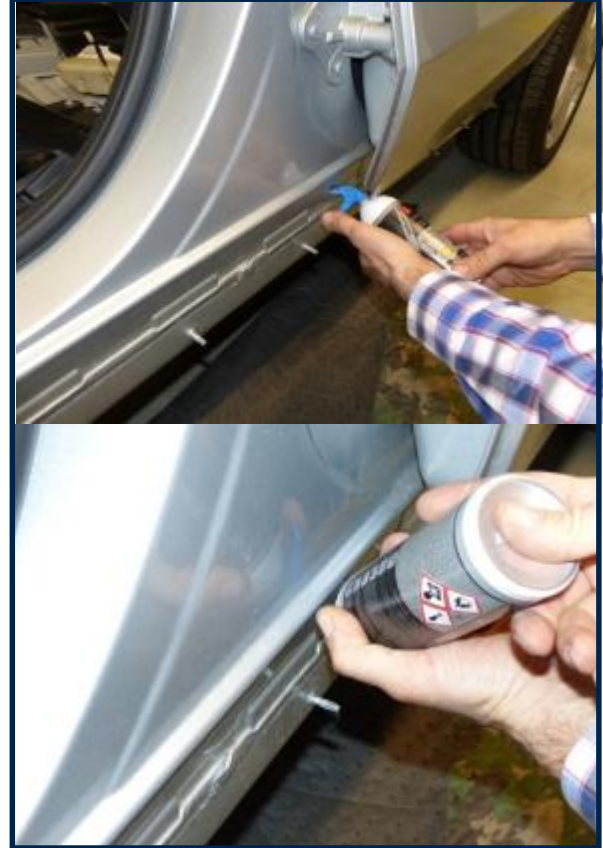
Fill bodyshell hole with foam

**Note:** Perform task on left- and right-hand sides. Fill specified area with foam for approx. 5-6 seconds with the pistol trigger fully depressed, pulling the hose out slowly in the process. Fill the specified area with foam toward the front (in the direction of travel) and toward the rear. After filling with foam, seal the bodyshell hole with the expansion plug. (Prevents the foam from escaping)

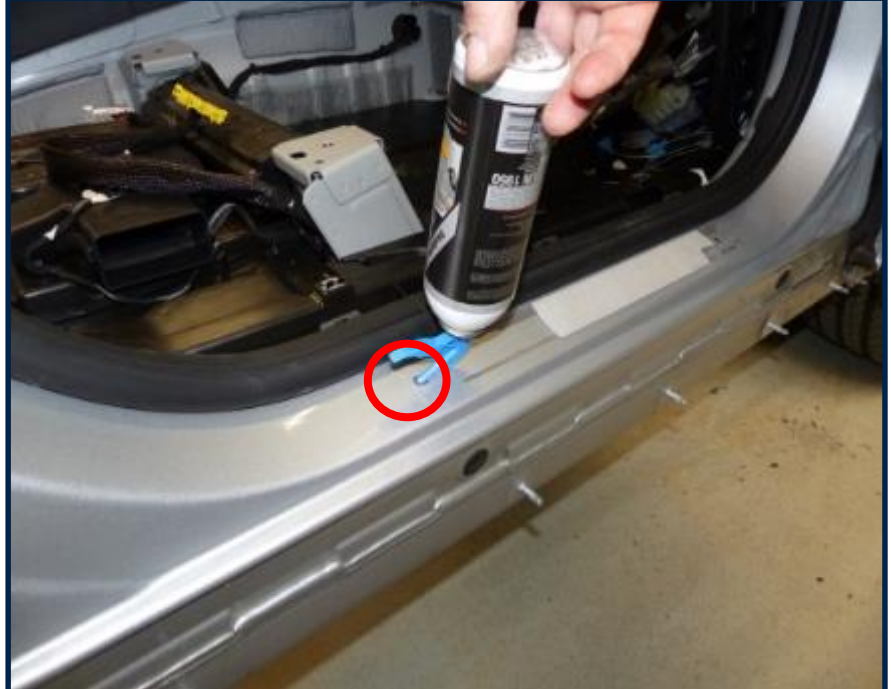
Fault location  
Door sill, outside, front

Fill bodyshell hole with foam

**Caution:** Depicted on right-hand side of vehicle

**Note:** Perform task on left- and right-hand sides. Bodyshell hole is located under the glued door sill panel. Fill specified area with foam for approx. 4-5 seconds with the pistol trigger fully depressed, pulling the hose out slowly in the process. Fill the specified area with foam only toward the rear in the direction of the B-pillar. After filling with foam, seal the bodyshell opening with adhesive tape. (Prevents the foam from escaping)

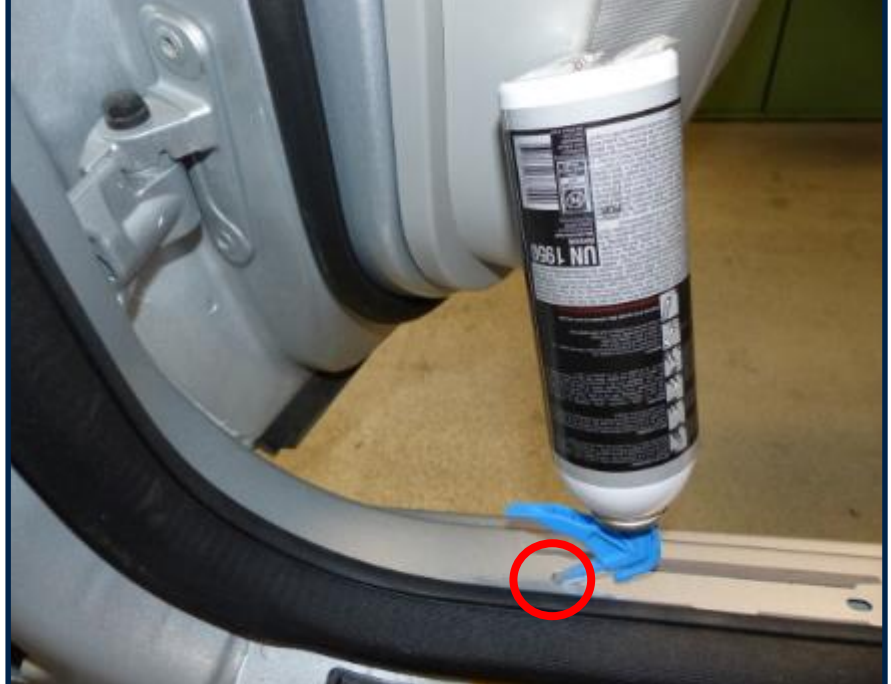
Fault location  
Door sill, outside, rear

Fill bodyshell hole with foam

**Caution:** Depicted on right-hand side of vehicle

**Note:** Perform task on left- and right-hand sides. Bodyshell hole is located under the glued door sill panel. Fill specified area with foam for approx. 4-5 seconds with the pistol trigger fully depressed, pulling the hose out slowly in the process. Fill the specified area with foam only toward the front in the direction of the B-pillar. After filling with foam, seal the bodyshell opening with adhesive tape. (Prevents the foam from escaping)

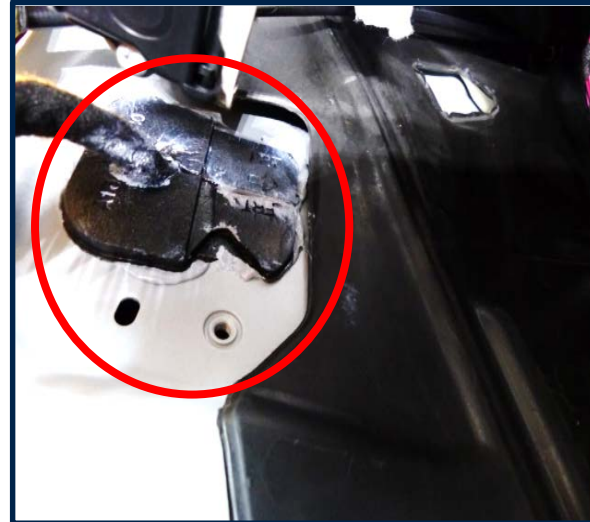
Sealing foam piece

Bodyshell hole sealed

**Note:** Perform task on left- and right-hand sides.

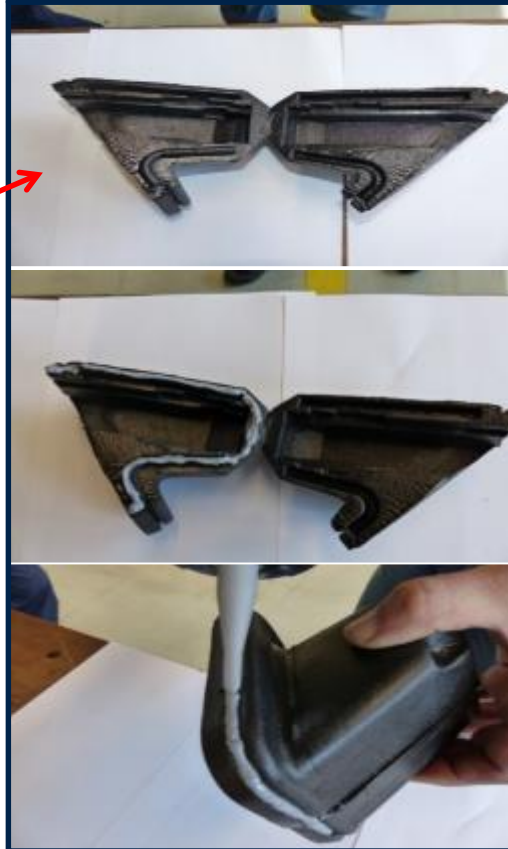
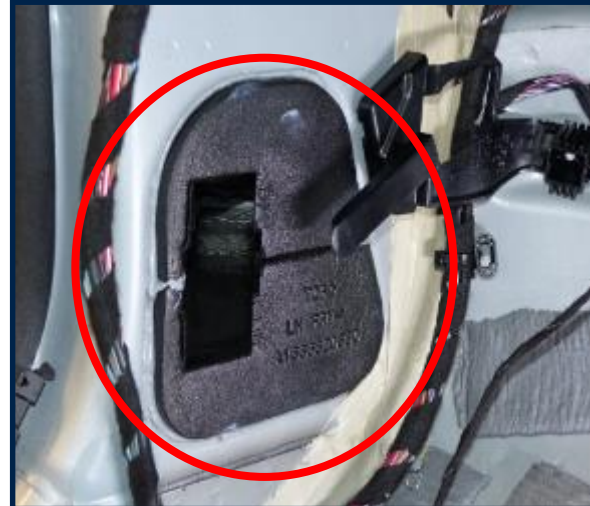
Sealing foam piece

Bodyshell holes sealed

**Note:** Perform task on left- and right-hand sides.

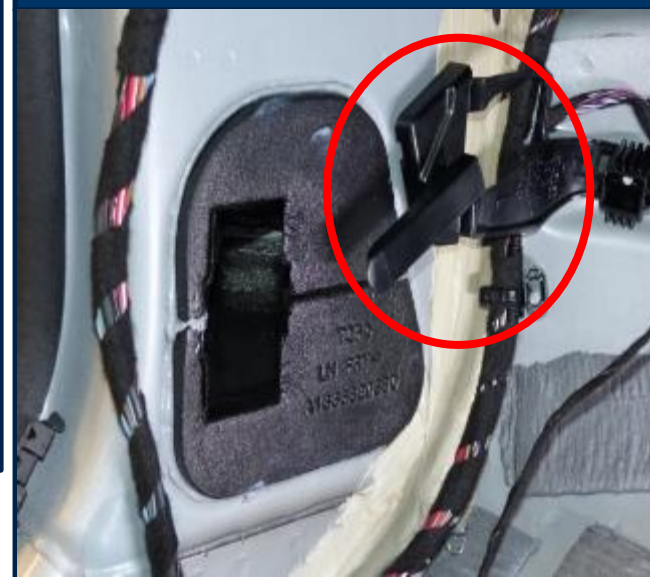
Bodyshell holes open

Bodyshell holes closed

**Note:** Perform task on left- and right-hand sides.

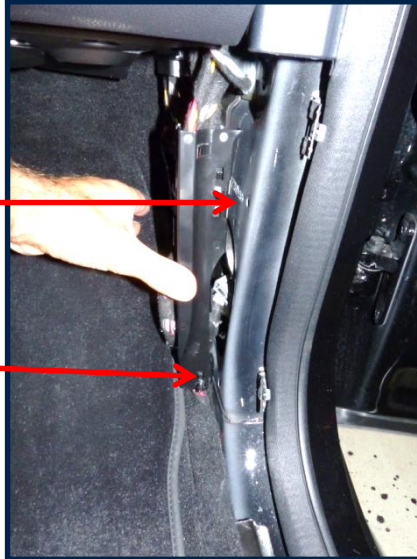
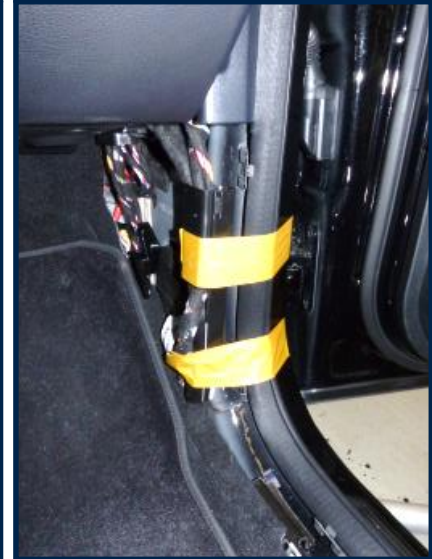
Bodyshell holes open

Bodyshell holes sealed

Cable duct, fixed

**Note:** Perform task on right-hand side. Check left-hand side (depending on equipment variant). If necessary, fix the cable duct with adhesive tape until the sealing compound has dried.

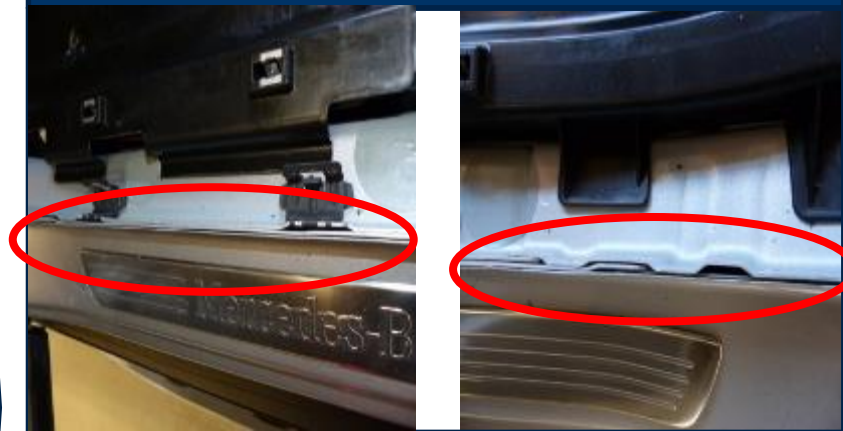
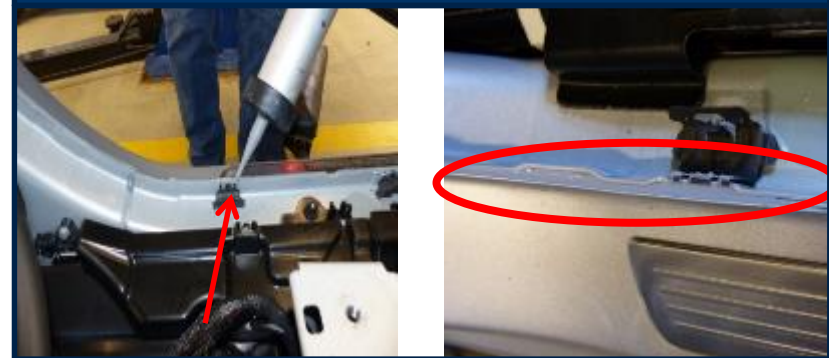
Fault location  
Door cut-outs

Bodyshell holes open

Bodyshell holes sealed

**Note:** Seal all spacers in the marked area (in illustration in top left) on the left- and right-hand side.

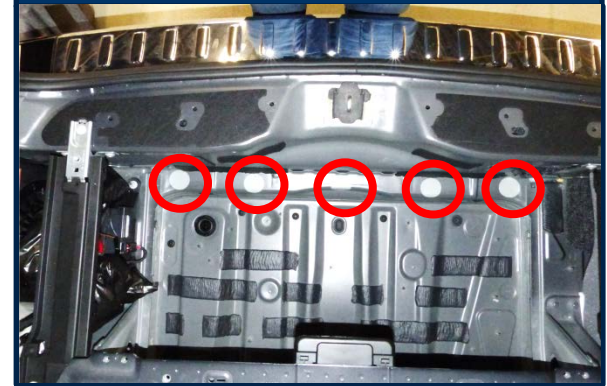
Bodyshell holes open

Bodyshell holes sealed

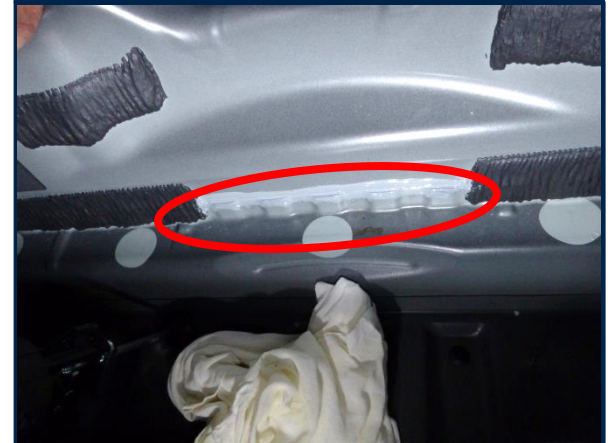
Bodyshell flange, open

Bodyshell flange, sealed

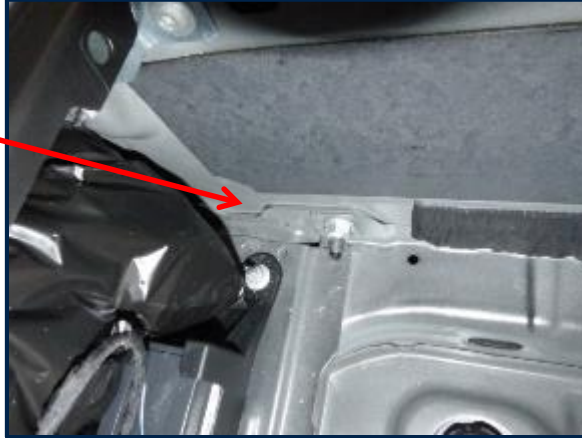
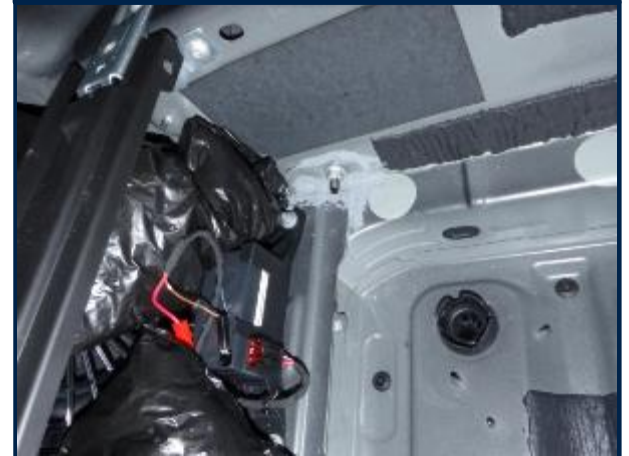
Bodyshell flange, open

Bodyshell flange, sealed

**Note:** Perform task on left- and right-hand sides

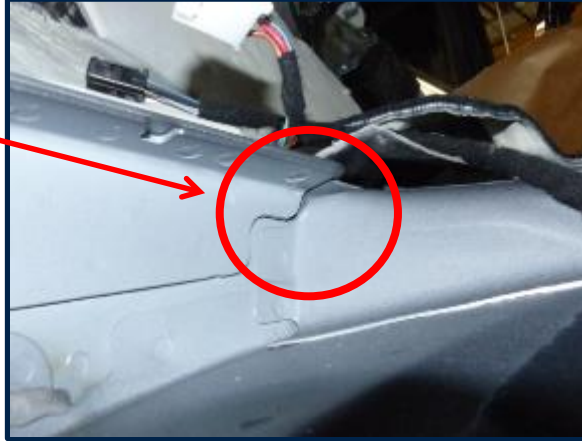
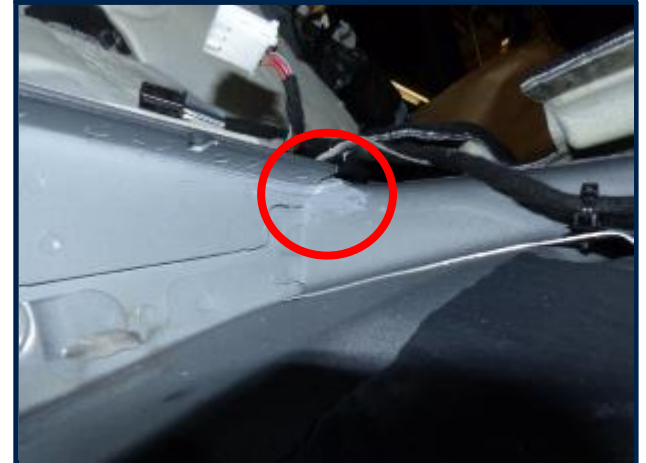
Bodyshell flange, open

Bodyshell flange, sealed

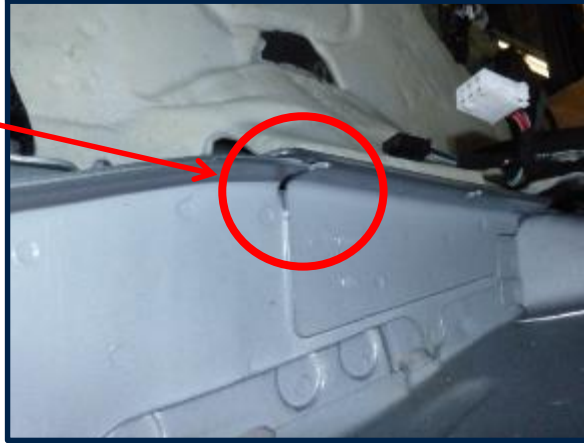
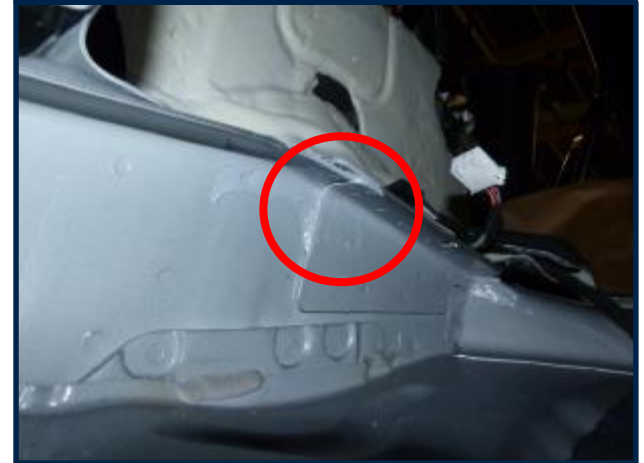
Bodyshell flange, open

Bodyshell flange, sealed
