## Creaking or squeaking noises heard from front struts or area of instrument panel

| Topic number | LI32.25-P-063651 |
| Design group | 32.25 Shock absorbers, damper struts, spring struts |
| Validity | MODEL 205, 253, 213 without CODE 489 |

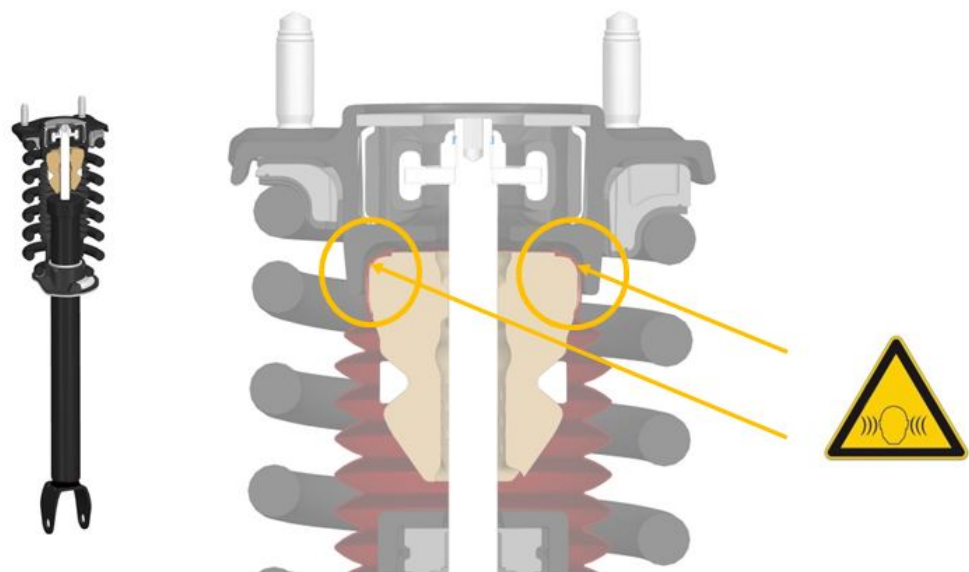
1\_Geräusch Knarzen.  
JPG:

1. When the suspension strut is compressed heavily, the expansion of the stop buffer may allow the boot to come into contact with the casing of the head bearing.
2. Squeaking noises between the buffer and the piston rod.
3. Squeaking noises due to micromovements between the upper coil of the spring and the upper spring cup mounting.

| Attachments | |
|---|---|
| 1_Geräusch Knarzen.JPG | Cause and remedy (lubrication area for grease) |

1. Raise vehicle at front axle.
2. Pull down stop buffer with boot.
3. Apply Krytox fluid/ grease to the following locations (also refer to picture in attachment):
  - Area (1) is the contact surface between the spring and the spring cup mounting.
  - Area (2) is the contact surface between the dust boot and the strut tower.
4. Grease with special grease A 001 989 84 51 between shock absorber piston rod and stop buffer.
5. Push stop buffer with boot back up to original position.

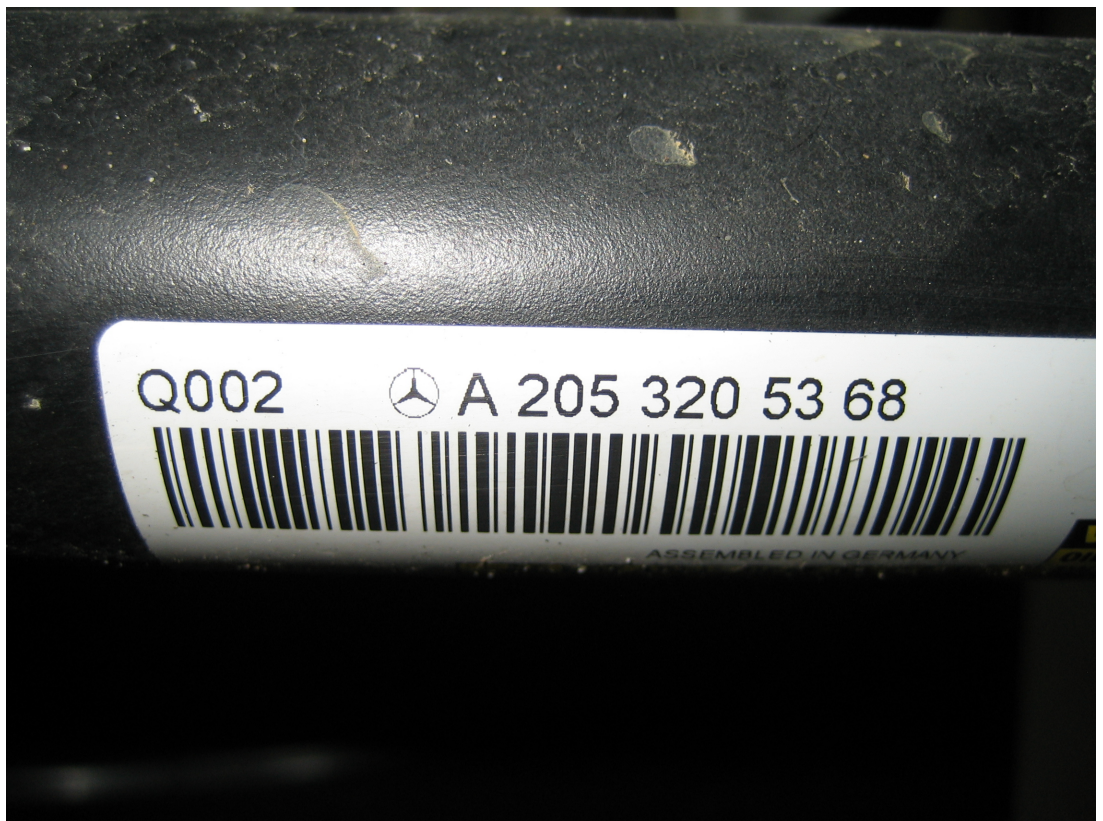
Label\_1\_Federbein\_205.  
JPG:

| Attachments | |
|---|---|
| Label_1_Federbein_205.JPG | Photo of suspension strut label no. 1 |

- Photo of labels on suspension strut/shock absorber, see attachment: "Photo of suspension strut label no. 1" and "Photo of suspension strut label no. 2".
- Photo on which the areas covered in grease can be seen in greater detail.

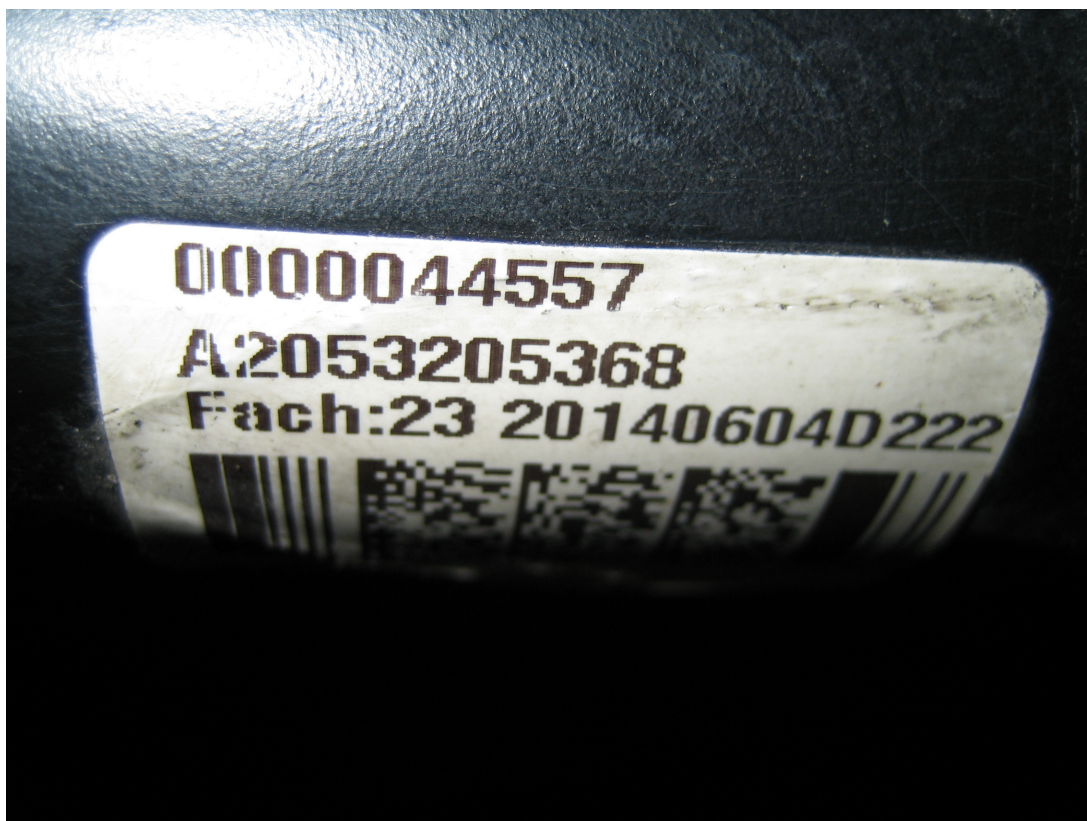
Label\_2\_Federbein\_205.  
JPG:

| Attachments | |
|---|---|
| Label_2_Federbein_205.JPG | Photo of suspension strut label no. 2 |

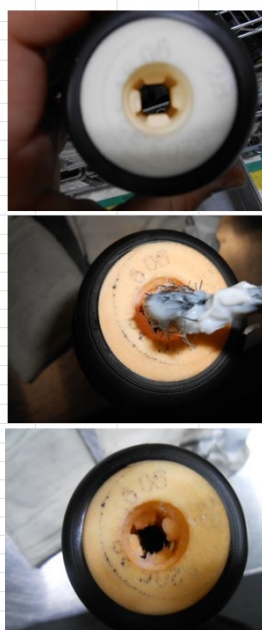
Fetten Anschlagpuffer.  
jpg:

| Attachments | |
|---|---|
| Fetten Anschlagpuffer.jpg | Greasing with A0019898451 09 between piston rod and stop buffer |

Grab completed dust tube/jounce bumper

Coat small brush with special grease A 001 989 84  
51 09

Place brush inside bumper, moving around to apply thin coat of material to bumper contact pads. Use of gloves is required.

Inspect inside surface for coating on all 4 surfaces,  
if not covered repeat

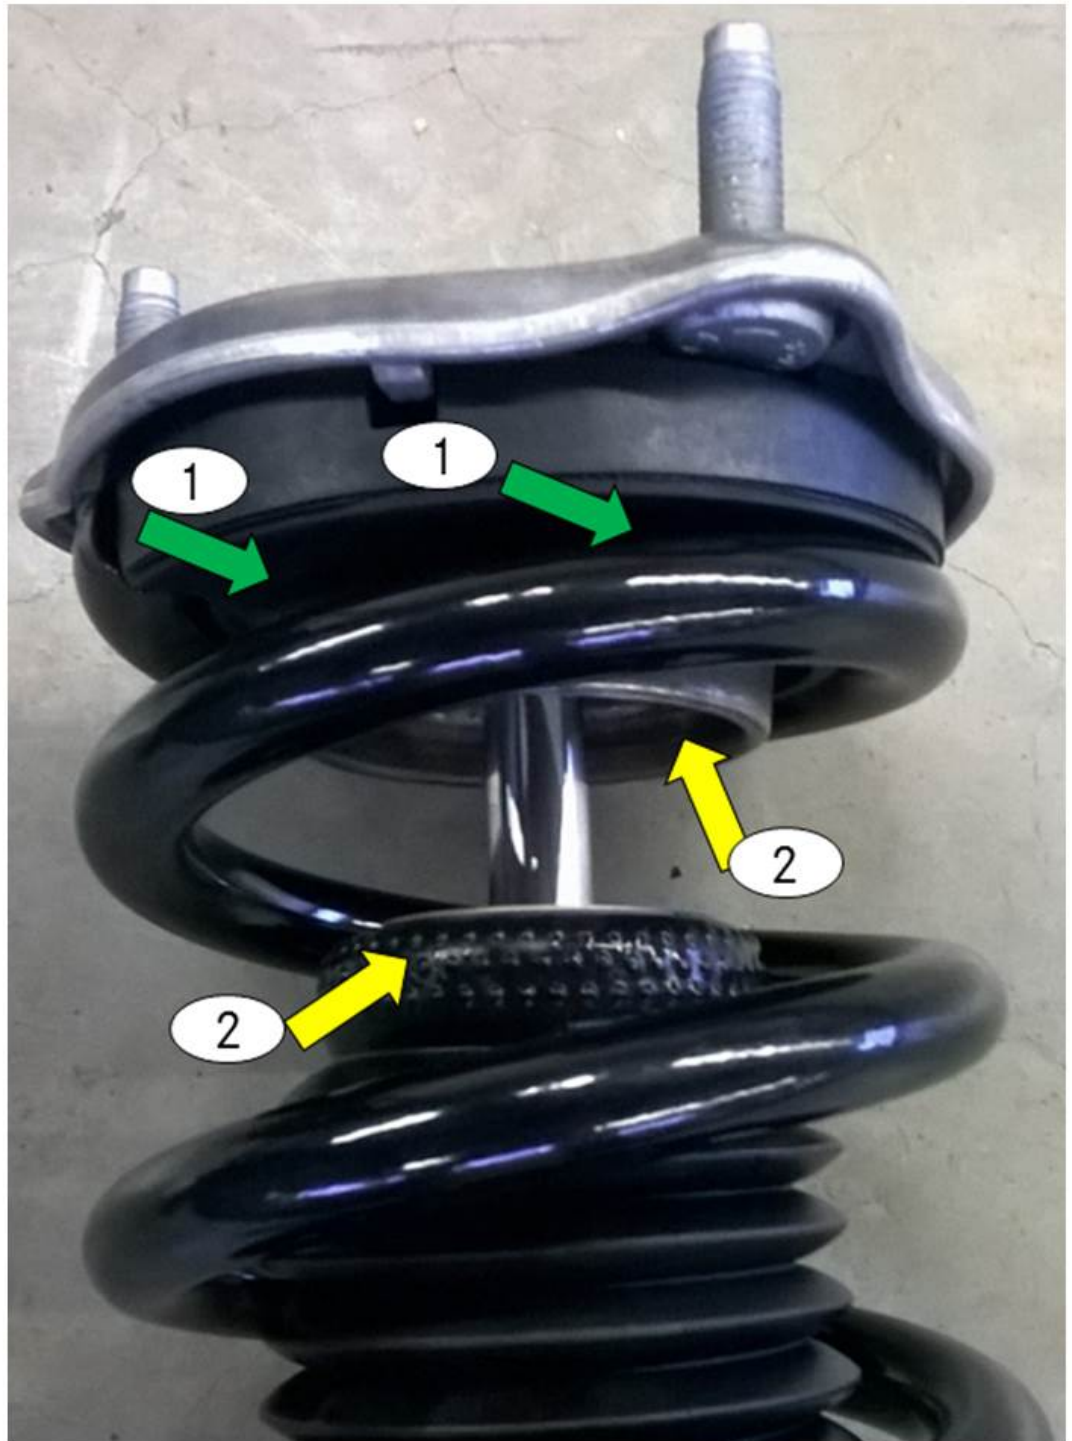
Fettstellen.jpg:

| Attachments | |
|---|---|
| Fettstellen.jpg | Areas to be greased |
