## MB-TeX detaches from side bolster of seat cushion cover on door side

| Topic number | LI91.18-P-066298 |
| Design group | 91.18 Seat covers |
| Validity | W/S 205 and X/C253 - All MB-TeX (100A, 101A, 130A, 131A, 140A, 160A, 300A, 301A, 320A, 600A, 610A, 621A, 630A, 631A, 641A, 645A, 650A) |

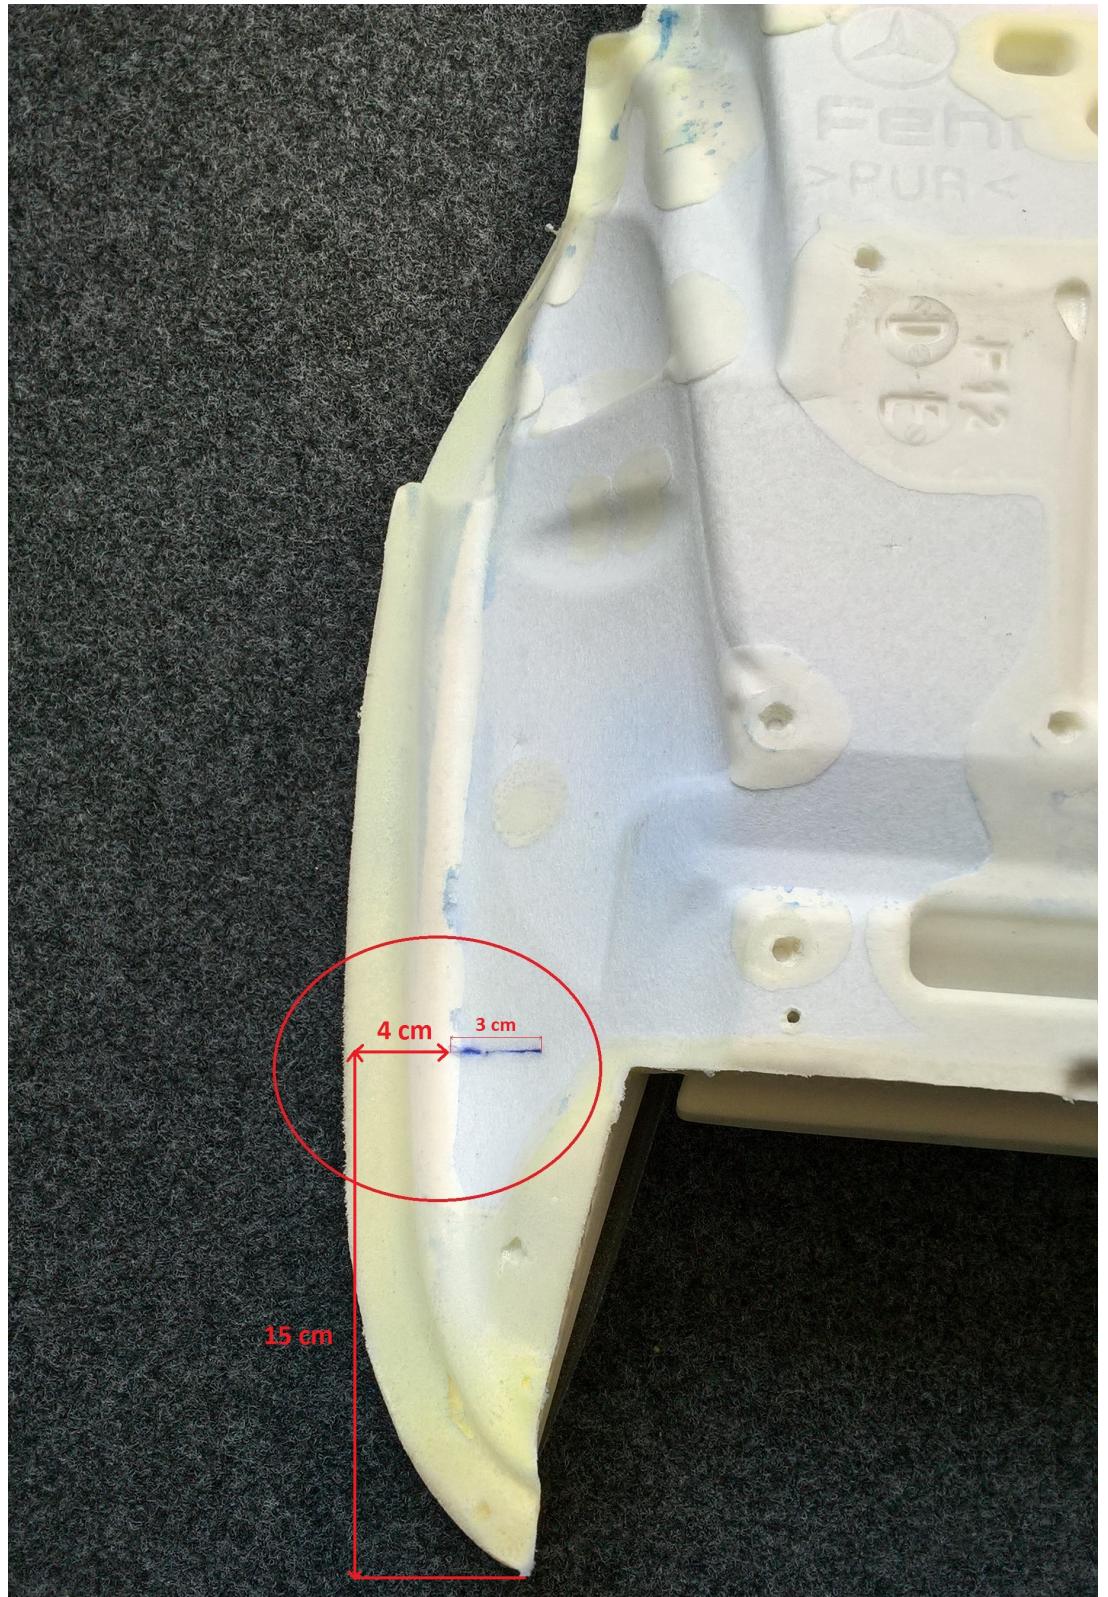
Pic.5.jpg:

| Attachments | |
|---|---|
| Pic.5.jpg | Foam padding, cut on left |

1. Mark both sides in the same way as shown (Pic.4, Pic.5 and Pic.6).
2. Use a cutter to make cuts of approx. 3 cm on left (Pic.7) and right (Pic.8).

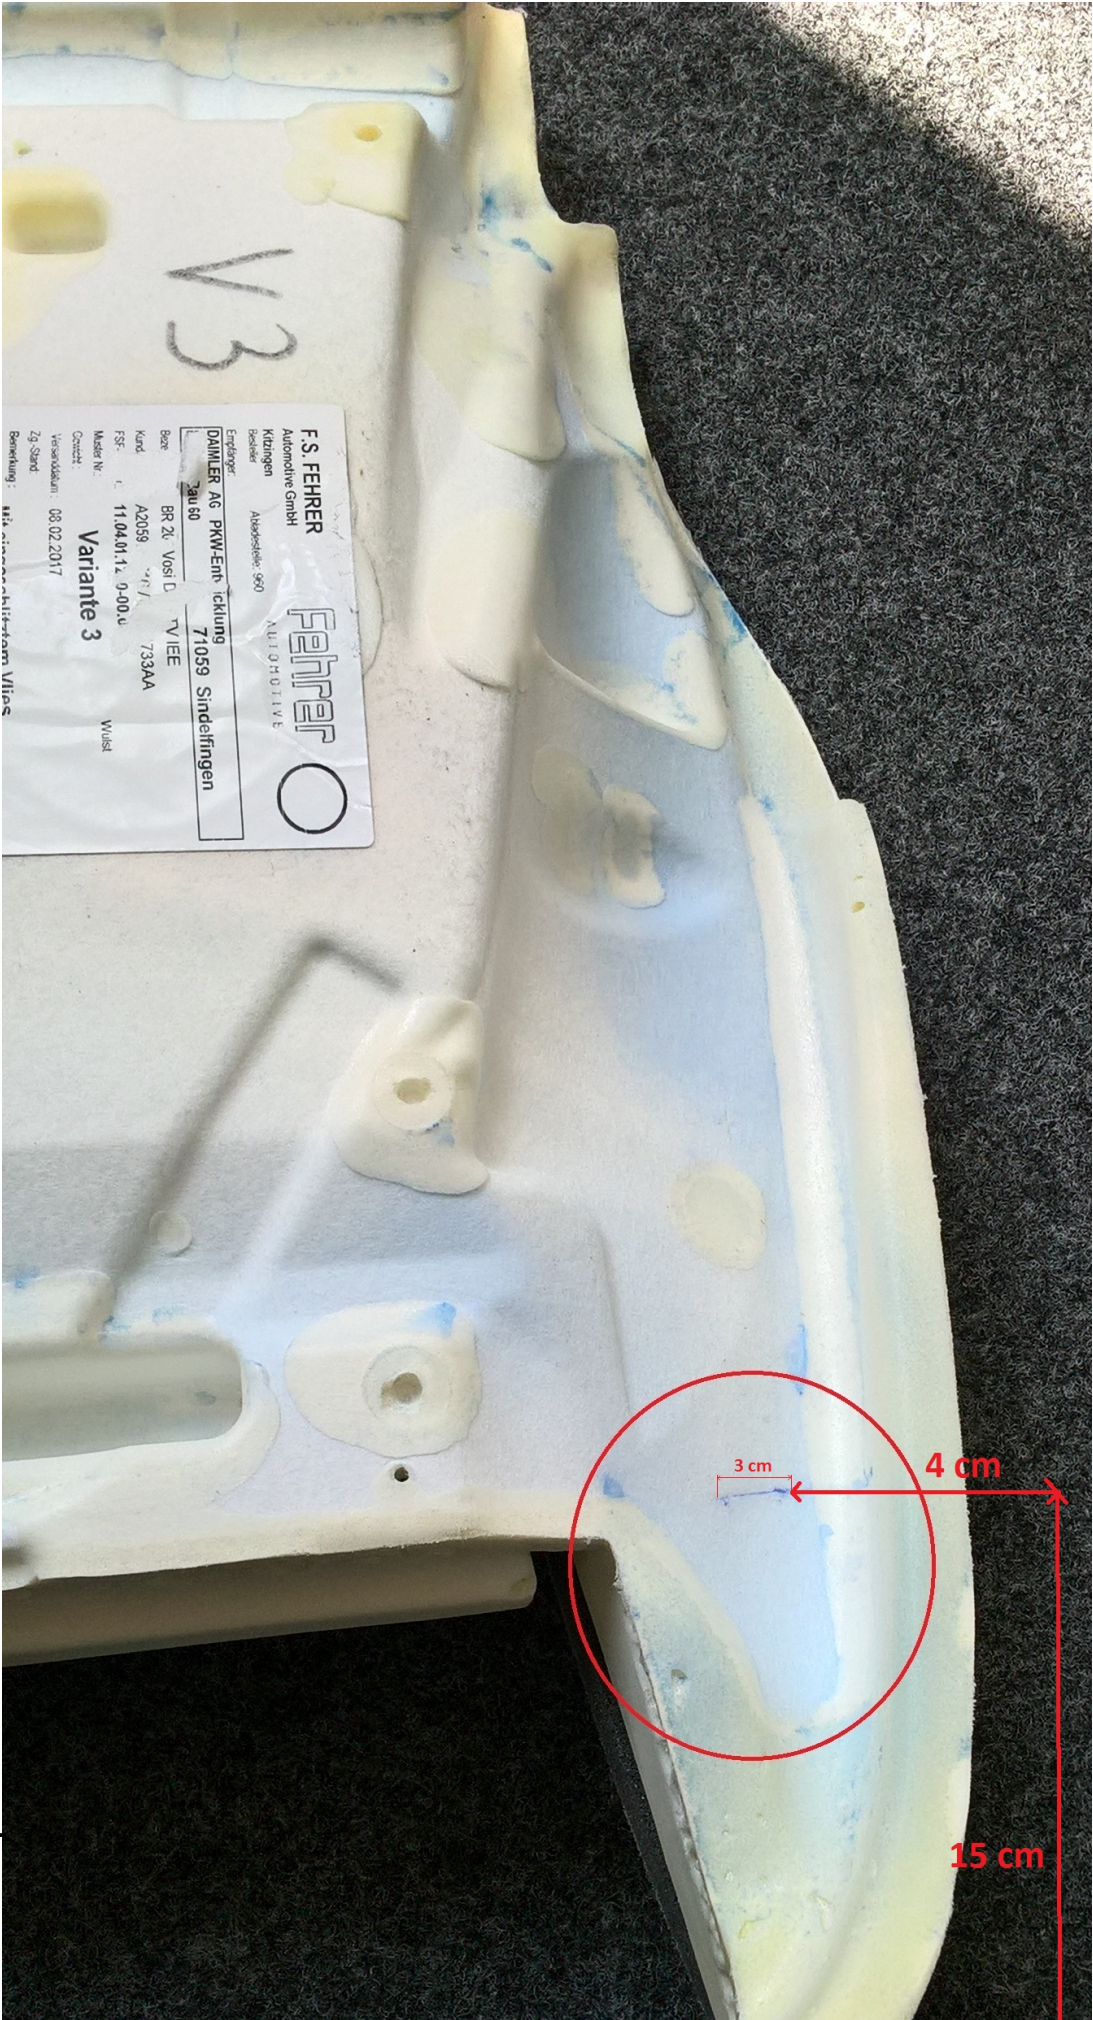
Pic.6.jpg:

| Attachments | |
|---|---|
| Pic.6.jpg | Foam padding, cut on right |

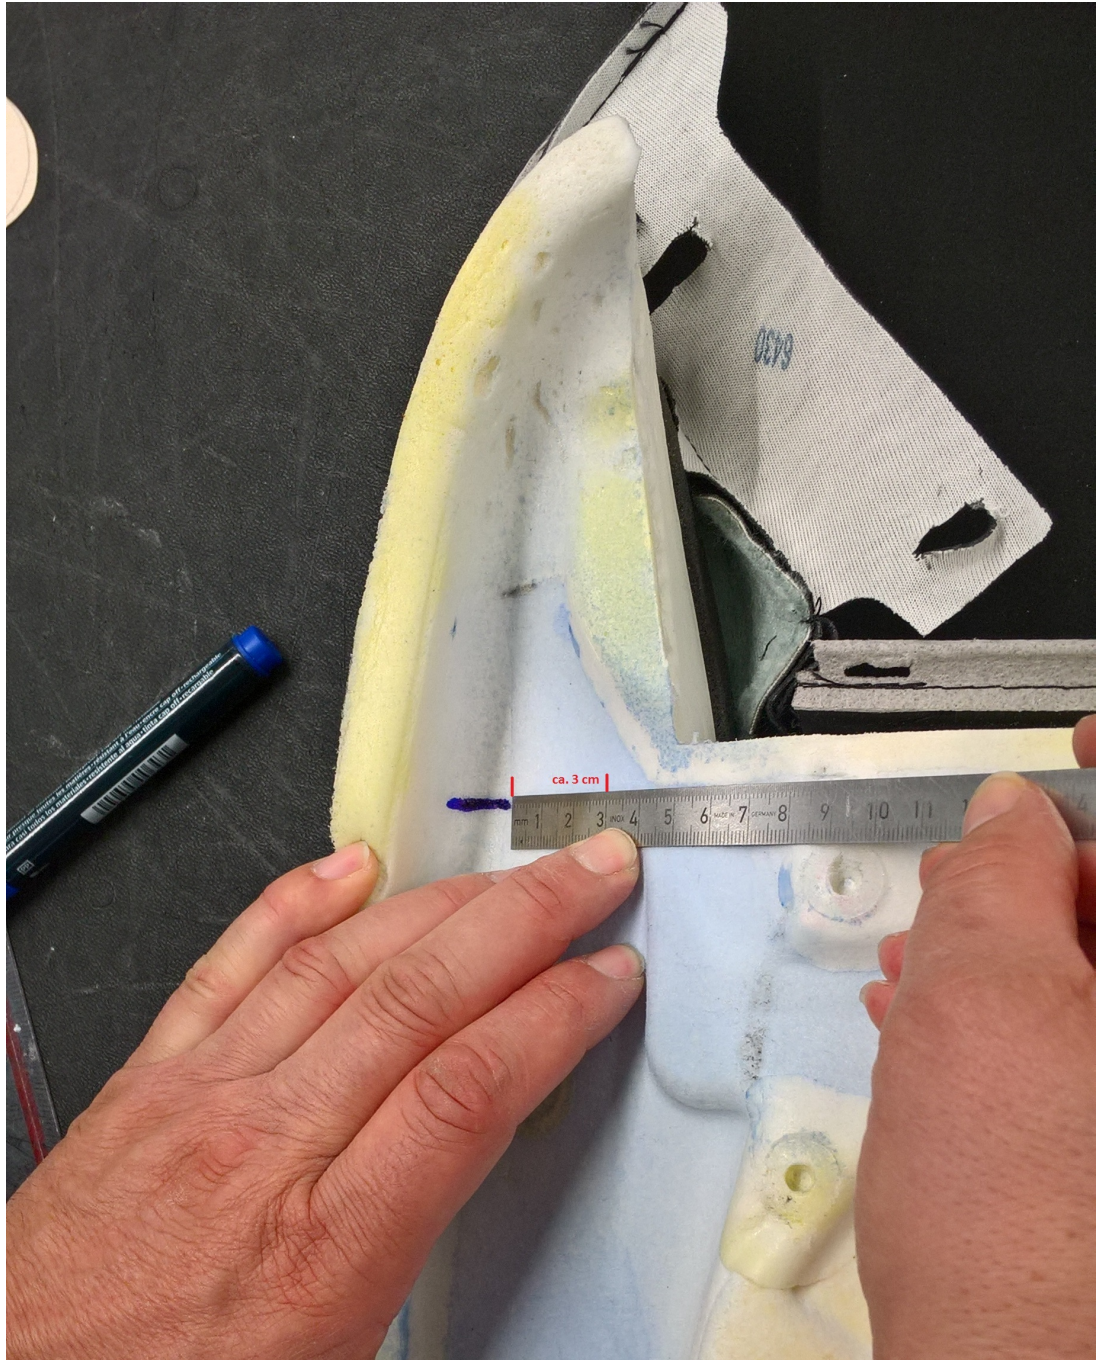
Pic.8.jpg:

| Attachments | |
|---|---|
| Pic.8.jpg | Foam padding, cut on right, position |

The wire frame can dip into these cuts in the foam, relieving the stress on the side bolsters. This increases the strength at the side bolsters.

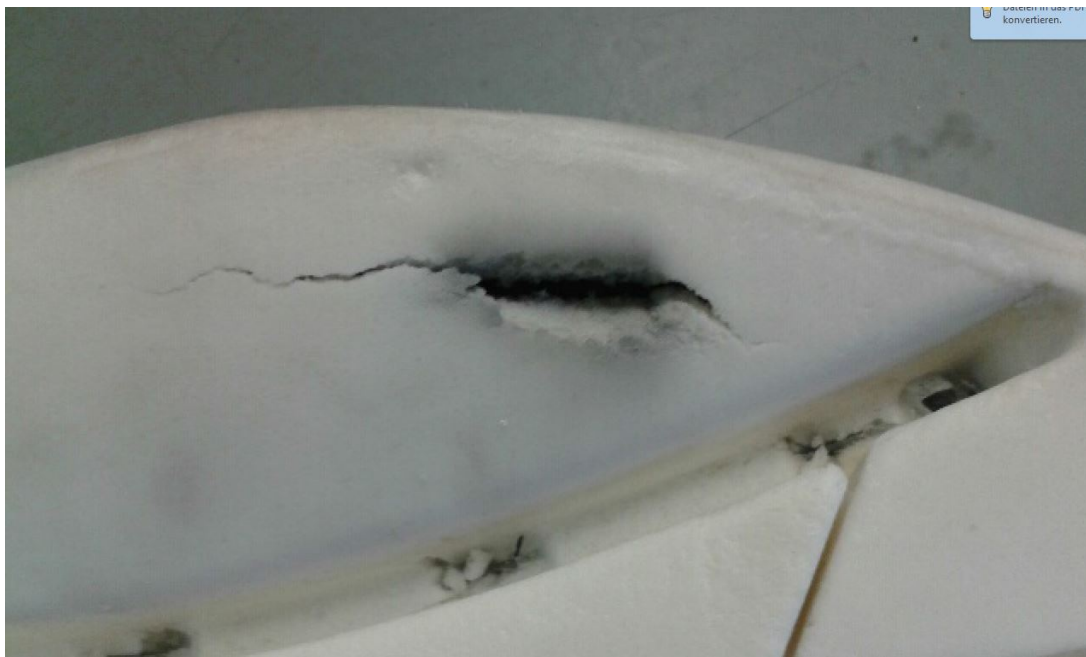
Pic.1.JPG:

| Attachments | |
|---|---|
| Pic.1.JPG | Wire frame working its way through the padding |

The wire frame in the padding (Pic.1 and Pic.2) can work its way through the padding over time and cause damage to the cover.

Replace padding and cover.

The padding must be modified as follows before installation:

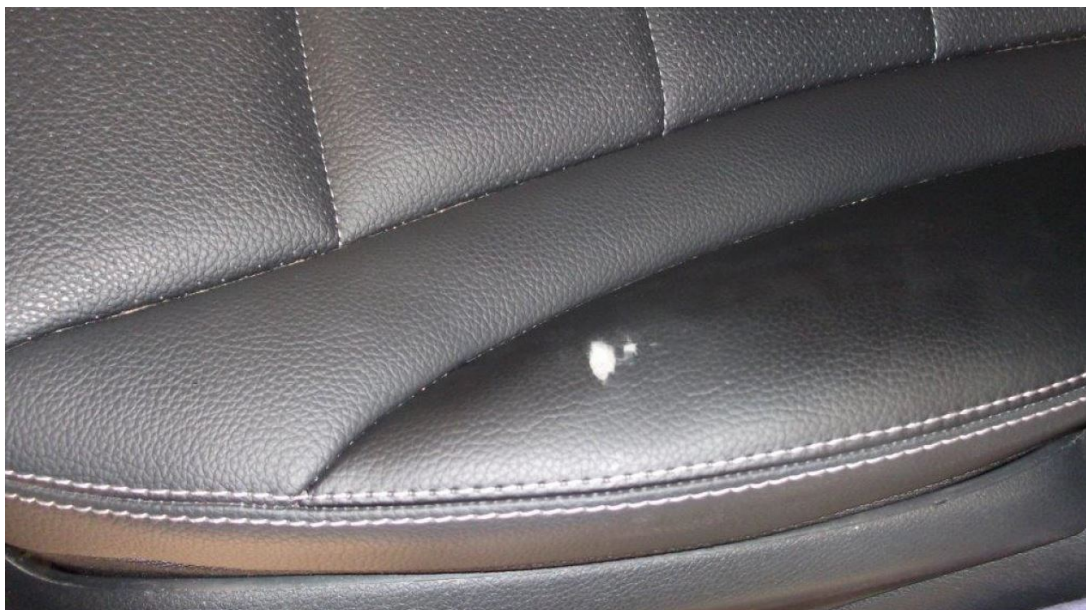
Pic.3.JPG:

| Attachments | |
|---|---|
| Pic.3.JPG | Seat cover with detached PUR |

Under severe cyclic tensile stresses the thin PUR finish (functional coating) can tear (Pic.3). The damage profile is not the fault of the customer.
