## White staining on Dinamica seat covers

| Topic number | LI91.18-P-058808 |
| Validity | BR 204/207 with equipment code A908, A911, A915, A921 up to production date 01.12.2014 |

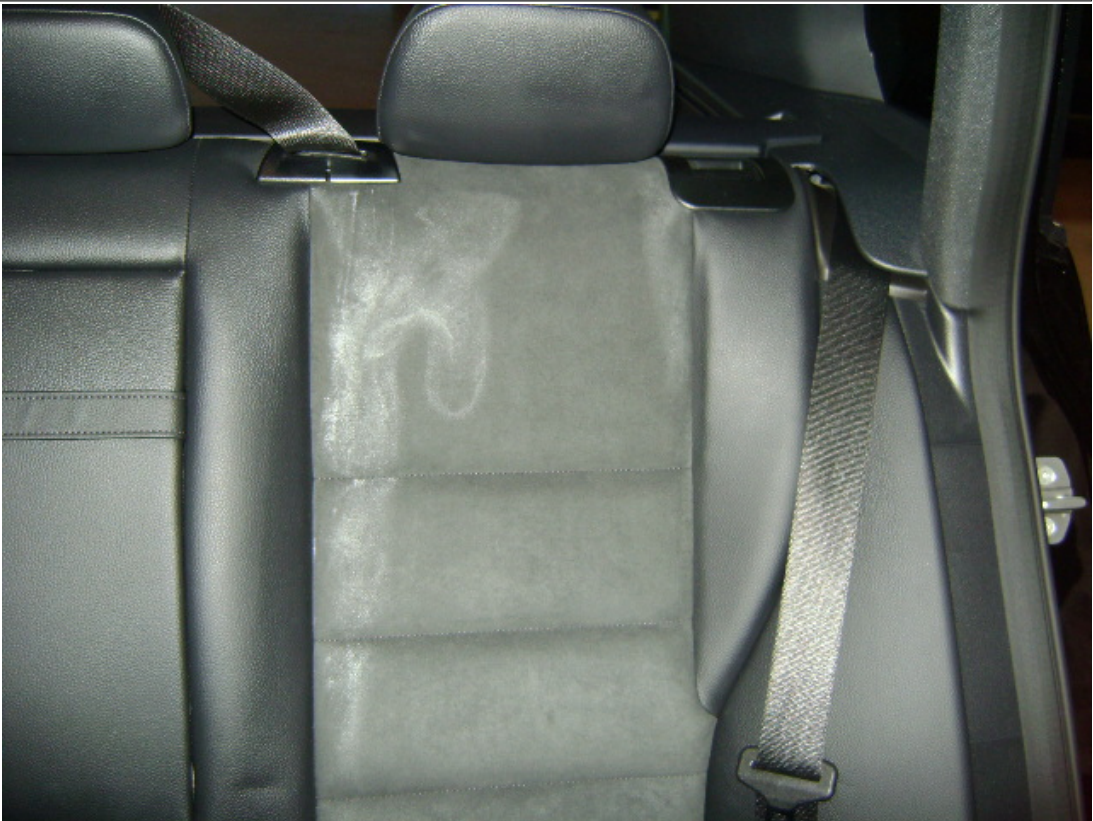
Dinamica1.JPG:

White staining on seat covers in equipment variant "Dinamica" (Pic.1 - Pic.3).

| Attachments | |
|---|---|
| Dinamica1.JPG | Staining on rear backrest |

Possible use of a non-approved thermoplastic adhesive in the seat cover production process.

If this kind of staining exists, please create a PTSS case so it can be sent to Engineering for an accurate evaluation.

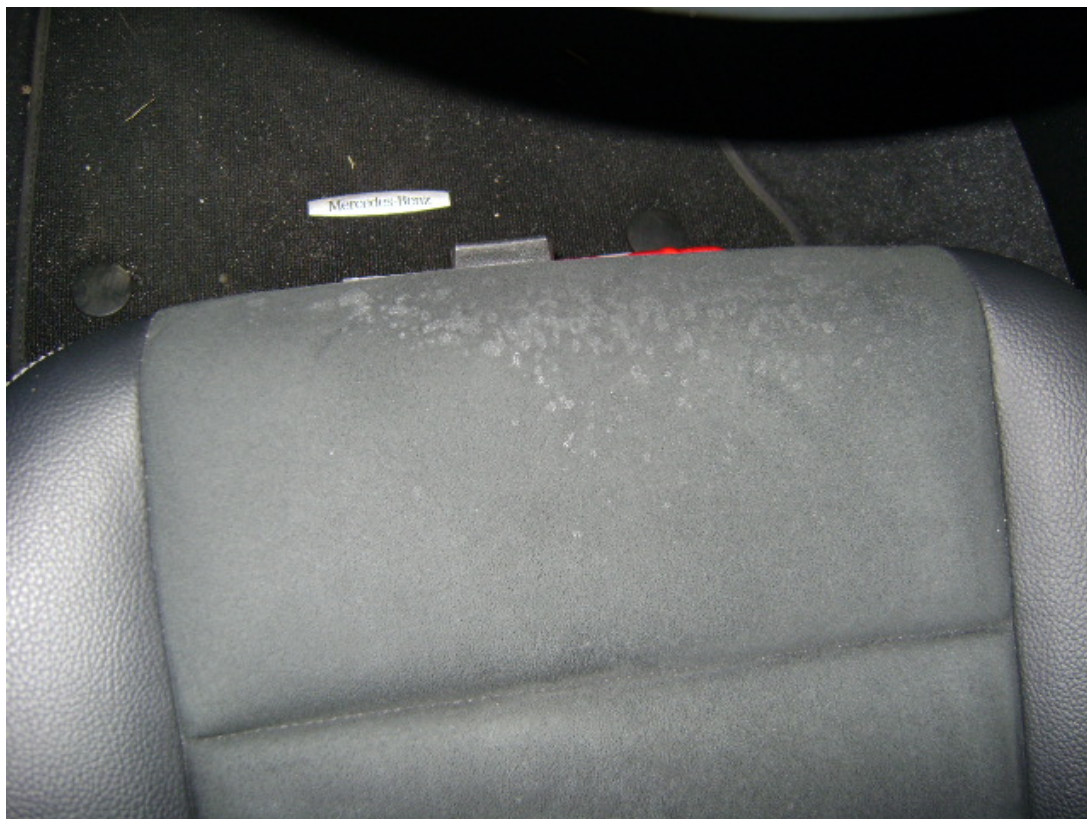
Dinamica2.JPG:

| Attachments | |
|---|---|
| Dinamica2.JPG | Stains on seat cushion |

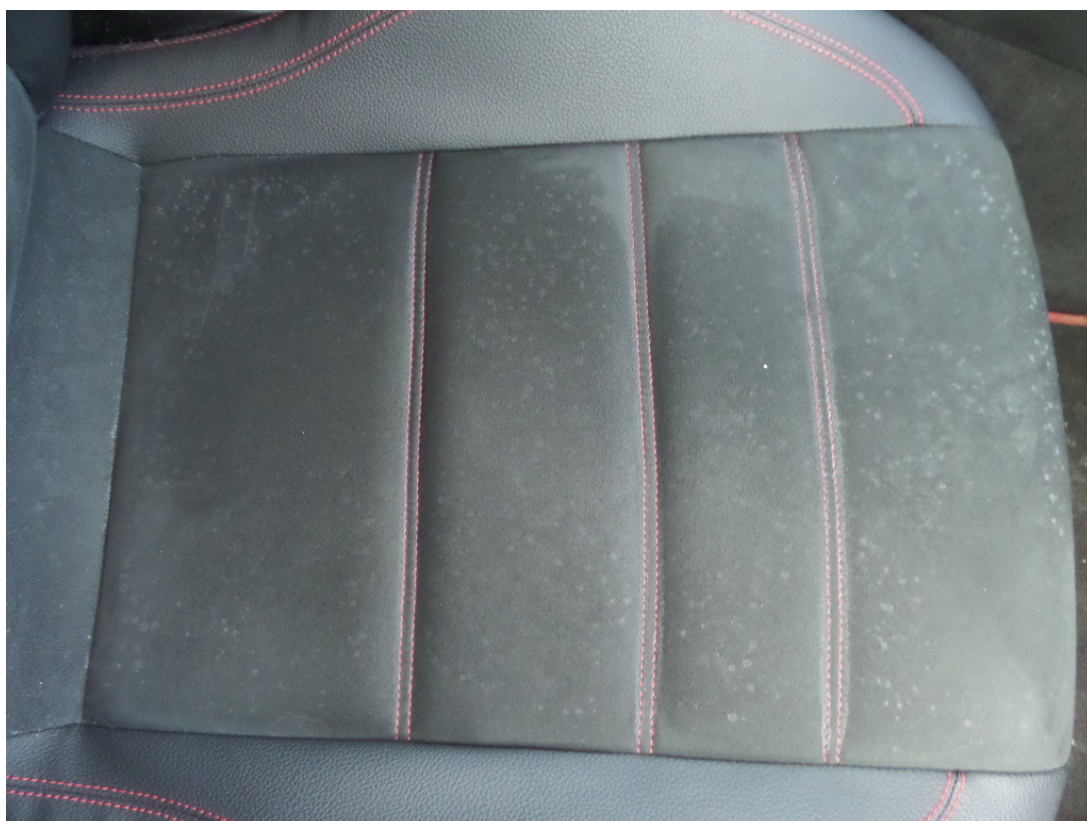
Dinamica4.JPG:

| Attachments | |
|---|---|
| Dinamica4.JPG | Stains on seat cushion |
