Date: January 12, 2017
To: Audi Dealer Principal, Service Manager, Warranty Administrator, Sales Manager, General Manager & Parts Manager
From: Audi Customer Protection
Subject: Emissions Modification Available – for Customer Only (Retail Sold) TDI Vehicles Only
Emissions Recall 23T4 – 2.0L TDI Engine (GEN 3) - Emissions Control Software – USA ONLY

Code: 23T4

Subject	2.0L TDI Engine (GEN 3) Emissions Control Software – Customer Only (Retail Sold) TDI Vehicles <u>USA ONLY</u>
Release Date	January 12, 2017
Affected Vehicles	U.S.A.: 2015 MY Audi A3 2.0L TDI, Customer (Retail Sold) Only <i>Check Campaigns/Actions screen in Elsa on the day of repair to verify that a VIN qualifies for repair under this action. Elsa is the <u>only</u> valid campaign inquiry & verification source.</i> <ul style="list-style-type: none">✓ Campaign status must show “open.”✓ If Elsa shows other open action(s), inform your customer so that the work can also be completed at the same time the vehicle is in the workshop for this campaign.
Problem Description	The Environmental Protection Agency and California Air Resources Board have determined that Audi A3 vehicles equipped with a 2.0L 4-cylinder TDI engine do n

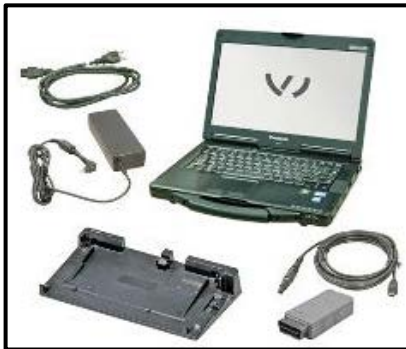
- VAS6150X – Diagnostic Tester (or equivalent)
- VAS5054X – Remote Diagnosis Head (or equivalent)

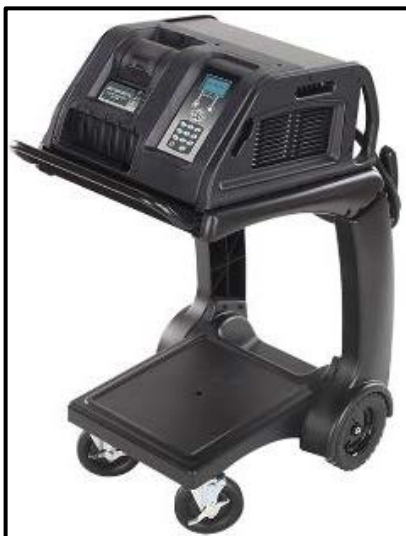
- GRX3000VAS – Battery Tester/Charger

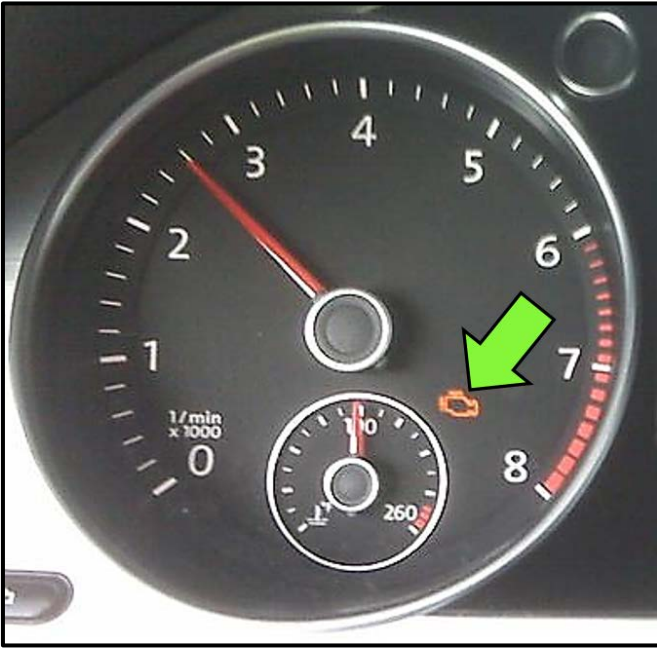
- Check for illumination of the MIL <arrow>.
 - If MIL is illuminated, STOP, obtain GFF diagnostic log, create an ATA ticket and contact the Audi Technicians Helpline.
 - If MIL is not illuminated, continue work procedure.

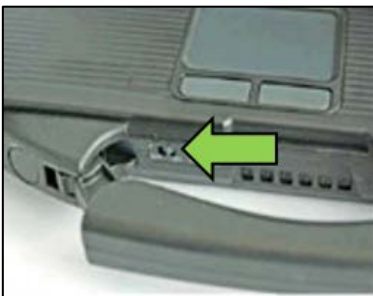
VAS 6150 & VAS 6150A
(Front panel behind handle)

- ✓ **The Bluetooth function of the scan tool is physically switched off <see pictures below>.**

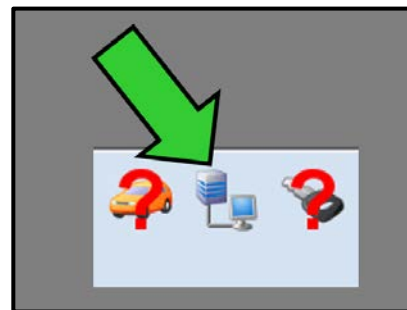
- ✓ Verify your network connection through LAN by checking the connection icon (lower right of the home screen).

- ✓ Check the icon <arrow> within the ODIS software that you have a connection.

- ✓ Within the Connection Tab, verify that the Connection type(s) display "Internet" <as shown>.

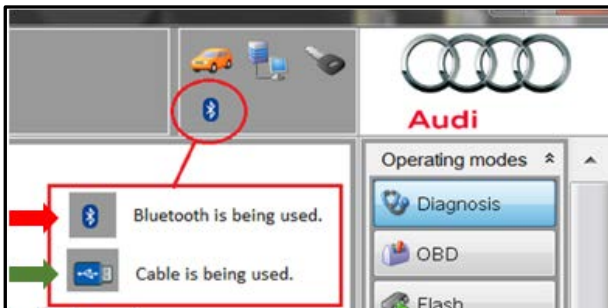
- Confirm that scan tool is communicating with the diagnostic head by USB <Green Arrow>.
 - If the Bluetooth symbol is shown <Red Arrow> then disconnect the diagnostic head from the vehicle and reconnect the USB cable to the diagnostic head and then reattach to the vehicle.

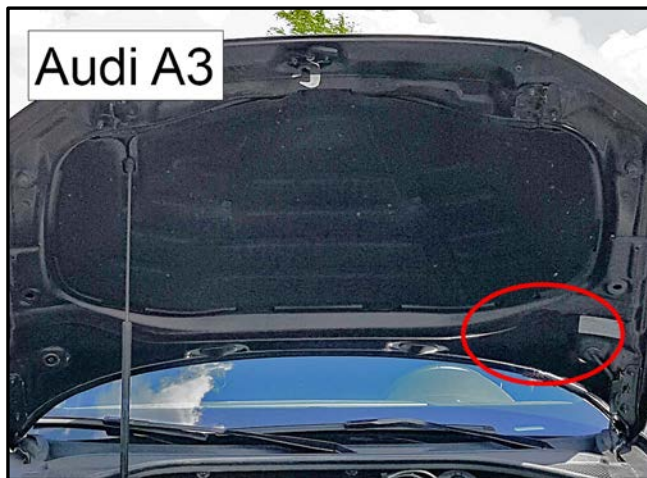
- Open the hood.
- Clean the surface where the label is to be installed <circle>.
- Install the Supplemental Vehicle Emissions Control Information Label, **03L 010 005 J**, in the location shown.

- The surface where the label is to be installed must be clean, dry, and free from oil residue prior to installing the label.
- Label must NOT cover any existing label(s).
- Label must be installed in location shown.
- Photo documentation of label installed is required.
