# Emissions Recall

## Code: 23Q3

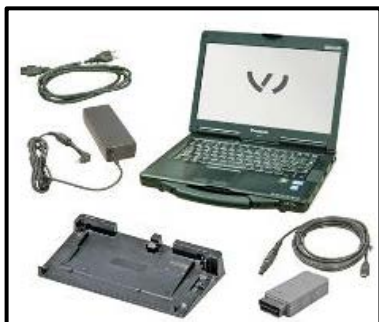
- VAS6150X – Diagnostic Tester (or equivalent)
- VAS5054X – Remote Diagnosis Head (or equivalent)

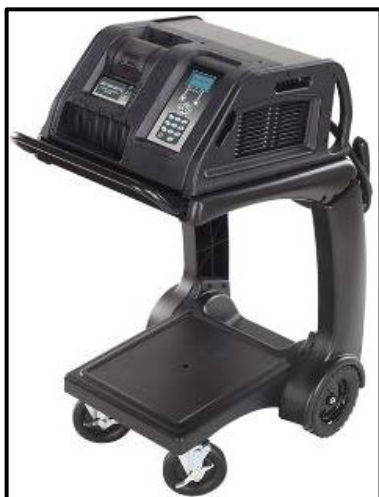
- GRX3000VAS – Battery Tester/Charger

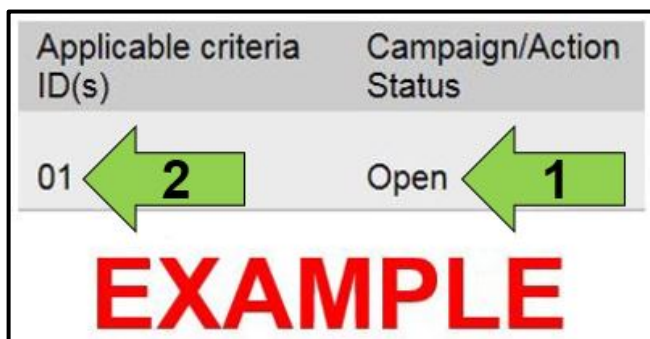
- Enter the VIN in Elsa and proceed to the "Campaign/Action" screen.

- Confirm the Campaign/Action is open <arrow 1>. If the status is closed, no further work is required.
- Note the Applicable Criteria ID <arrow 2> for use in determining the correct work to be done and corresponding parts associated.

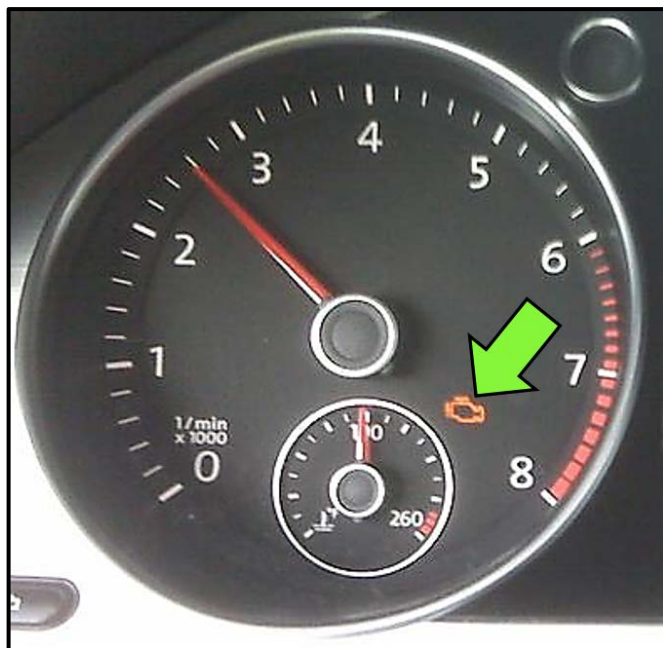
- Check for illumination of the MIL <arrow>.
  - o If MIL is illuminated, STOP, obtain GFF diagnostic log, create a VTA ticket and contact the Volkswagen Technicians Helpline.
  - o If MIL is not illuminated, continue work procedure.

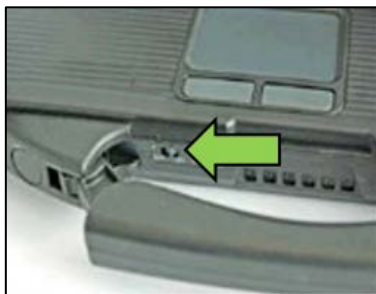
**VAS 6150 & VAS 6150A**  
(Front panel behind handle)

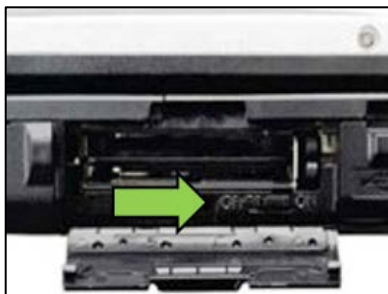
**VAS 6150B**  
(Right side behind WIRELESS door)

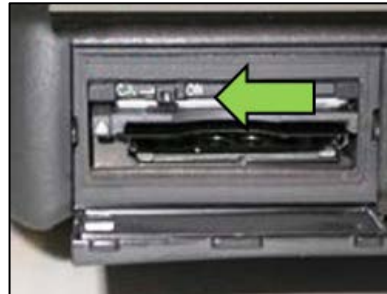
**VAS 6150C**  
(Left side behind SC/EX door)

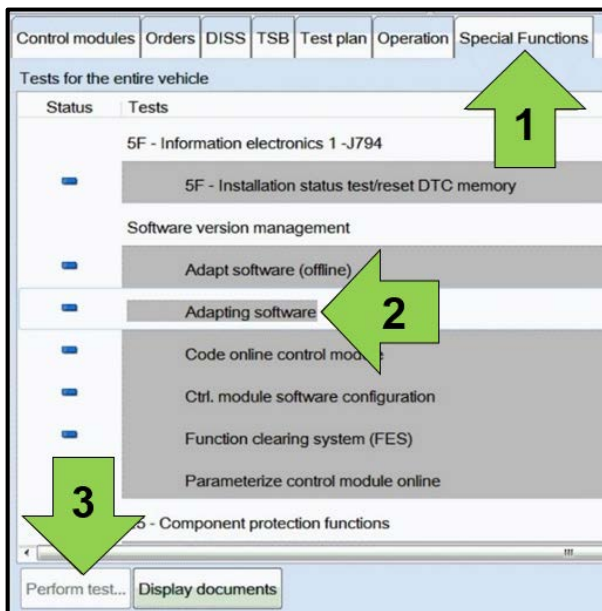
- Once the GFF scan is complete, select "Special functions" <arrow 1>, then "Adapting software" <arrow 2>, then select "Perform test" <arrow 3>.

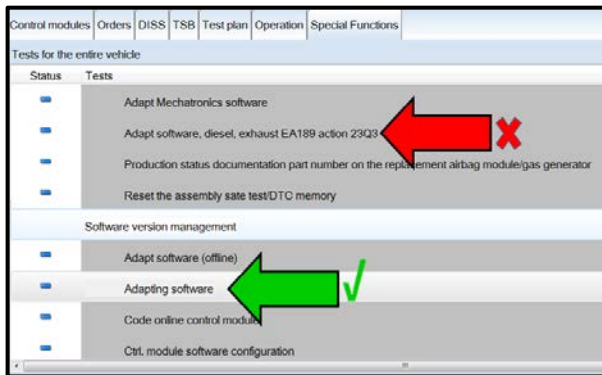
- **DO NOT SELECT** the test plan for “Adapt software, diesel, exhaust EA189 action 23Q3” <red arrow>.
- **ONLY SELECT** the test plan “Adapting software” <green arrow> to perform this repair.

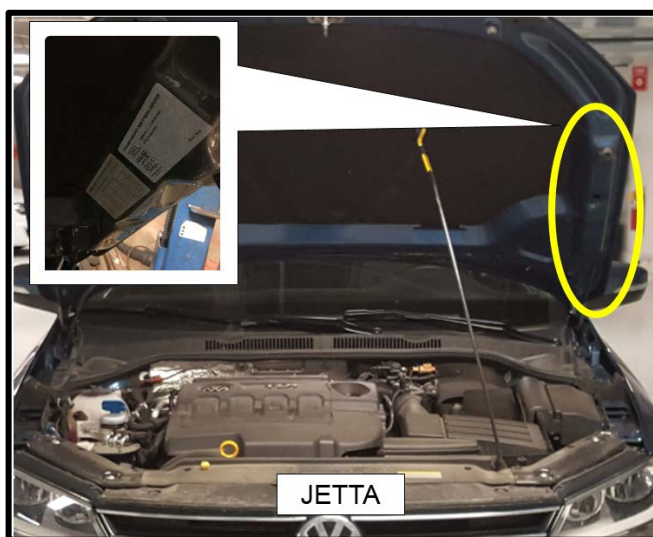
- Open the hood.
- Clean the surface where the label is to be installed <circle>.
- Install the Supplemental Vehicle Emissions Control Information Label, **03L 010 005 J**, in the location shown <circle>.

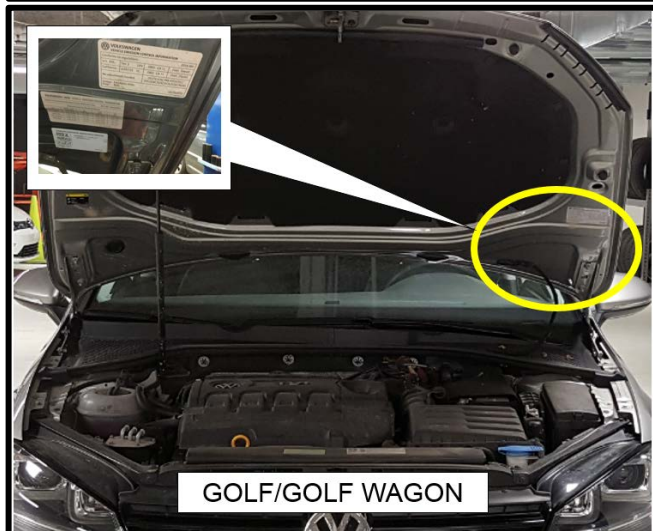
New Vehicle Emissions Control Information (VECI) label MUST NOT be placed over original VECI label.
