Technical Service Bulletin

06-001/17 - LEATHER STEERING WHEEL SURFACE WEAR / PEEL

Bulletin No.: 06-001/17

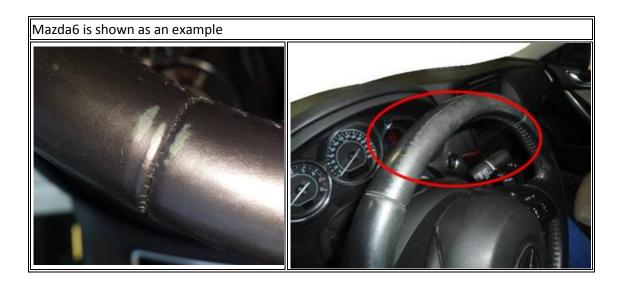
Some vehicles may exhibit wear/peel-off of the leather steering wheel surface causing a poor appearance. This concern may be caused by an insufficient wear resistance of the steering wheel surface.

Customers having this concern should have their vehicle repaired using the following repair procedure.

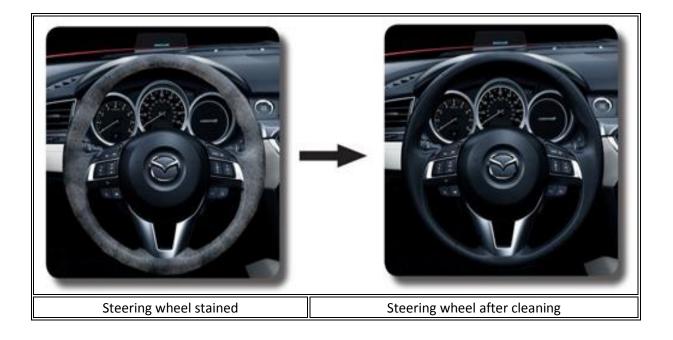
Note: Some vehicles may have steering wheel stains caused by chemicals such as hand lotions.

1. Use a clean towel damped in leather/vinyl cleaner or mild soap to clean the steering wheel.

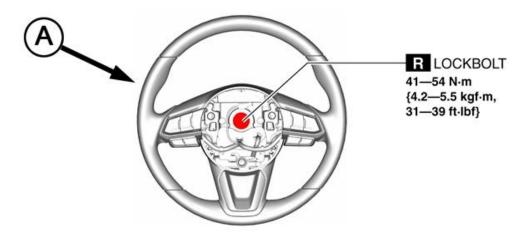
- 2. Is the steering wheel wear/peel concern present after cleaning the steering wheel?
 - Yes Go to Step 3.
 - No This service bulletin does not apply.
- 3. Replace the steering wheel (A). Refer to MGSS online Workshop Manual:
 - Mazda3 STEERING WHEEL AND COLUMN REMOVAL/INSTALLATION.
 - Mazda6 STEERING WHEEL AND COLUMN REMOVAL/INSTALLATION.
 - CX-3 STEERING WHEEL AND COLUMN REMOVAL/INSTALLATION.
 - CX5 STEERING WHEEL AND COLUMN REMOVAL/INSTALLATION.

4. Verify repair.
