Technical Service Bulletin

Subject: 02-003/17 - KNOCKING / SQUEAKING NOISE FROM FRONT SHOCK ABSORBER, CREAKING NOISE FROM FRONT LOWER ARM BUSHING	Bulletin No.: 02-003/17
	Last Issued: 06/09/2017

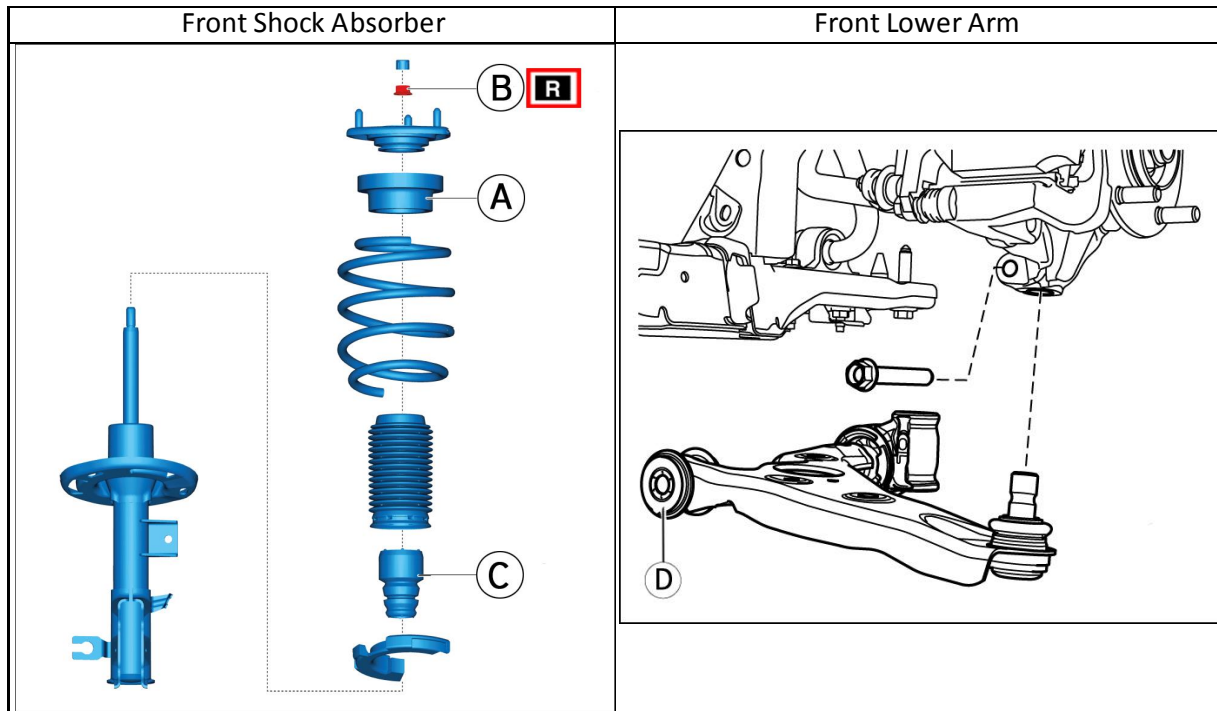
Some vehicles may exhibit a knocking / squeaking noise from the front shock absorber when driving on rough roads and/or when turning the steering wheel while the vehicle is stopped.

The noise may be due to:

- Upper front strut bearing (A) damage. (CX-5 and Mazda6)
- Squeak type noise between the front strut bearing and coil spring. (CX-3, CX-5 and Mazda6)
- The bump stopper (C) may be contacting the strut bearing when the front shock absorber is compressed, causing a popping noise. (Mazda6 only)
- The front lower arm bushing (D) is making a creak type noise in wet road conditions. (CX-5 and Mazda6).

To eliminate the noise, the following mass-production changes have been made:

1. The material and production method of the front strut bearing (A) has been changed. (CX-5 and Mazda6)
2. A protector has been installed onto the coil spring. (CX-5 and Mazda6)
3. The shape of the bump stopper (C) will be modified in the future. (Mazda6 only)
4. The shape of the coil spring has been changed. (CX-3 only)
5. Friction of the lower arm bushing has been reduced by adding a dry coating. (CX-5 and Mazda6).

NOTE: The piston rod nut (B) requires replacement.

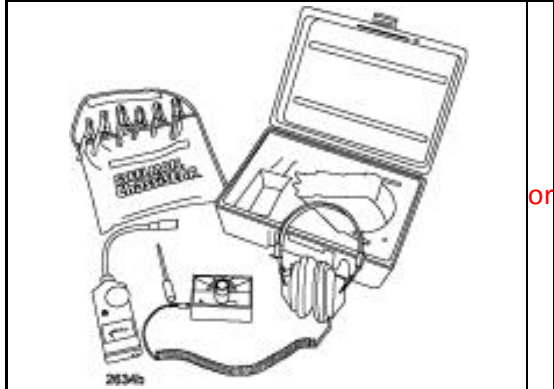
ChassisEAR/ EngineEAR II Combo JSP06608

1. Use Special Service Tool (SST) ChassisEAR / EngineEAR II Combo JSP06608 or Wireless ChassisEAR JSP97202 to confirm noise is coming from the front suspension when driving over bumps and/or turning the steering wheel while the vehicle is stopped:
