# Product Upgrade Bulletin 170614REV

**UPGRADE  
BULLETIN:  
170614REV****YEAR(S)  
AFFECTED:**  
2017**PRODUCT(S)  
AFFECTED:**  
Fleetwood Bounder  
Holiday Rambler  
Vacationer**MODEL(S)  
AFFECTED:**  
35P Only,  
Manufactured  
November 18, 2016  
through  
March 24, 2017**SUBJECT:**  
Installing  
attachment  
bracket for galley  
overhead cabinet**KEYWORDS:**  
cabinet, overhead**ISSUE DATE:**  
June 2017

The purpose of this Product Upgrade bulletin is to inform REV dealers of the procedure for installing additional means of securing the overhead galley cabinet to the slide-out ceiling in certain model year 2017 Fleetwood Bounder and Holiday Rambler Vacationer, Model 35P motorhomes. A list of affected vehicles appears at the end of this Bulletin.

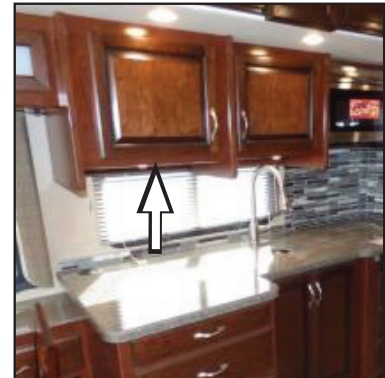
**Figure 1**

On motorhomes affected by this Product Upgrade, the fasteners for the galley overhead cabinet may be inadequately secured by the existing fasteners, and may come loose over time.

1. Park the motorhome on dry, level pavement with adequate clearance to extend the galley slide-out room. Place the transmission in Park and set the parking brake. Chock the wheels to prevent movement.
2. Level the unit using the leveler touchpad.
3. With the engine running, extend the galley slideout room.
4. Open the front galley overhead cabinet door to gain access to the horizontal pine cleat that secures the cabinet face to the ceiling. See Figures 1 & 2.
5. Position a bracket against the horizontal pine cleat and the ceiling. Using the holes in the bracket as a guide, mark the locations for two holes in the pine cleat. See Figure 3.
