SERVICE BULLETIN

Classification: AT15-015f	Reference: NTB15-086f	Date: February 10, 2017
------------------------------	--------------------------	----------------------------

2013-2014 ALTIMA AND 2014-2016 ROGUE; MIL ON WITH DTC P0776, P1715 MAY HAVE HESITATION AND/OR LACK OF POWER

APPLIED VEHICLES: 2013-2014 Altima (L33) with 4-cyl engine only
2014-2016 Rogue (T32)

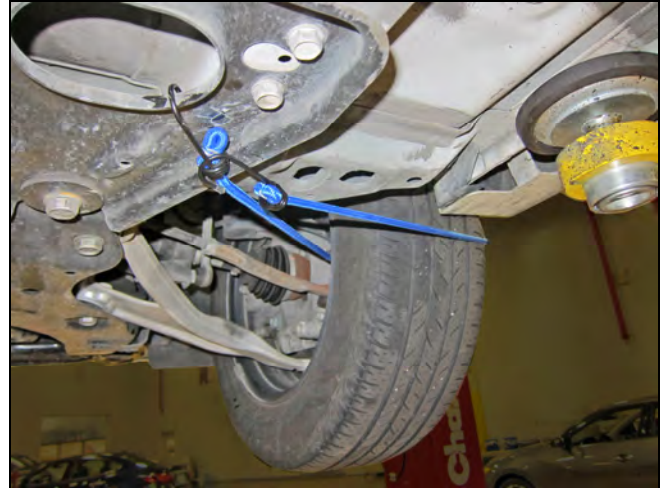
Figure 2

2. Secure the front right tire with a suitable strap.
 - This will assist in making the belt turn.
3. Mark the front left tire with a suitable marking.
 - This will assure all 360° of the belt is inspected.

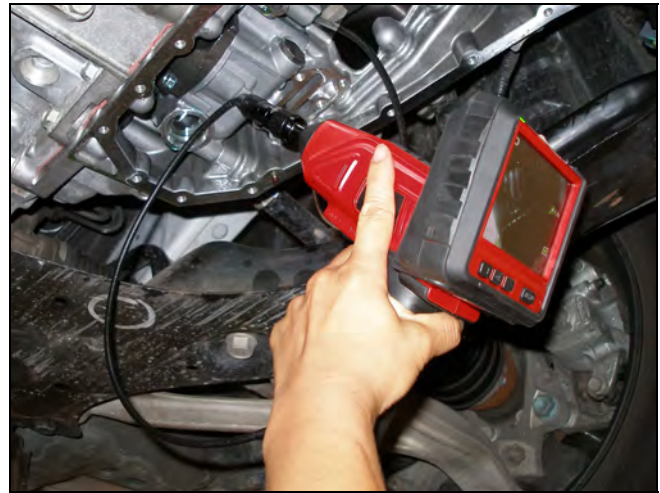
Figure 5

- Holding the borescope with one hand allows for turning the tire with the other hand (see Figure 5).

CAUTION: If the tire is rotated in the rearward rotation, the camera lens may get caught between the belt and pulley.

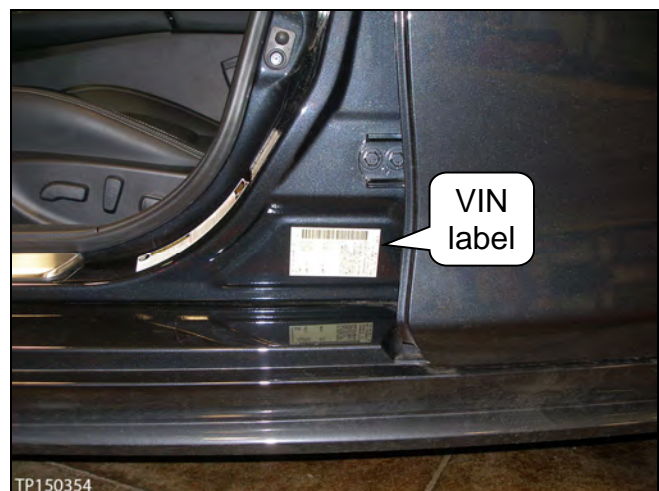
Figure 7

- e. Once CVT replacement is determined as required, use borescope J-51951 to record a 15 second or less continuous video of the most severe evidence of belt slip and the VIN on the F.M.V.S.S. certification label (VIN label). See Figure 7.

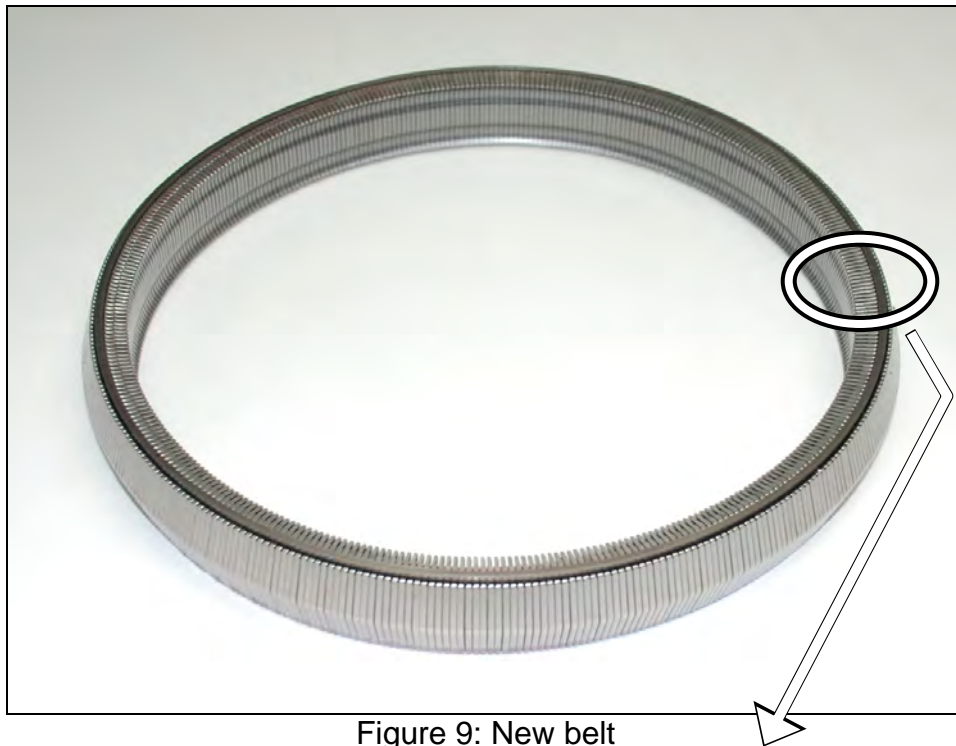
Figure 9: New belt

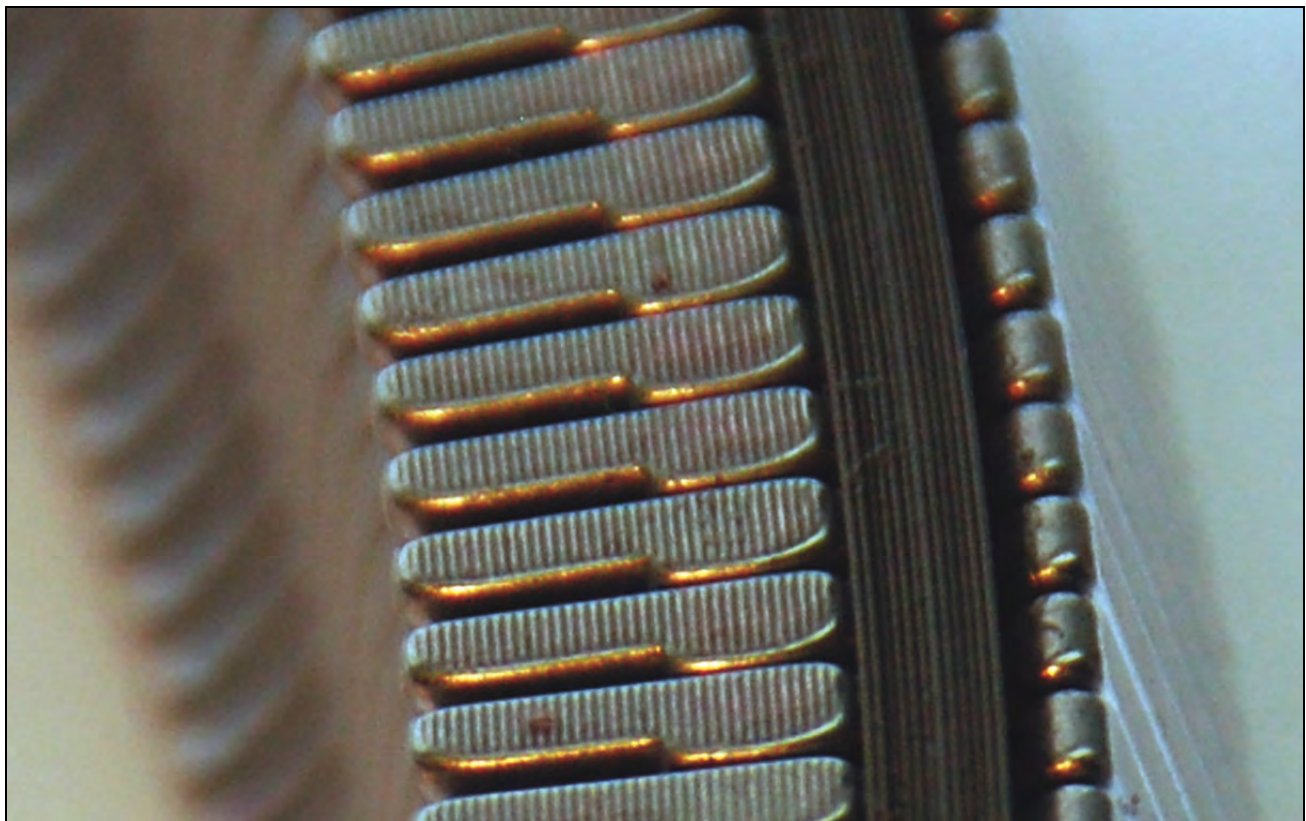
Figure 10: Close-up of section to be inspected

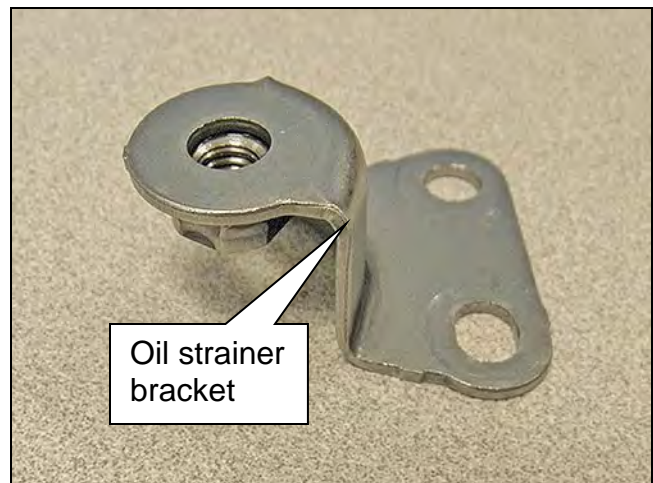
Figure 1A

NOTE: If an oil strainer bracket was removed, discard it. An oil strainer bracket (Figure 1A) will not be used with the new oil strainer.

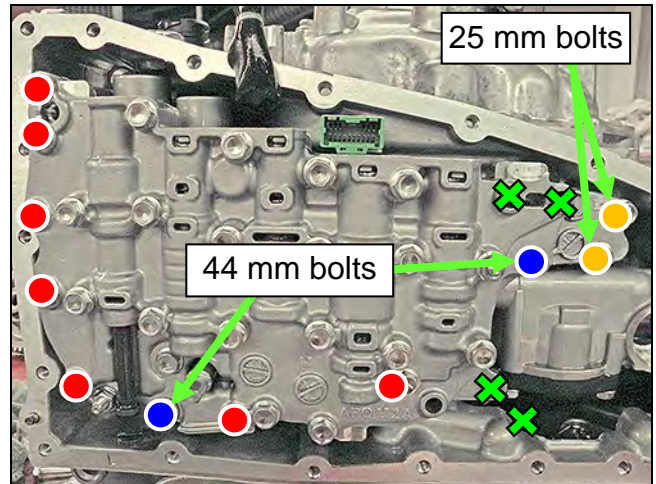
Figure 3A

2. Install the Control Valve with eleven (11) mounting bolts (Figure 3A).

- 54 mm (2.125 inches) long bolt

; 7 pieces
- 44 mm (1.73 inches) long bolt

; 2 pieces
- 25 mm long (1 inch) long bolt

CAUTION: The two 25 mm bolts are installed WITHOUT the strainer bracket.

- Bolt torque: 7.9 N•m (0.81 kg-m, 70 in-lb.)

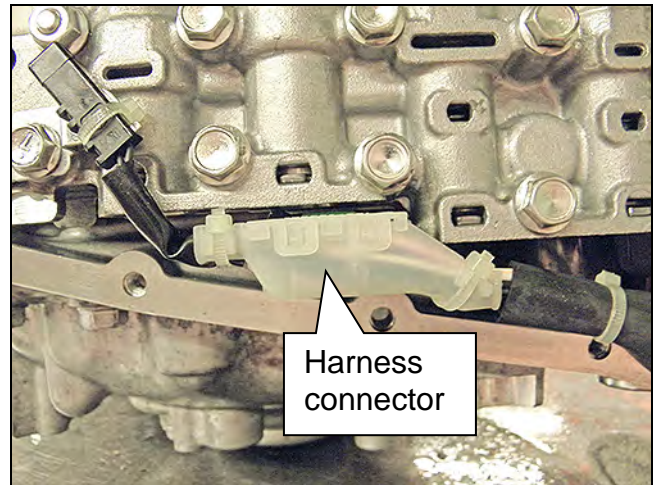
Figure 8A

4. Connect the electrical harness connector (Figure 8A).

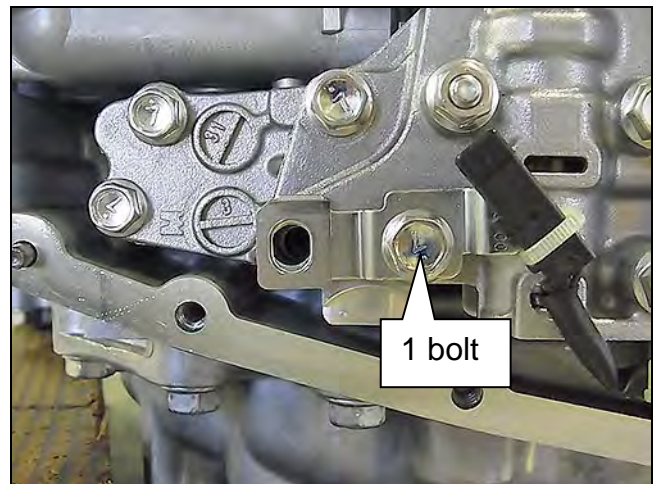
Figure 9A

5. Install the CVT fluid temperature sensor bracket to the valve body with one (1) bolt (Figure 9A).

NOTE: Leave one (1) bolt hole blank as it will be used to secure the oil strainer at a later step.

- 54 mm (2.125 inches) long bolt.
- Bolt torque: 7.9 N•m (0.81 kg-m, 70 in-lb.)

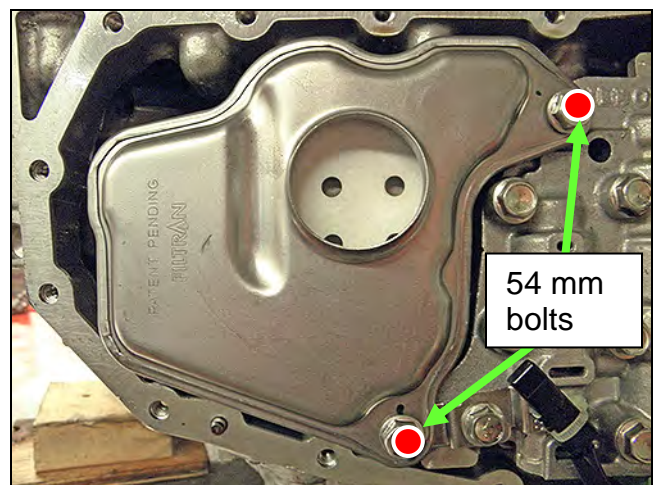
Figure 10A

6. Install the new oil strainer with its new O-ring seal with two (2) bolts (Figure 10A).

NOTE: Replacement strainer maybe a different shape than the original.

- 54 mm (2.125 inches) long bolt

; 2 pieces.
- Bolt torque: 7.9 N•m (0.81 kg-m, 70 in-lb.)

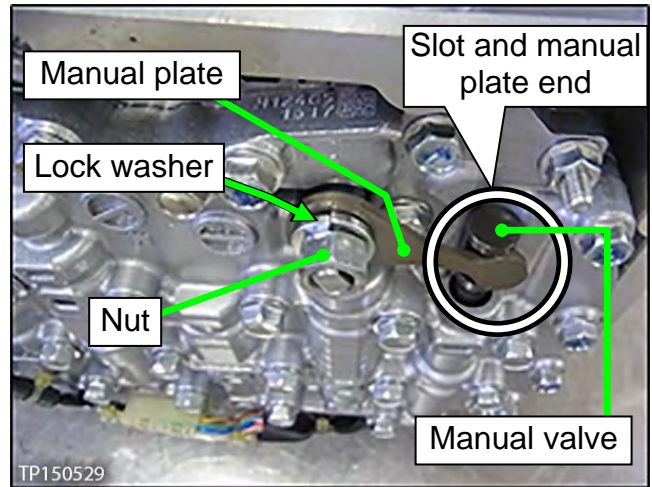
Figure 11A

7. Install the manual plate, lock washer, and nut (Figure 11A).

NOTE: Make sure the manual plate fits into the slot of the manual valve before applying torque to the nut.

- Reuse the existing manual plate, lock washer, and nut.
- Nut torque: 22.1 N•m (2.3 kg-m, **16 ft-lb.**)
