# Keystone RV Company

## SERVICE ADVISORY # 17-283

### Raptor and Carbon Furnace

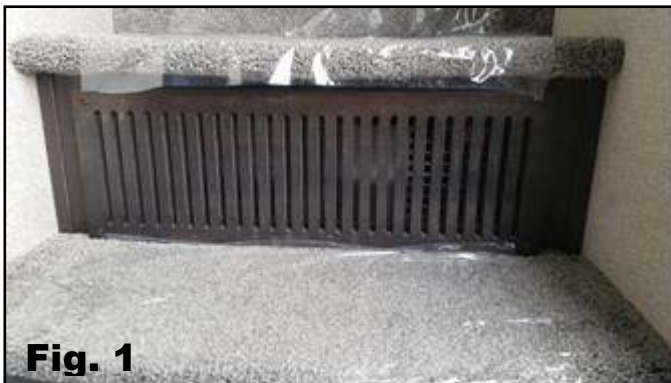
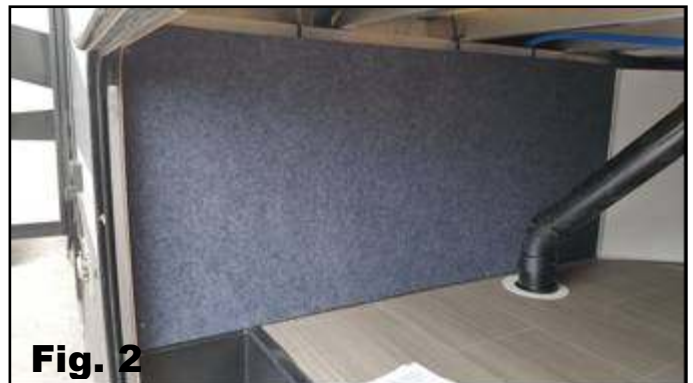
Remove the screws holding the return air panel for the furnace or remove the panel in the pass-through compartment to access the furnace, Figure 1 & Figure 2.

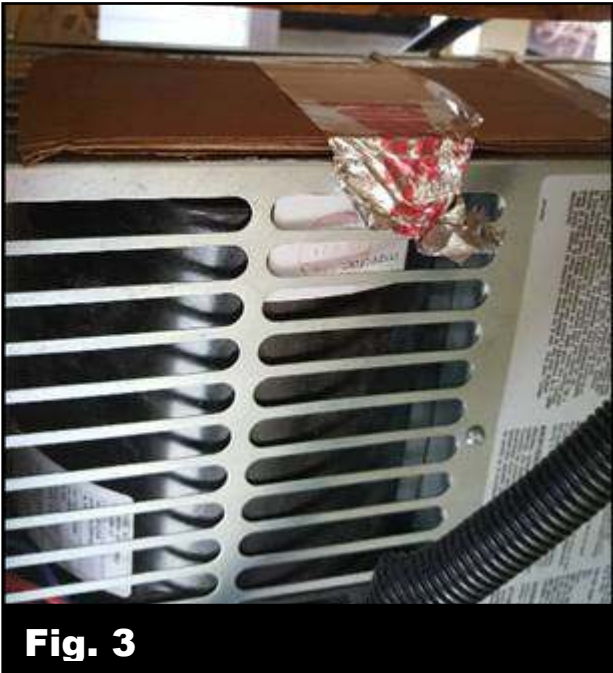
After the furnace is accessed, inspect the top of the furnace for a piece of cardboard used for protection during the manufacturing process, Figure 3. The cardboard is taped on, remove the cardboard.
