Emissions Recall

Code: 23Q3

Subject	2.0L TDI Engine (GEN 3) Emissions Control Software – Customer Only (Retail Sold) TDI Vehicles <u>USA ONLY</u>											
Release Date	January 20, 2017											
Revision Summary	Label ordering information and work procedure updated.											
Affected Vehicles	U.S.A.: 2015 MY Volkswagen 2.0L TDI (Gen 3), Customer (Retail Sold) Only

Campaign Work Procedure for Customer (Retail Sold) TDI Vehicles Only 23Q3 Emissions Recall

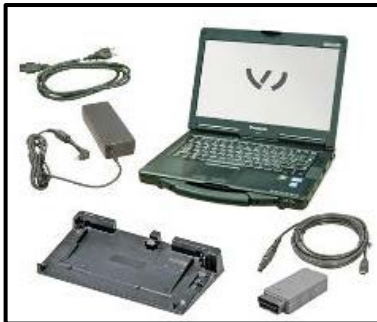
- VAS6150X – Diagnostic Tester (or equivalent)
- VAS5054X – Remote Diagnosis Head (or equivalent)

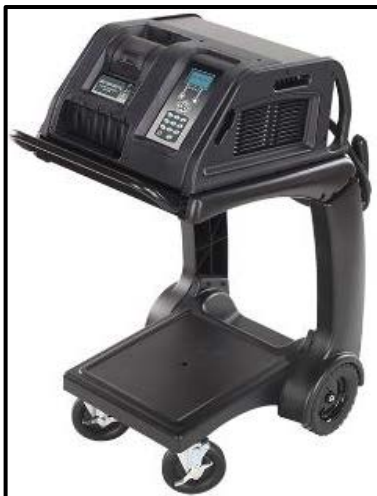
- GRX3000VAS – Battery Tester/Charger

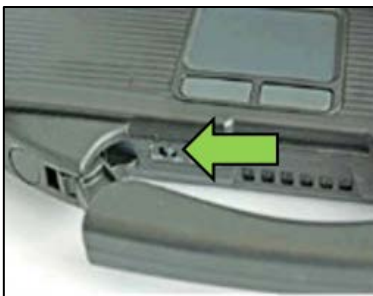
VAS 6150 & VAS 6150A
(Front panel behind handle)

- ✓ **The Bluetooth function of the scan tool is physically switched off <see pictures below>.**
