NUMBER: 23-041-17

Incorrect Hellcat Emblem on Front Fenders

2018 (LD) Dodge Charger

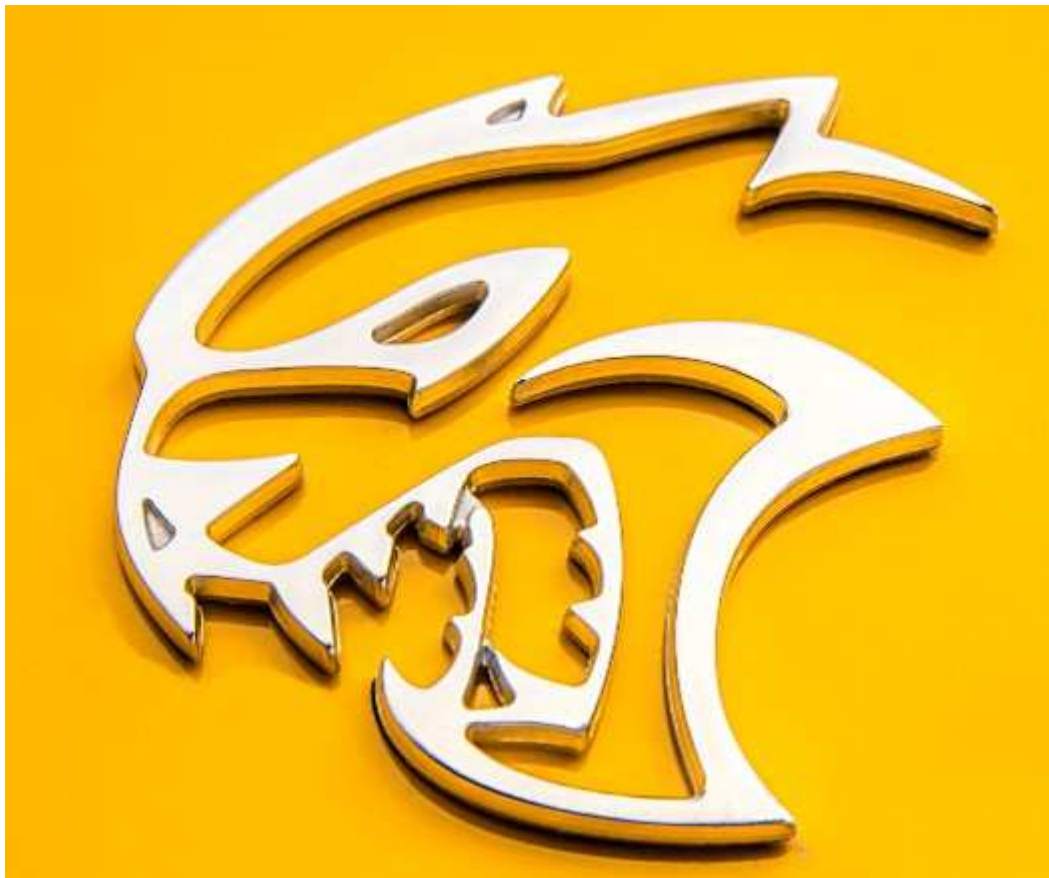
This bulletin involves replacing the Hellcat emblem on both front fenders, due to an adhesion process change (Fig. 1) .

Fig. 1
Current Emblem Being Replaced

Some of the Hellcat emblems on the front fender of the vehicle may have been installed incorrectly at the factory.

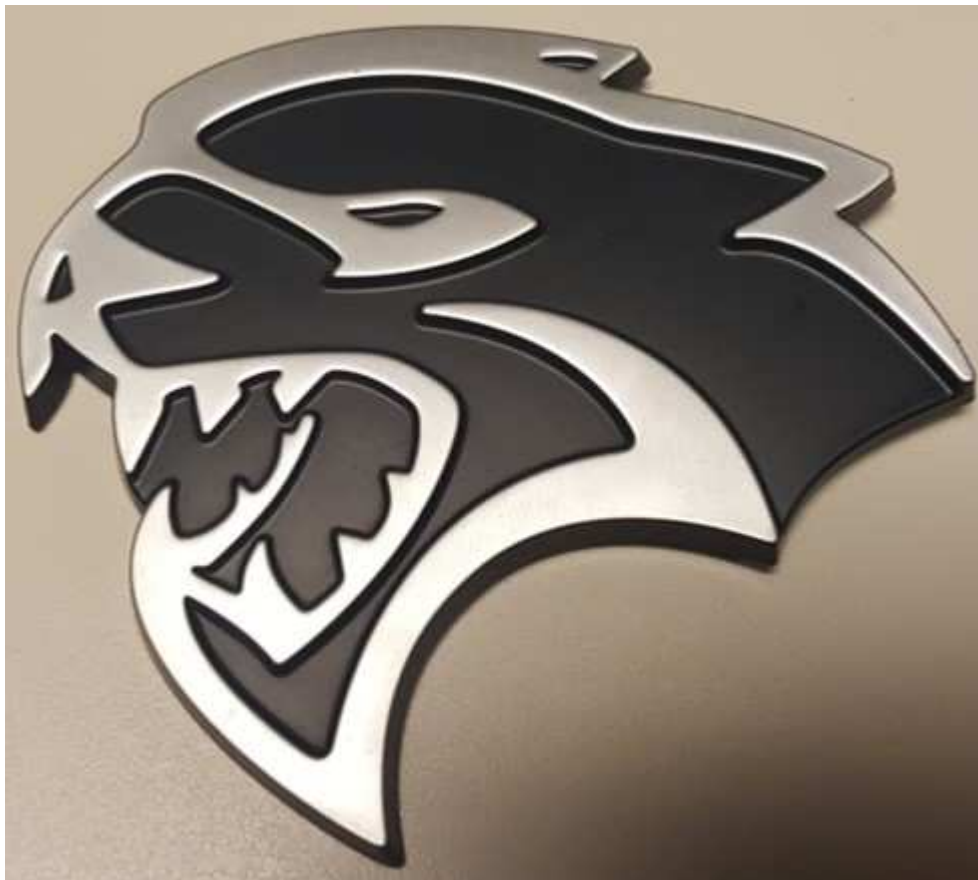
NOTE: The correct replacement Hellcat emblems (Fig. 2) will be different than the current emblems being replaced on the vehicle.

Fig. 2
Hellcat Emblem

NOTE: The exterior emblems are attached to the body with adhesive tape.

1. Apply a length of masking tape on the body, parallel to the top edge of the emblem to use as a guide.
2. If temperature is below 21°C (70°F), warm emblem with a heat lamp or gun.

CAUTION! Do not exceed 52° C (120° F) when heating emblems or body panels. Failure to follow this caution may result in damage to the emblems and/or the vehicle paint finish.

3. Using a trim stick or equivalent, carefully remove the emblem from the body panel, as necessary.
4. Thoroughly clean all residue from the emblem attachment areas of the body.
5. Wipe the attachment areas with a clean, lint-free cloth, moistened with a 50% solution of water and alcohol, Wipe dry the areas immediately with a dry, lint-free cloth.

NOTE: If ambient temperatures are below 21° C (70° F), warm the emblem and body panel with a heat lamp or gun to assure proper adhesion.

6. Remove the protective covering from the back of the emblem and position onto the body using the previously installed guide tape.
7. Press emblem firmly to body with palm of hand.
8. Remove the guide tape.
