NUMBER: 08-090-17

Tire Pressure Monitor Jumper Harness

This bulletin involves installing a Tire Pressure Monitor (TPM) jumper harness.

RAM ProMaster

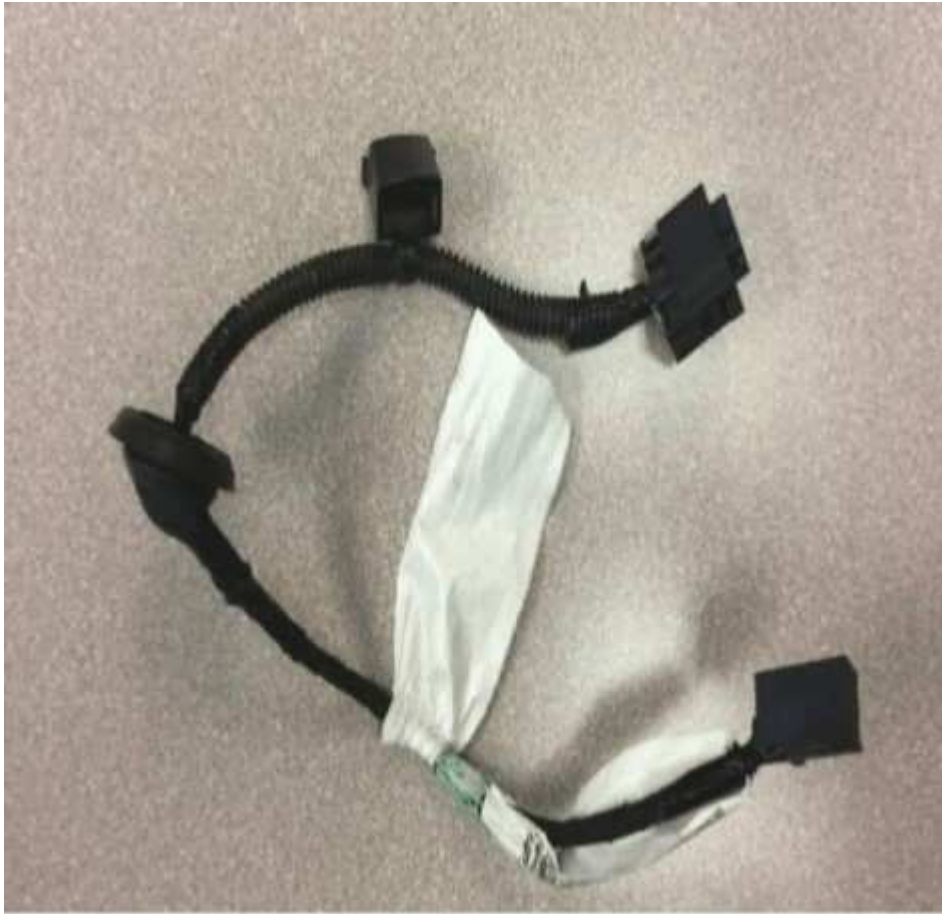
**Fig. 1****Tire Pressure Monitor Jumper Harness*****DIAGNOSIS:***

The customer may describe a TPM warning light turn on due missing information or localization failure.

Replacement of the TPM jumper harness ([Fig. 1](#)) will be necessary. Refer to [Step 1](#).

1. Remove the cup holder. Refer to the detailed service procedures available in DealerCONNECT> TechCONNECT under: Service Info> 23 - Body/Instrument Panel/Cupholder, Instrument Panel/Removal.
2. Remove the battery cover.
3. Disconnect the battery negative cable terminal clamp and remove the negative cable from the terminal.
4. Disconnect the **old** TPM jumper harness electrical connectors from inside the vehicle.
5. Raise and support the vehicle. Refer to the detailed service procedures available in DealerCONNECT> TechCONNECT under: Service Info>04 - Vehicle Quick Reference/Hoisting/Standard Procedure.
6. Disconnect the **old** TPM jumper harness electrical connectors from outside and under the vehicle.
7. Disconnect the grommet through the floor for the harness and remove.
8. Install the **new** TPM jumper harness through the floor of the vehicle and seat the grommet.(Fig. 2)

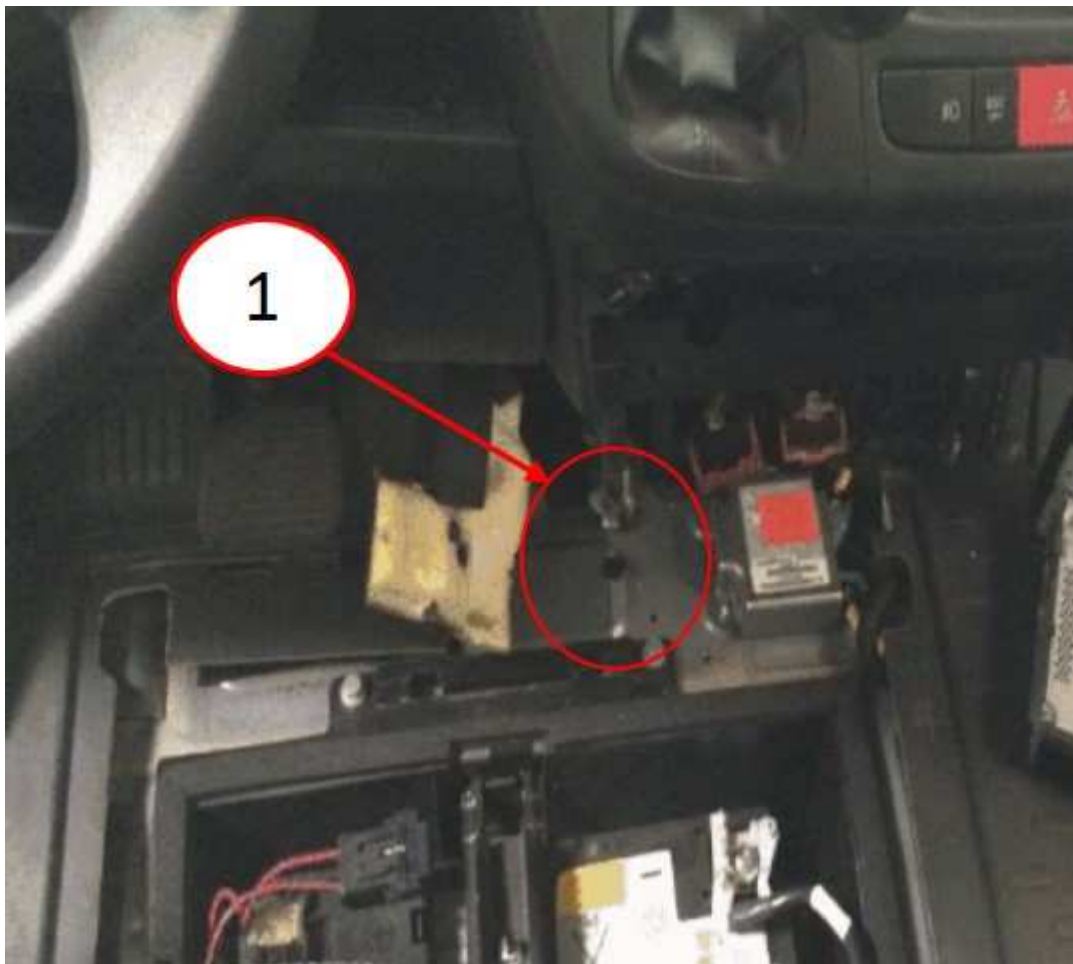
Fig. 2
TPM Grommet Hole in Floor

1 - Hole In Floor For TPM Grommet.

9. Reconnect the electrical connectors to the appropriate connectors outside and under the vehicle.
10. Lower the vehicle.
11. Reconnect the electrical connectors to the appropriate connectors inside the vehicle.
12. Reconnect the negative battery cable.
13. Install the battery cover.
14. Install the cup holder. Refer to the detailed service procedures available in DealerCONNECT> TechCONNECT under: Service Info> 23 - Body/Instrument Panel/Cupholder, Instrument Panel/ Installation.
