07560 Version 2

Product Update: Primer Not Applied to Sliding Door Spot Welds

AFFECTED VEHICLES

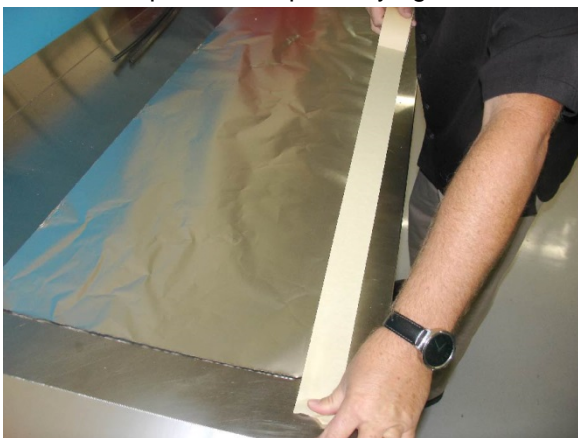
- To make preparing the aluminum foil masking easier, apply the tape to the aluminum foil while it's on a table or bench, then press the tape firmly against the aluminum to ensure there are no gaps.

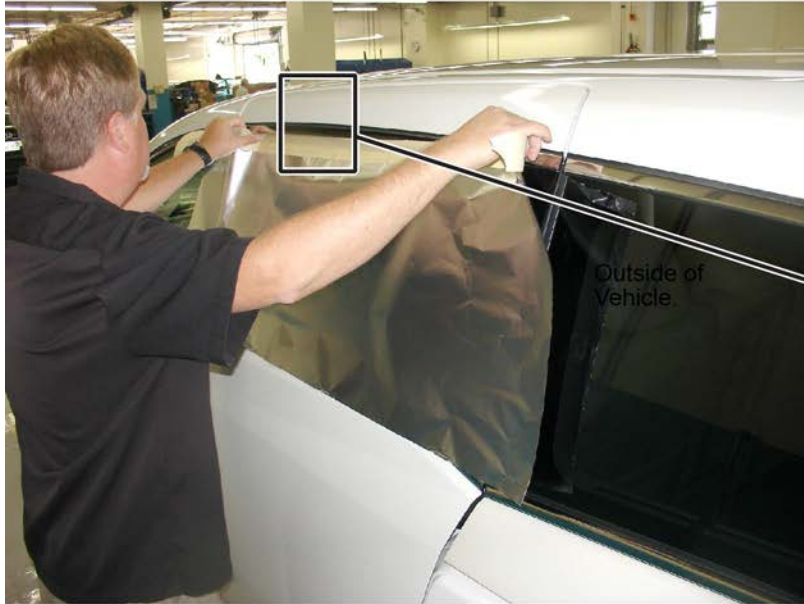
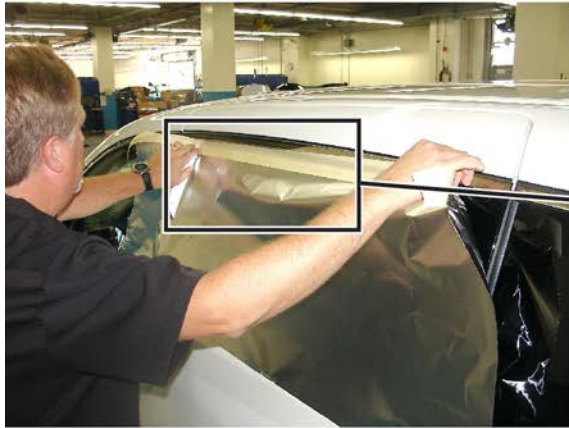
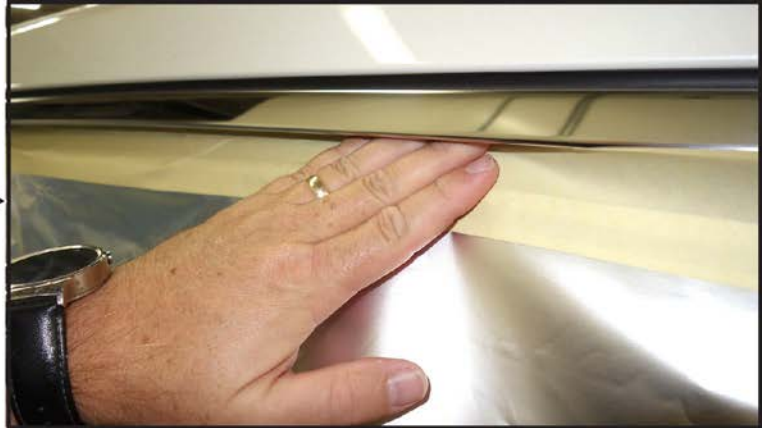
Foil extends past the length of the door.

4. Mask the rear door with aluminum foil as shown by taping a sheet of aluminum foil to the top inner flange of the driver's side sliding door. Make sure the aluminum foil extends past the length of the door.

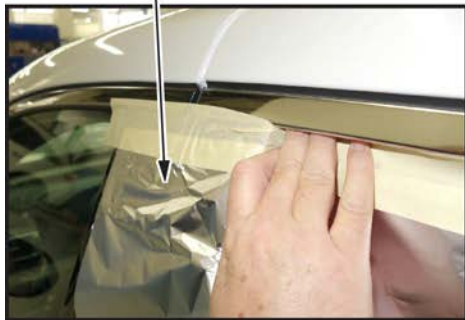
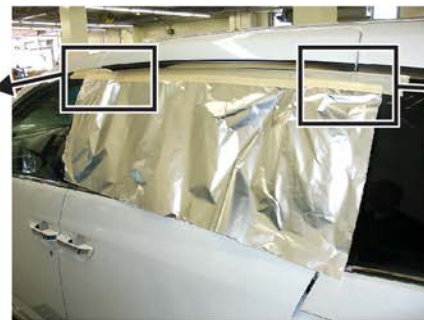
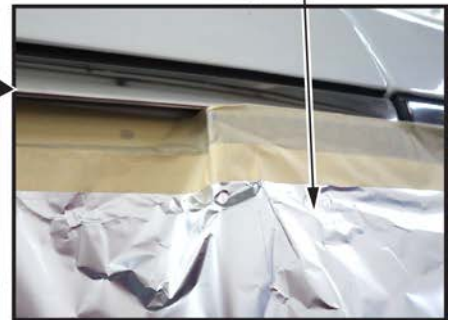
- Apply a piece of tape over the chrome trim. Make sure there is enough tape to cover the bottom of the chrome trim.

- Make sure the tape covers the chrome trim but does not cover the inner run channel sheet metal to ensure the primer is properly applied to the areas affected by the corrosion.
- Make sure the strip of tape extends past the length of the door and that there are no gaps between the foil and tape as noted.

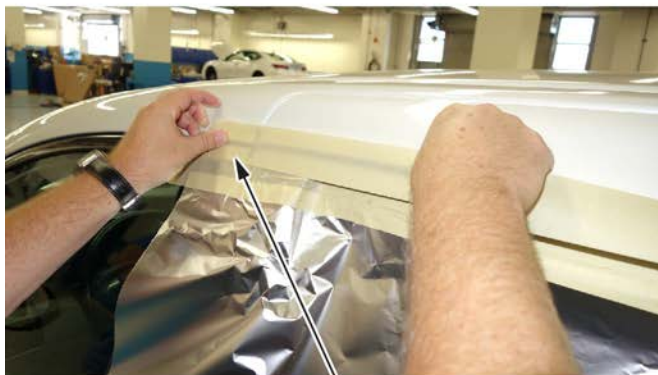
Tape extends beyond length of door

Tape extends beyond edge of chrome strip.

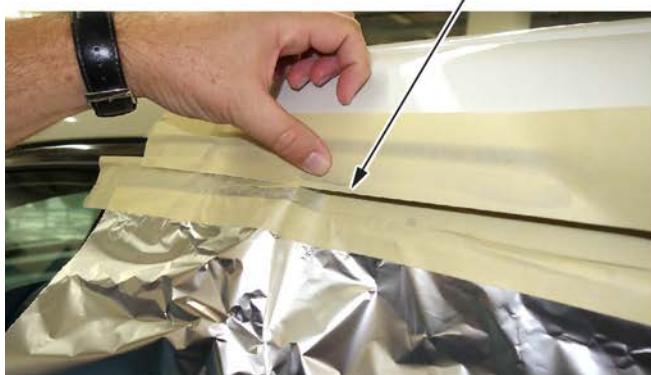
No gaps between pieces of tape.

Roll tape around lip of chrome trim.
