MODEL: Karma Revero**DATE:** October 2017**TITLE:** Rear seat cushion heater inspection**First Release****PRIORITY:** On Complaint**APPLICABILITY:** MY17 and MY18 Revero**MARKET REGION:** North America**PURPOSE:** Inspect the rear seat cushion heater connections

SC-17-86-20

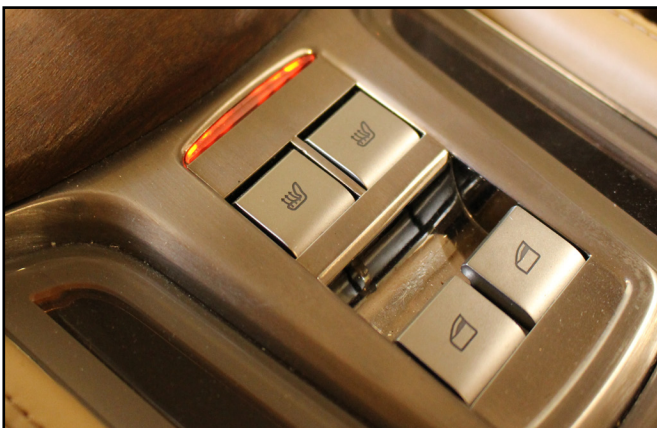
**fig.1a**

Verification is required during pre-delivery inspection. If missed, verify that the rear seat heaters are operating as normal. Turn on the seat heater to level three (3) setting and wait five (5) minutes for the surface temperature to increase (fig 1a). Measure the surface temperature of the seat cushion (80°-90° F) using an infrared thermometer (fig 1b).
