# SERVICE BULLETIN

Classification: AT15-012d	Reference: NTB15-084d	Date: August 29, 2017
------------------------------	--------------------------	--------------------------

## 2013-2014 ALTIMA AND 2014-2016 ROGUE; CVT JUDDER AND DTC P17F0 OR P17F1 STORED

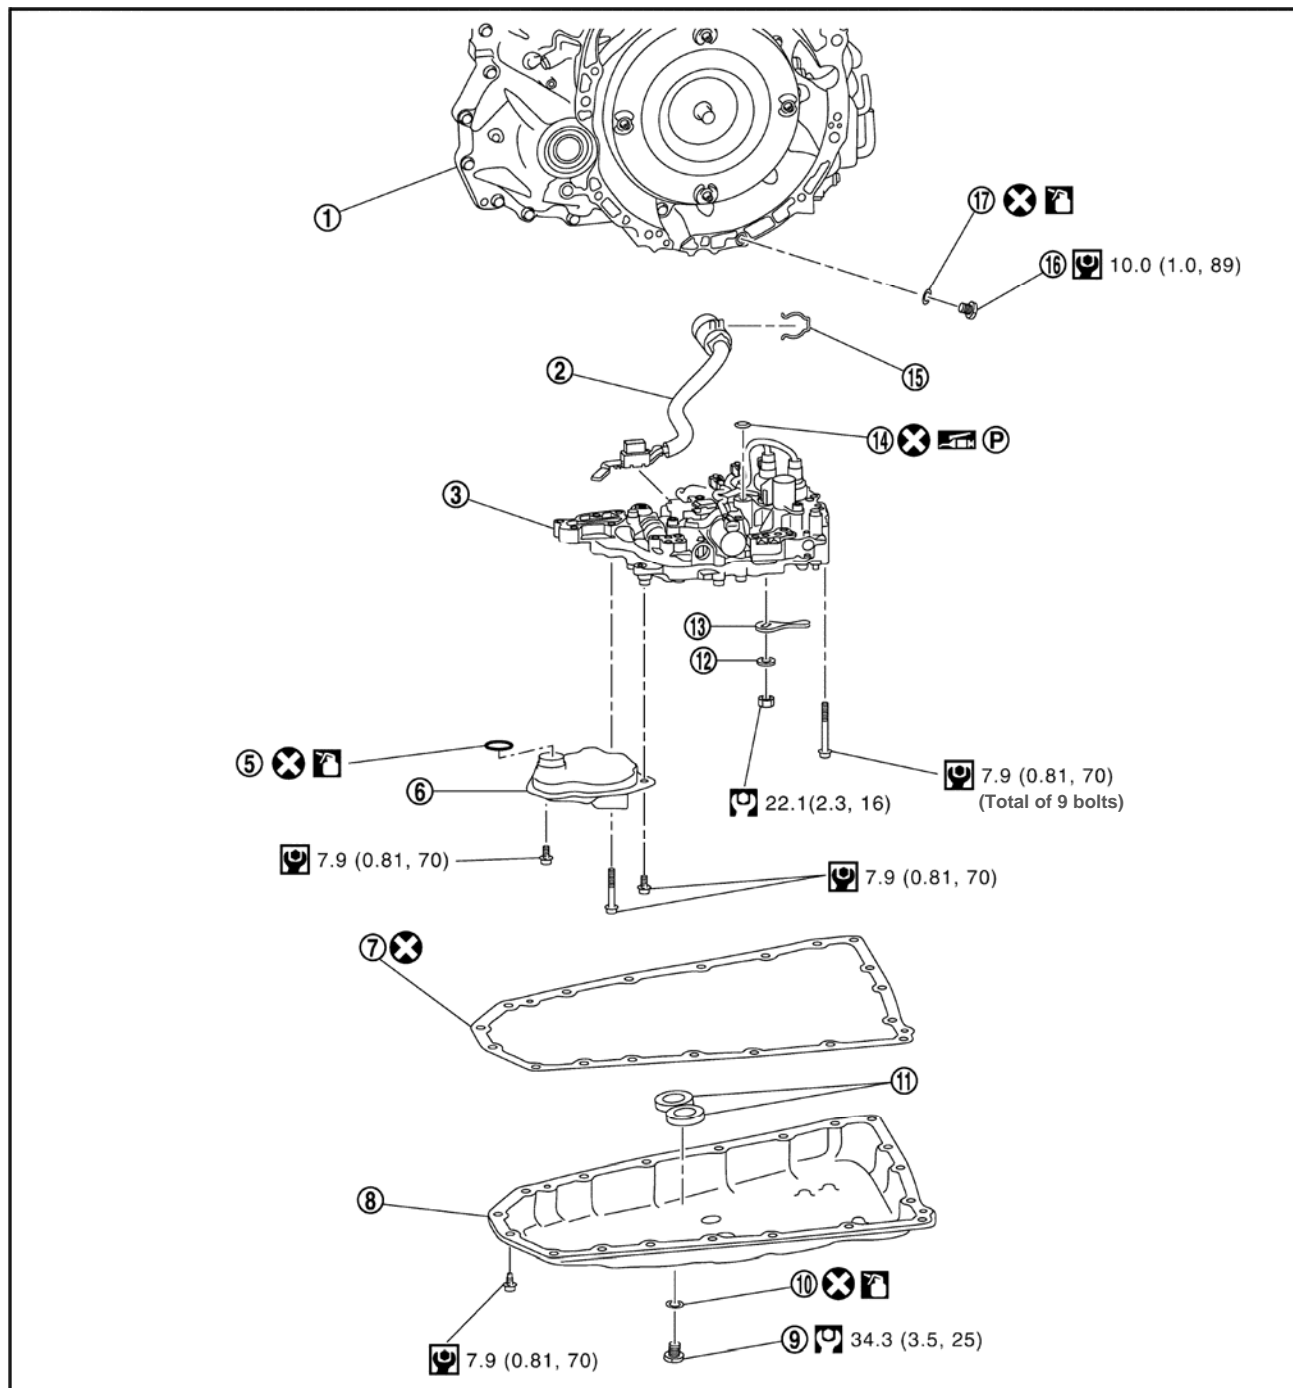
Figure 4

Exploded View

| ① Transaxle (CVT) assembly | ② Terminal cord assembly | ③ Control valve (valve body) |
| ④ Manual plate | ⑤ O-ring | ⑥ Oil strainer assembly |
| ⑦ Oil pan gasket | ⑧ Oil pan | ⑨ Drain plug |
| ⑩ Drain plug gasket | ⑪ Two original magnets | ⑫ Spring washer |
| ⑬ Manual plate | ⑭ Lip seal | ⑮ Snap ring |
| ⑯ Overflow plug | ⑰ O-ring | |

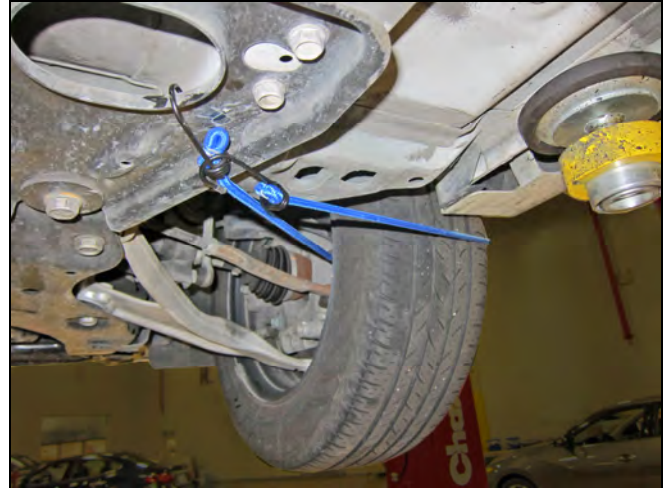
Figure 5

2. Secure the front right tire with a suitable strap.
  - This will assist in making the belt turn.
3. Mark the front left tire with a suitable marking.
  - This will assure all 360° of the belt is inspected.

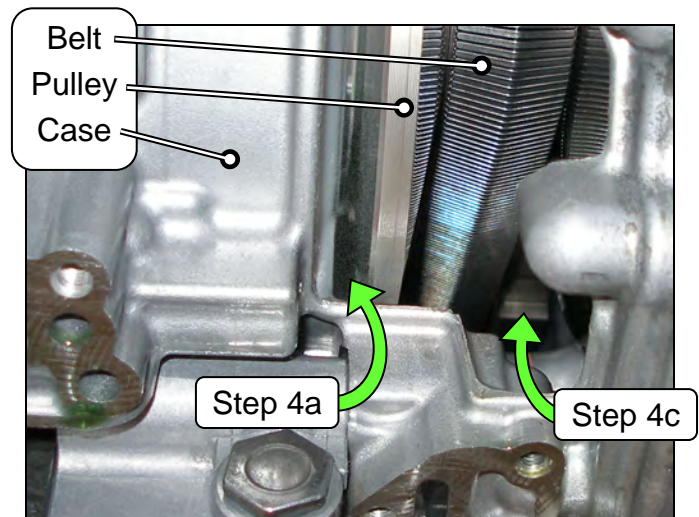
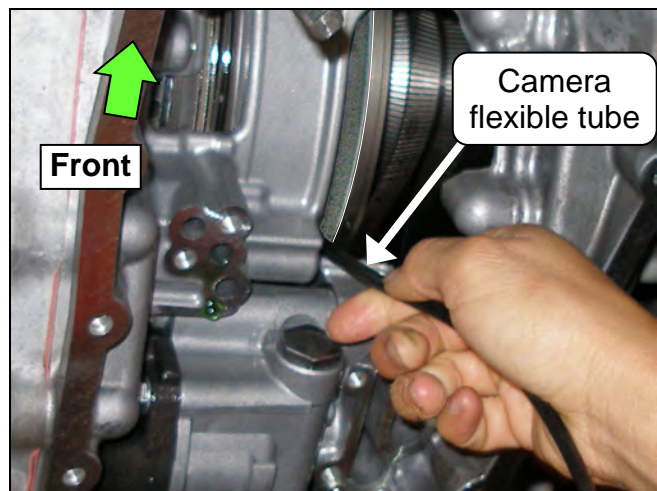
- a. Insert the camera lens between the CVT case and pulley where shown in Figure 6 and 7.
  - Insert the lens approximately seven (7) inches, and then view the side of the belt that contacts the pulley.

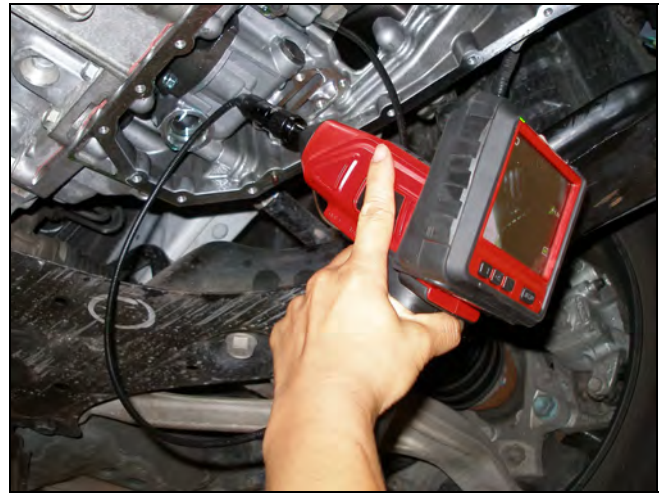
Figure 8

- Holding the borescope with one hand allows for turning the tire with the other hand (see Figure 8).

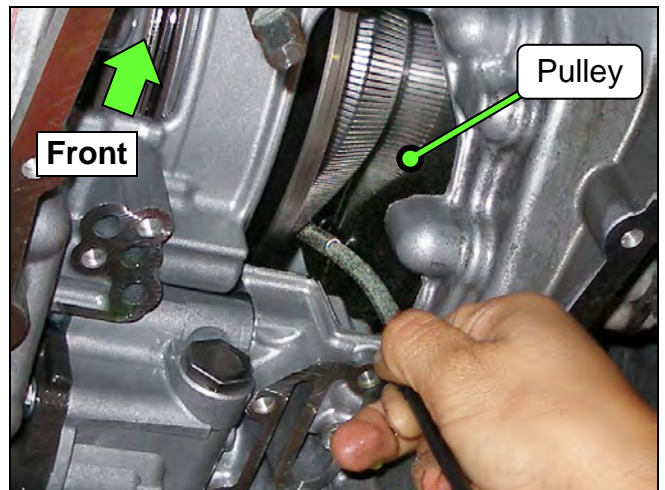
Figure 9

- Insert the camera lens in the second location where shown in Figure 6 and 9, and then perform step 4b again.

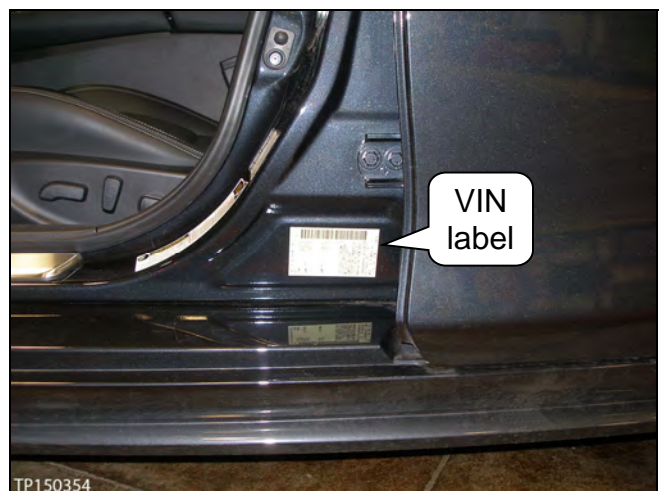
Figure 10

- e. Once it is determined that CVT replacement is required, use borescope J-51951 to record a 15 second or less continuous video of the most severe evidence of belt slip and the VIN on the F.M.V.S.S. certification label (VIN label). See Figure 10.

**NOTE:** This required video must be attached to the Powertrain Call Center CVT Preauthorization Form (in ASIST) prior to calling for authorization. Failure to submit a continuous video will cause immediate denial of request for replacement.

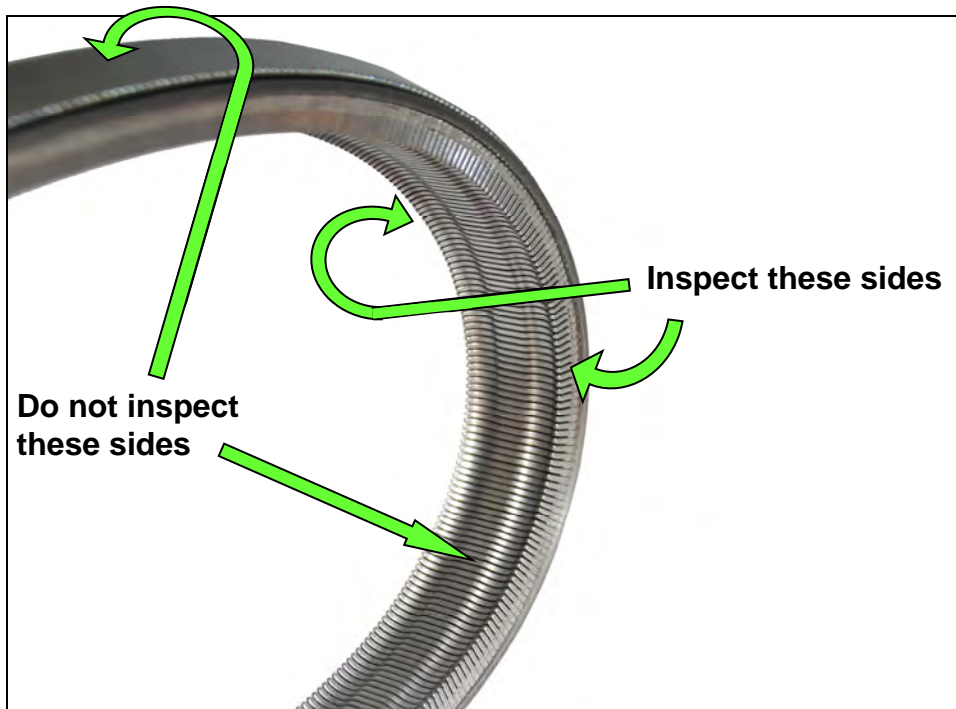
Figure 11

4. Using borescope J-51951 with mirror attachment, inspect the entirety of the two sides of the belt that come in contact with the pulleys (see page 10, Figure 11). Reference the pictures on pages 10 through 14 for comparison.

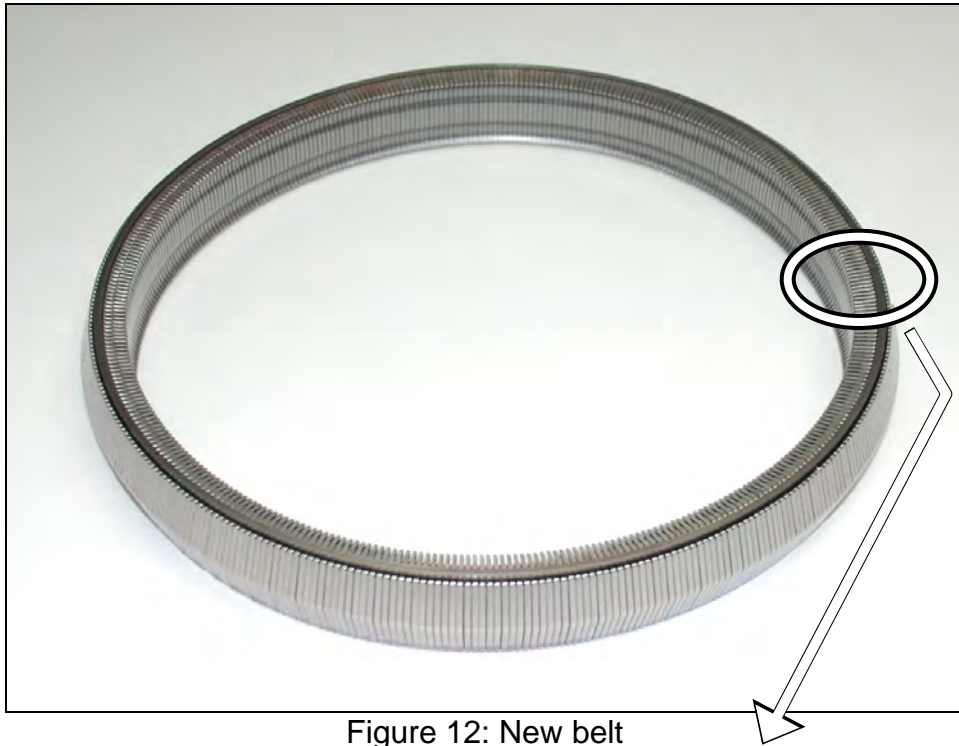
Figure 12: New belt

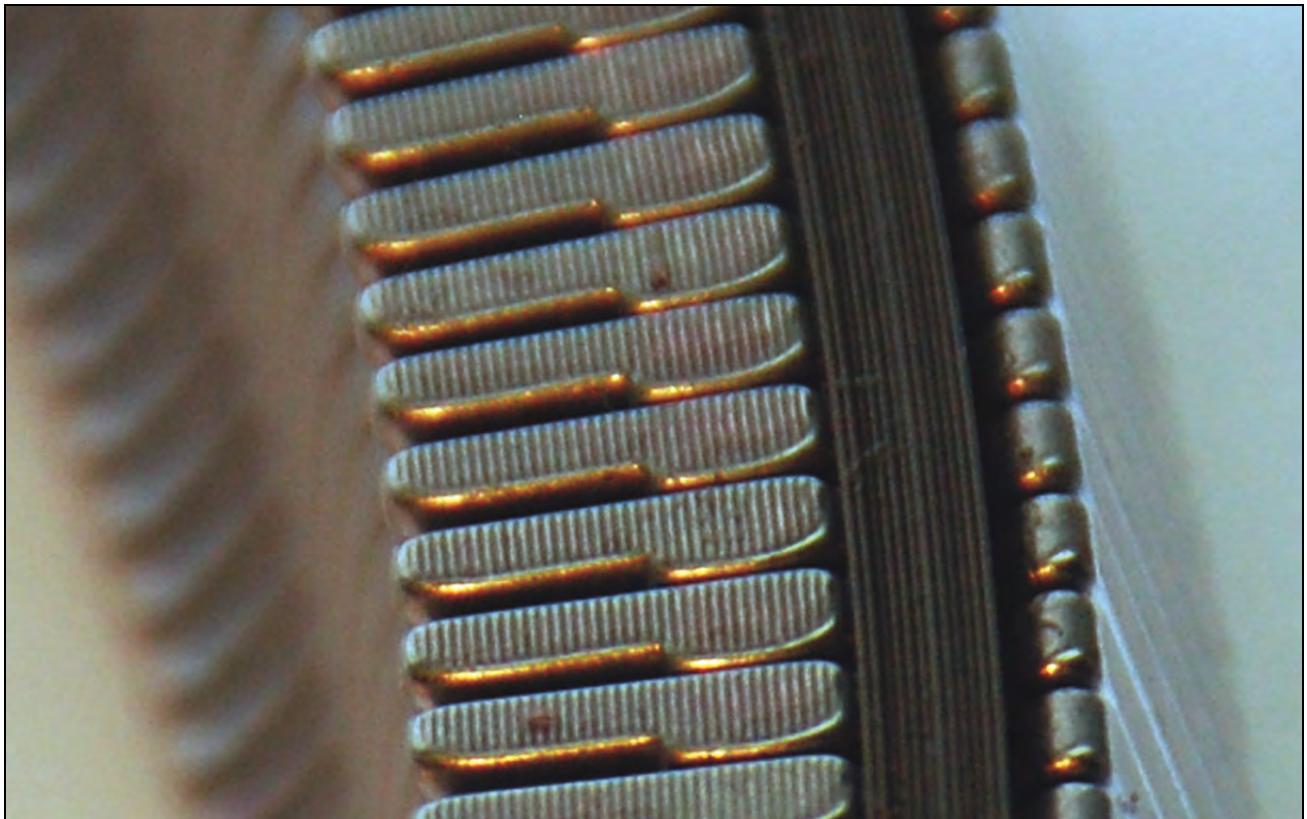
Figure 13: Close-up of section to be inspected

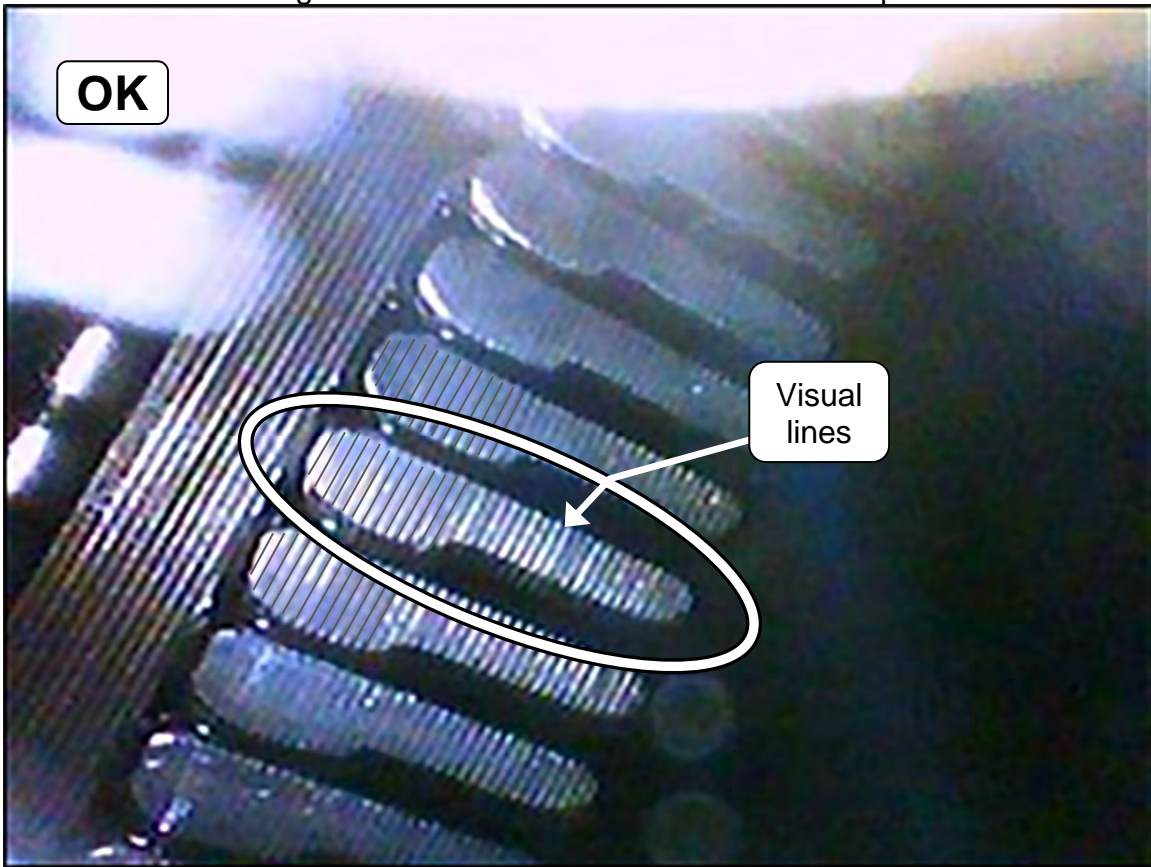
Pictures in Figures 14 and 15 were taken with borescope J-51951.

Figure 14: Belt is OK

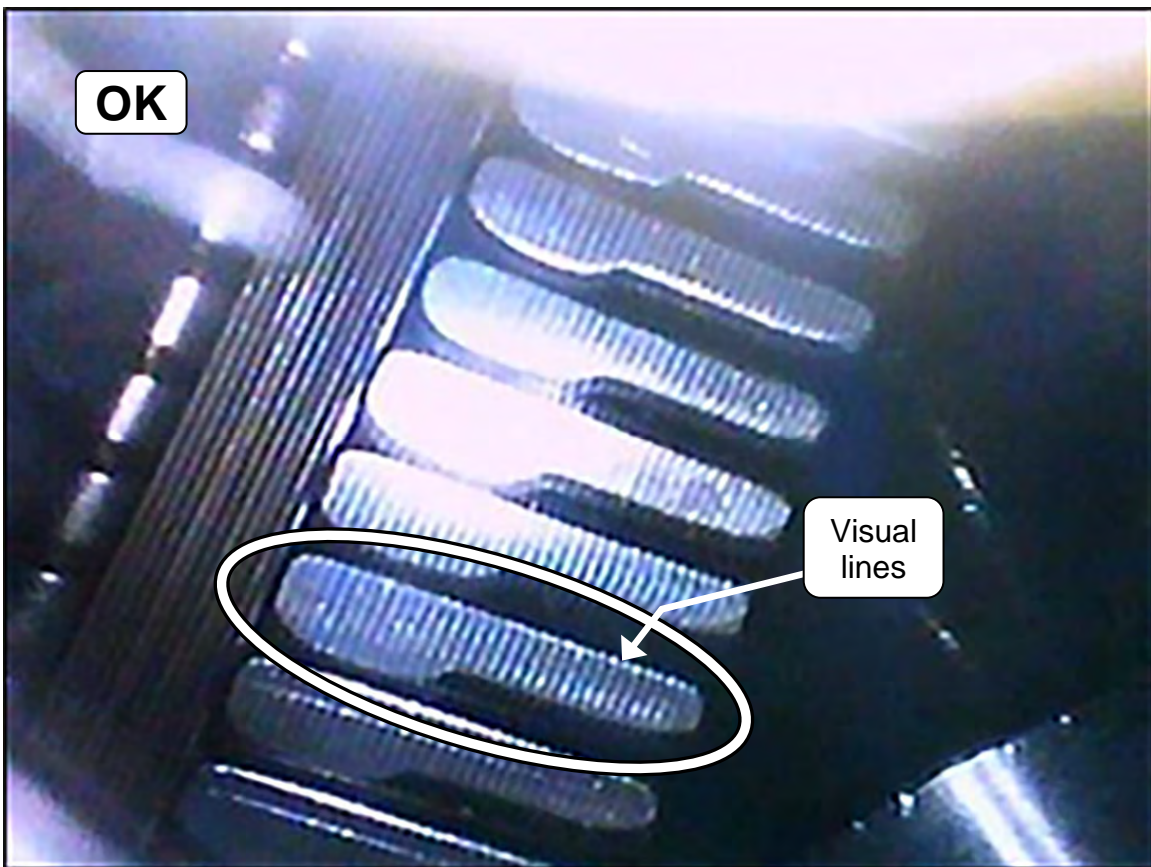
Figure 15: Belt is OK

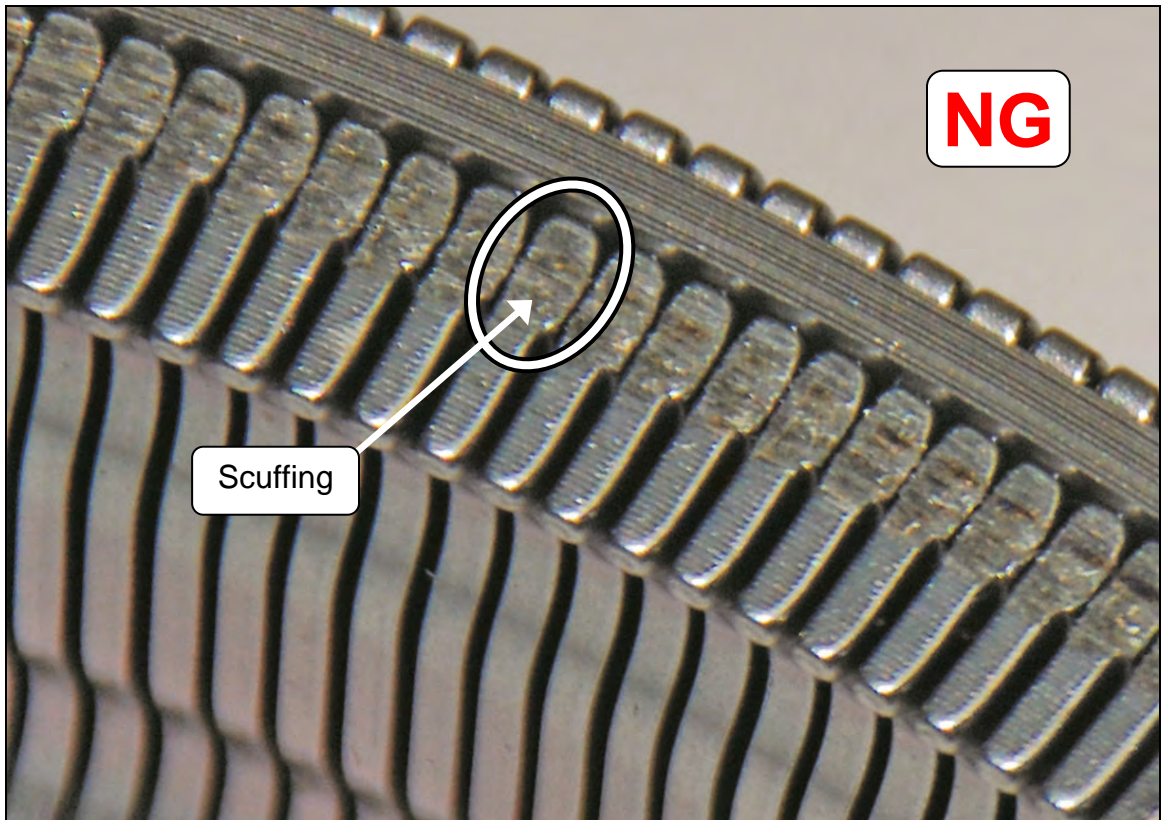
Figure 16: Example of NG belt

6. If the belt inspection result is NG, replace the CVT assembly.
- Get authorization to replace the CVT assembly (see page 23).
  - Make sure to perform step 4e on page 9.

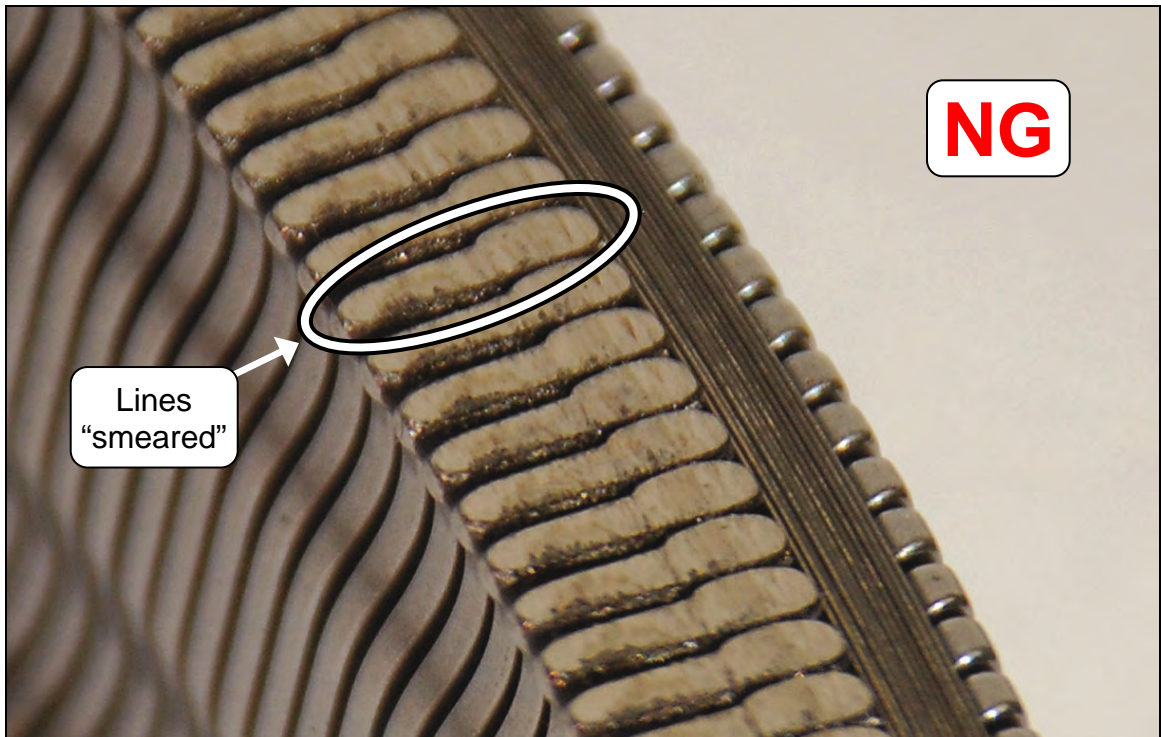
Figure 17: Example of NG belt

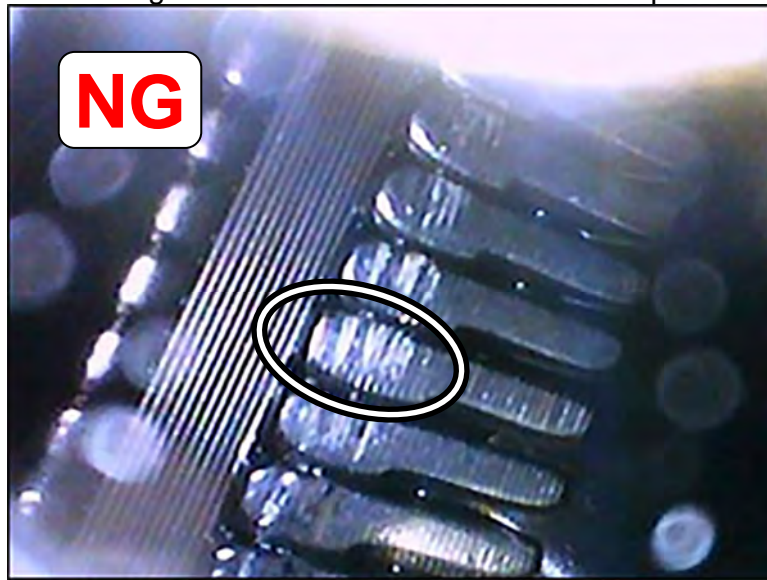
Pictures in Figures 18-20 were taken with borescope J-51951.

Figure 18: Example of NG belt

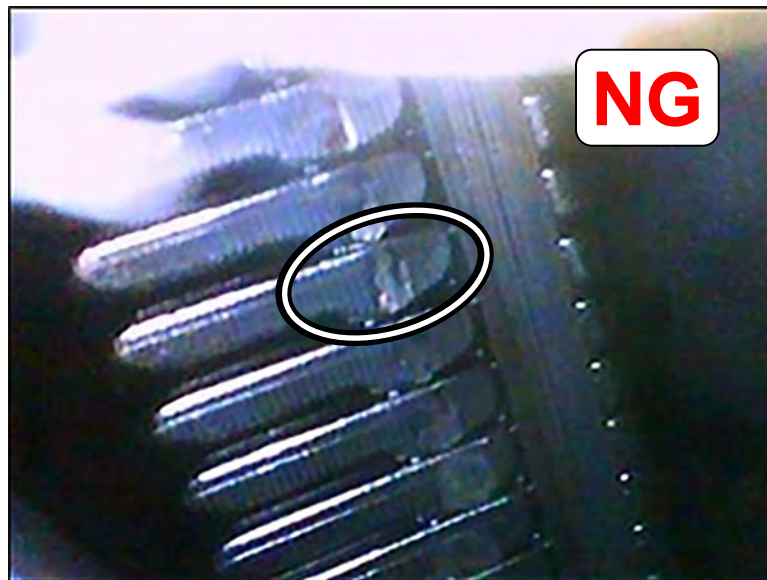
Figure 19: Example of NG belt

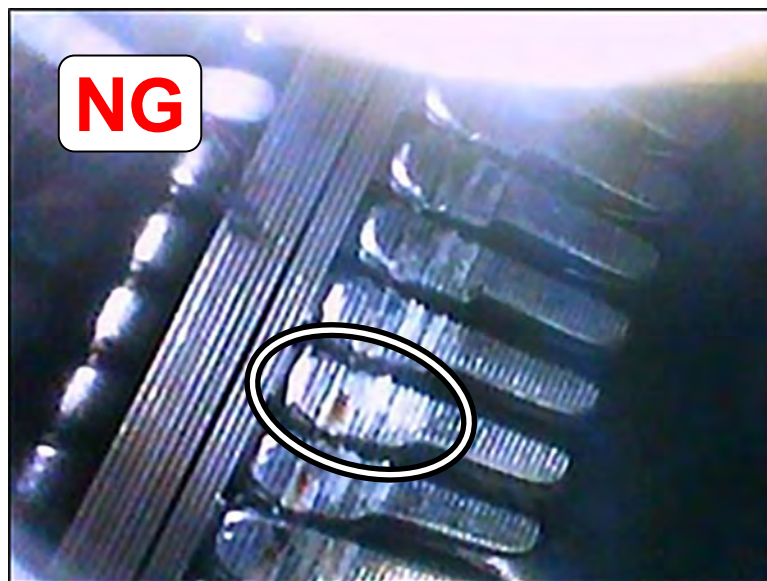
Figure 20: Example of NG belt

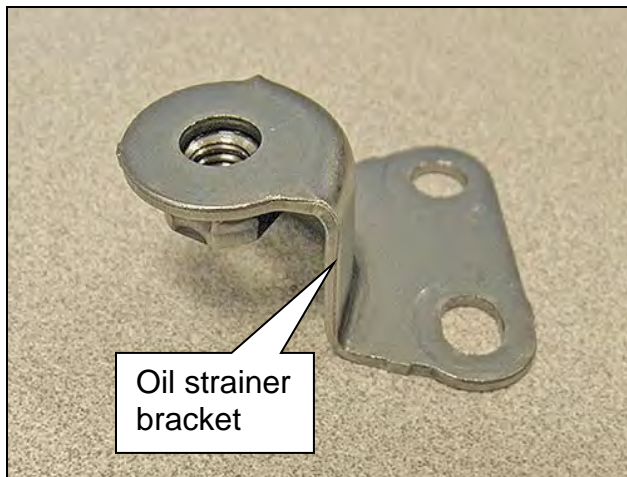
Figure 21

1. Discard the oil strainer bracket (Figure 21).
2. Install a new lip seal. Do NOT reuse the old lip seal (Figure 22).

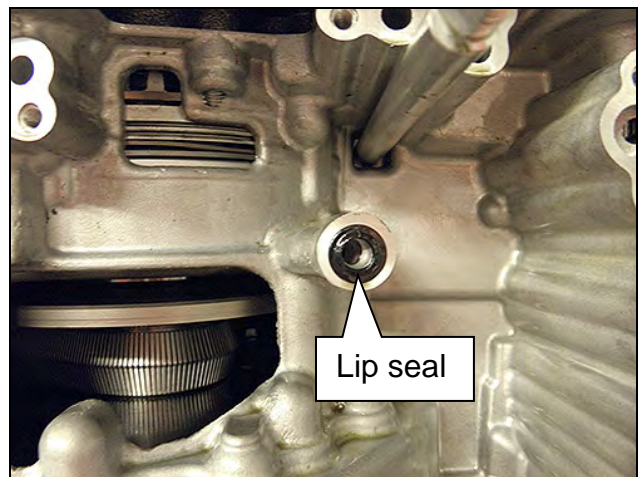
Figure 22

**NOTE:** Apply a small amount of petroleum jelly to the lip seal to keep it in place on the CVT.

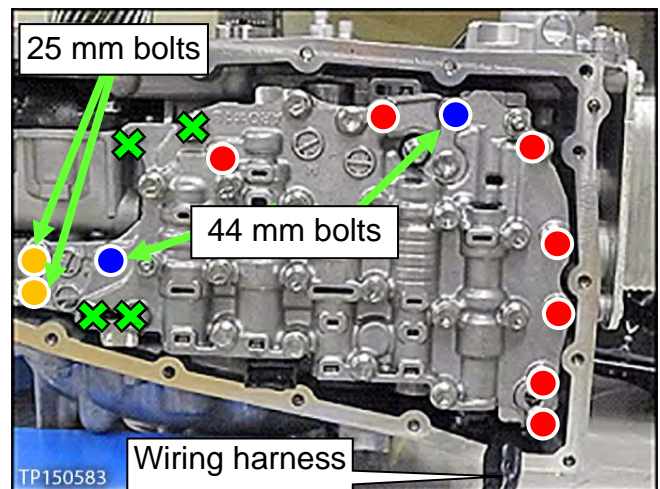
Figure 23

3. Install the Control Valve with nine (9) mounting bolts (Figure 23).

**IMPORTANT:** Leave Four (4) ✘ bolt holes blank at this step.

- 54 mm long bolt ● – 7 pieces
- 44 mm long bolt ● – 2 piece
- 25 mm long bolt ● – 2 piece

**CAUTION:** These two bolts are installed WITHOUT the strainer bracket.

- Bolt torque: 8.0 N•m (0.81 kg-m, 70.8 in-lb.)

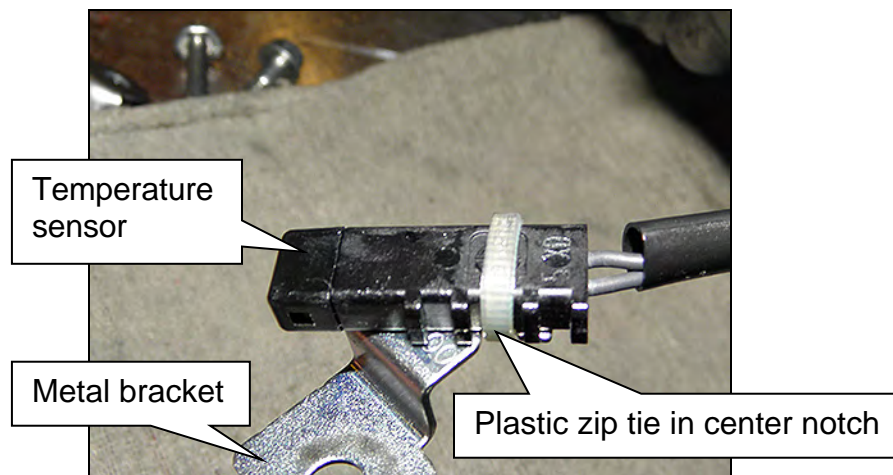
Figure 24

- a. Cut the plastic zip tie with an appropriate tool to remove the temperature sensor bracket from the terminal harness assembly. (Figure 24).

**CAUTION:** Cut the plastic zip tie over the metal bracket to avoid damage to the temperature sensor.

**IMPORTANT:** Locate the plastic zip tie at the center notch of three notches on the temperature sensor.

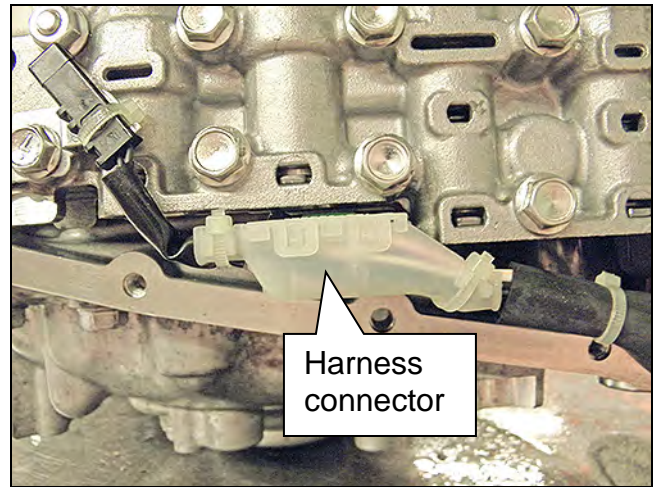
Figure 25

5. Connect the electrical harness connector (Figure 25).

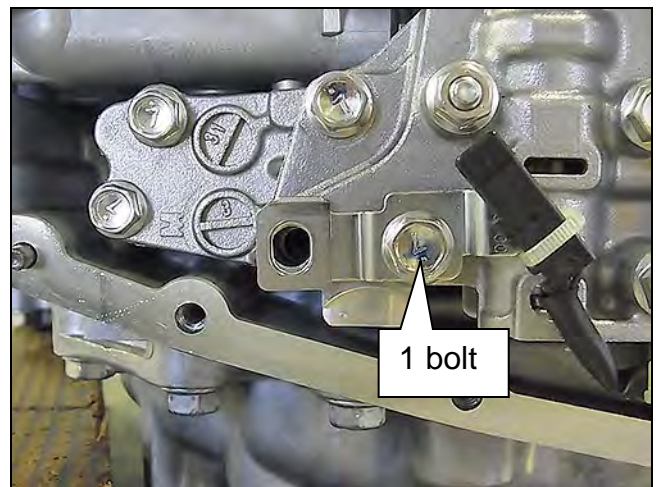
Figure 26

6. Install the CVT fluid temperature sensor bracket to the valve body with one (1) bolt (Figure 26).

**NOTE:** Leave one (1) bolt hole blank as it will be used to secure the oil strainer at a later step.

- Bolt torque: 8.0 N•m (0.81 kg-m, **70.8 in-lb.**)
- Bolt length: 54 mm

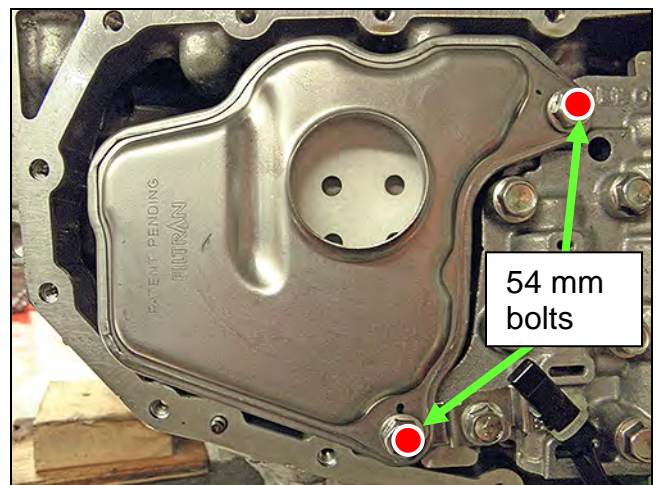
Figure 27

7. Install the new oil strainer with its new O-ring seal with two (2) bolts (Figure 27).

**NOTE:** Replacement strainer maybe a different shape.

- Bolt torque: 8.0 N•m (0.81 kg-m, **70.8 in-lb.**)
- 54 mm long bolt

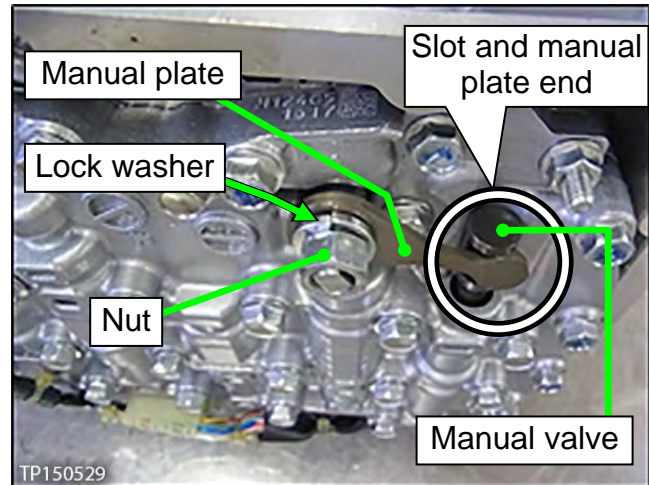
Figure 28

8. Install the manual plate, lock washer, and nut (Figure 28).

**NOTE:** Make sure the manual plate fits into the slot of the manual valve before applying torque to the nut.

- Reuse the existing manual plate, lock washer, and nut.
- Nut torque: 22.5 N•m (2.29 Kg-m, **16.6 ft-lb.**)

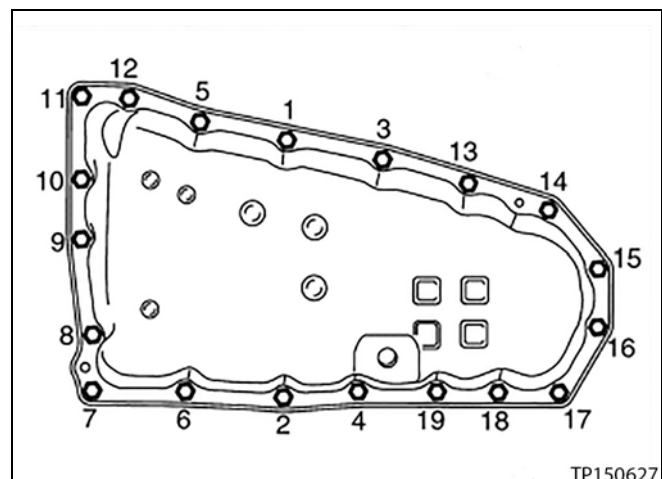
Figure 29

12. Install the oil pan bolts (see Figure 29).

- Reuse the existing pan bolts.
- Oil pan bolts torque: 8.0 N•m, (0.81 Kg-m, **70.8 in-lb.**)

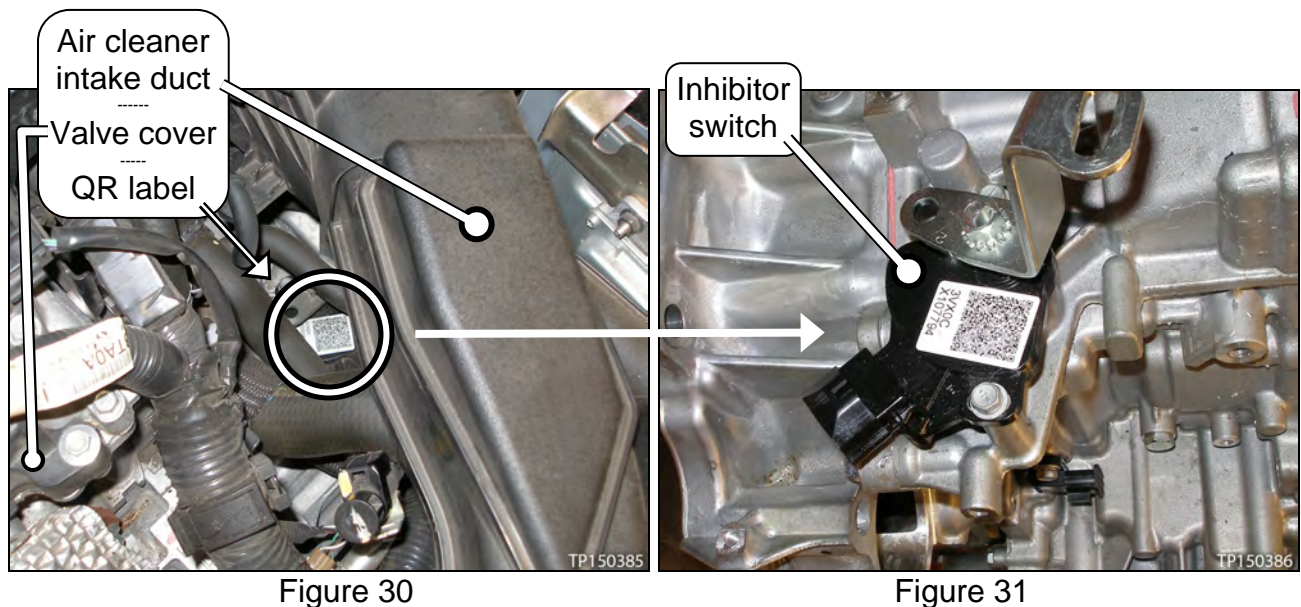
- Refer to **TM – Transaxle & Transmission / RE0F10D / BASIC INSPECTION**, and perform **ADDITIONAL SERVICE WHEN REPLACING CONTROL VALVE**.
  - Check for fluid leakage.
  - Attach the QR label with the new calibration data onto the transmission range switch (inhibitor switch).
    - See Figure 30 and 31 below.
    - A QR Label and CD-R are included with the replacement valve body.

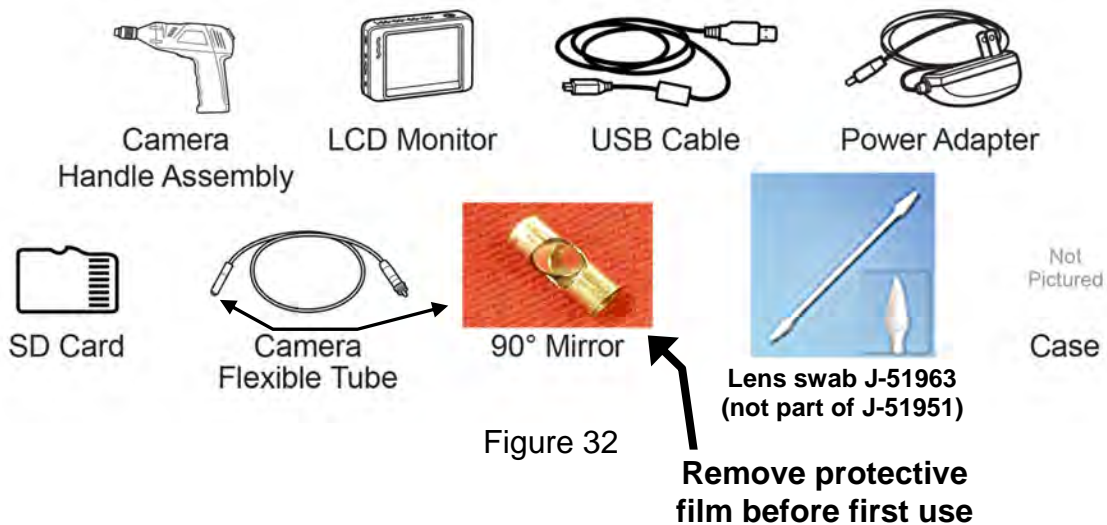
### Tech Cam J-51951

**NOTE:** Essential Tool Tech Cam (borescope) J-51951 has been sent to dealers. This tool's attachments make CVT inspection possible.
