<b>Topic</b>	17-17-01TT – Oil Leak at - <b>N205</b> - Camshaft adjustment valve 1
<b>Market area</b>	United States 444 Volkswagen of America, Inc. (6444)
<b>Brand</b>	Volkswagen
<b>Date</b>	March 17, 2017

### Oil Leak at -N205- Camshaft Adjustment Valve 1

Model(s)	Year	Eng. Code	Trans. Code	VIN Range From	VIN Range To
Jetta, Golf, Passat, Beetle	2014-2017	1.8L/2.0L (CPKA, CPRA, CPPA, CPLA)	All	All	All

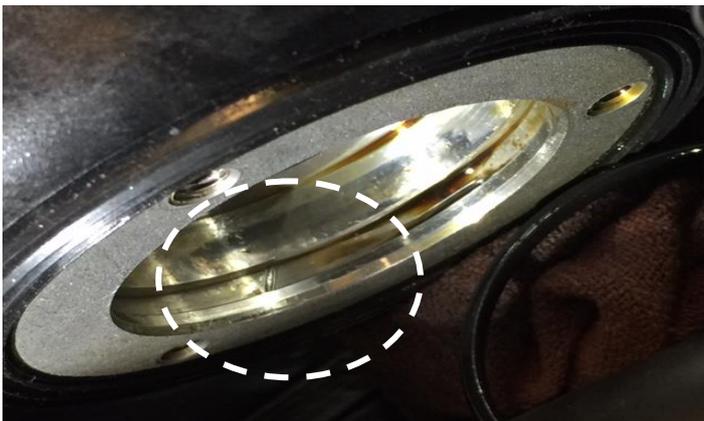
If an oil leak is noted at the Camshaft Adjustment Valve 1 -**N205**-, its connector or the cam bridge, check the O-ring seal inside of the cam bridge.

Remove the Camshaft Adjustment Valve 1 -**N205**- and its O-ring seal, inspect for nicks, cuts or irregularities in the O-ring seal.
