Preliminary Information

PIP5395C Ticking Rattle Or Buzz Noise Heard The Best In The Passenger Compartment

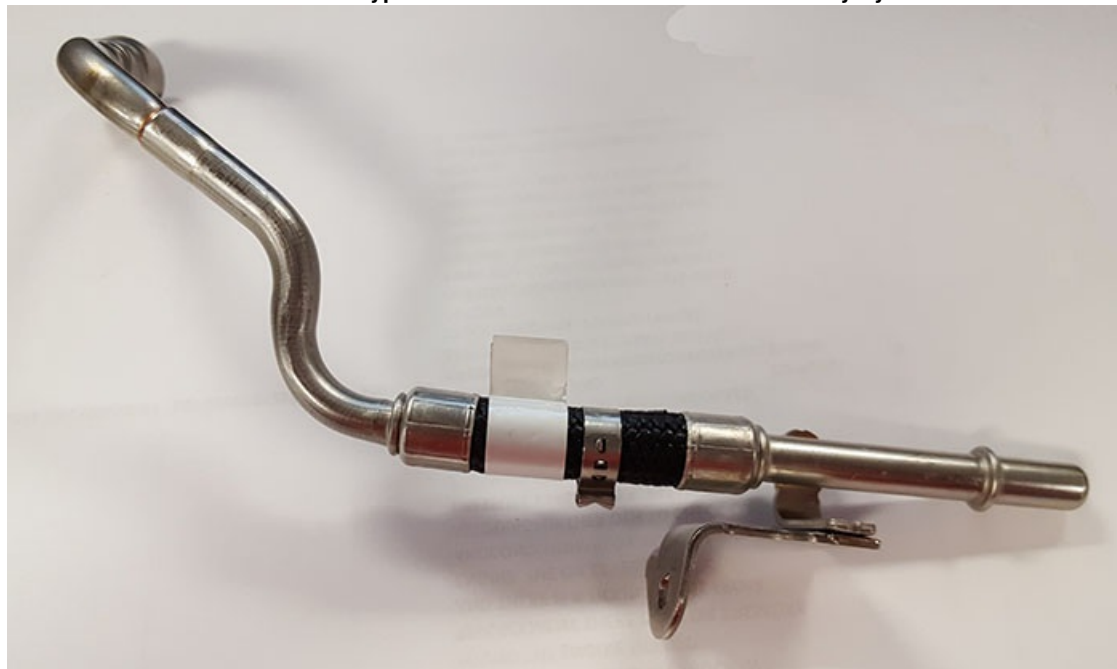
The line above is the fuel feed pipe for Corvette, truck and SUV.

This line connects the chassis fuel line to the high pressure fuel pump.

The fuel feed line between the high pressure fuel pump and chassis fuel line could be the cause allowing high pressure pulsation back to the low side of the fuel system. There is not a good way to test the check valve, the line will need to be replaced.
