HYUNDAI

Technical Service Bulletin

GROUP AUTOMATIC TRANSMISSION	NUMBER 17-HC-003-1
DATE OCTOBER, 2017	MODEL SONATA HYBRID (YF HEV/LF HEV)

SUBJECT:	AUTOMATIC TRANSAXLE INHIBITOR SWITCH
-----------------	---

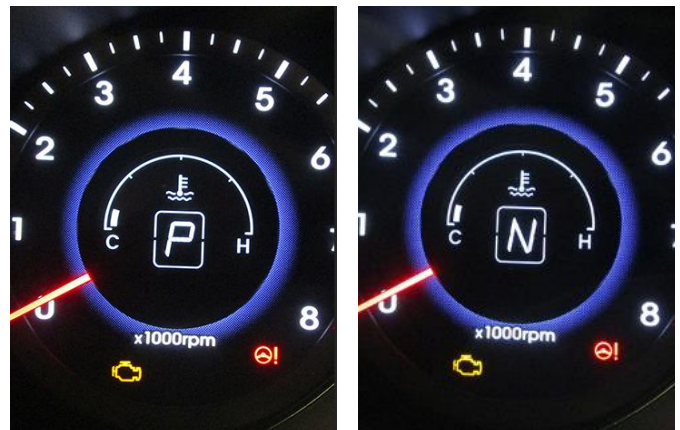
6. Turn the ignition switch to the ON position and place the shift lever in P and N. Confirm the indicator lights in the dash cluster show the correct gear in P and N.

- If P and N are displayed, go to Step 7.
 - If P or N are not displayed, go to Step 20 and check the alignment of the inhibitor switch. If P and N are not displayed after adjustment, go to Step 7.

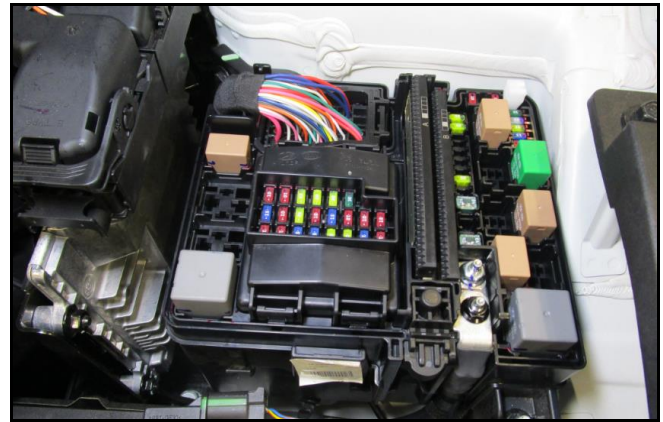
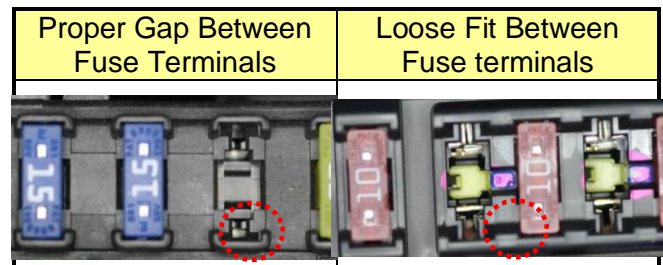
7. Check the TCU and TCU2 fuse in the junction box in the engine compartment:
- Check the fuse for an open circuit.
 - Check the fuse for correct capacity.
 - Check the fuse holder for a tight fit.
 - Check for loose or damaged wires.

If damage or intermittent open circuit is found, repair or replace the junction box and front harness.

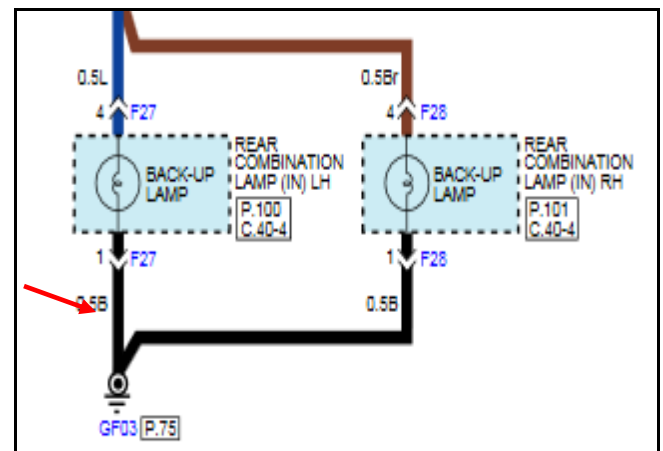
8. Check the rear combination lamp ground for tightness.

Turn the ignition and headlights on. Use a DVOM to check the voltage drop between the combination lamp wiring terminal and ground.

Specification: Less than 0.2 V.

If more than 0.2V, clean the terminal and bolt threads and tighten the bolt.

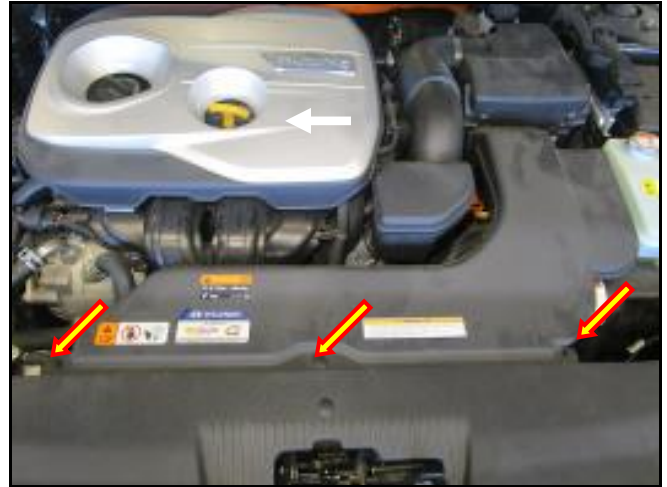
10. Remove the plastic tabs and remove the air duct.

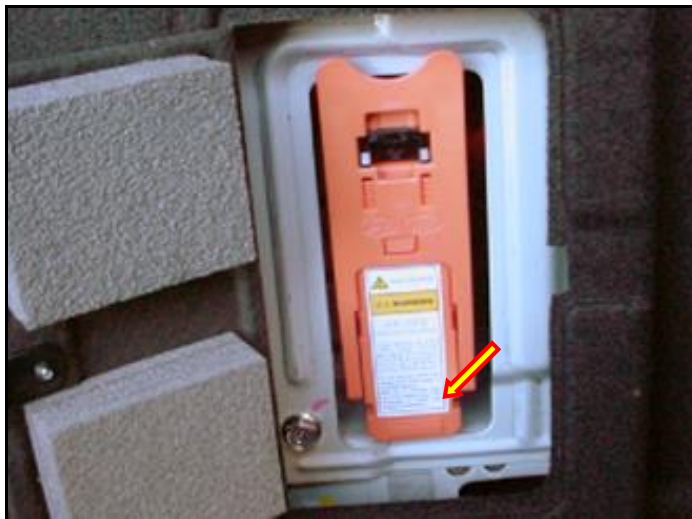
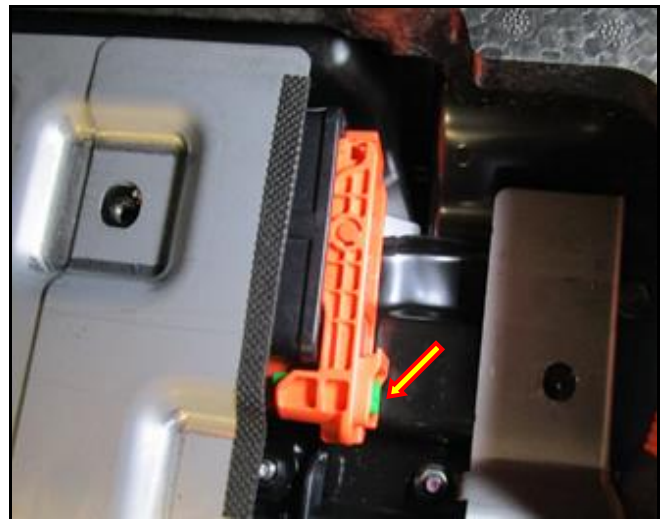
11. Put on insulation gloves.

Open the trunk. Remove the carpet and access the safety plug.

YF HEV: Open the access cover. Pull the latch outward and remove the safety plug.

LF HEV: Remove the access cover. Pull the green tab outward and pull out the safety plug.

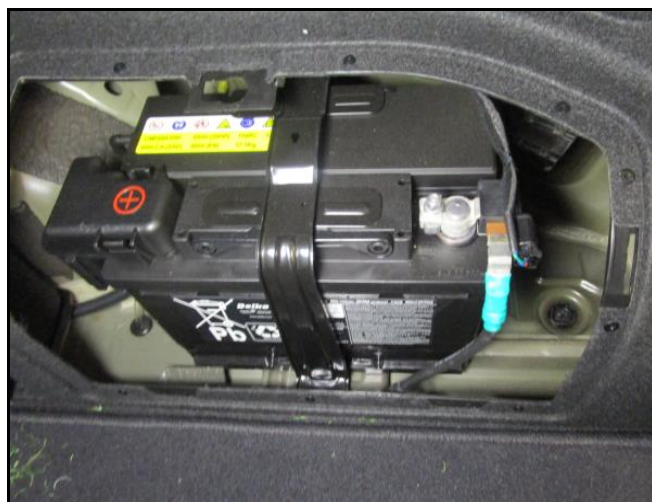
13. Record the preset radio stations and reset after repairs are completed.

Open the trunk and disconnect the negative battery cable.

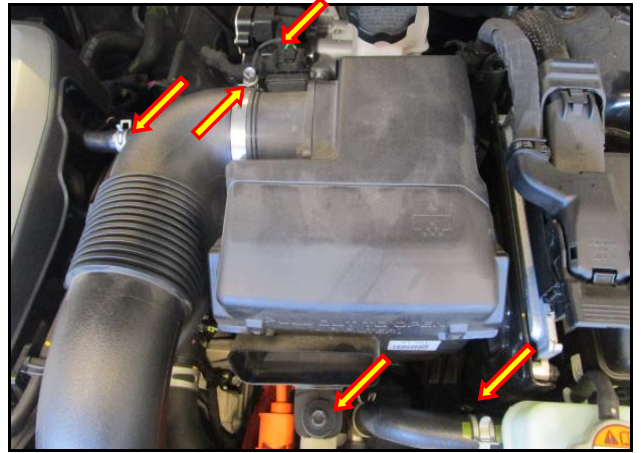
14. Disconnect the breather hose and the air duct.
Disconnect the intake air temperature sensor.
Loosen the clamp on the air duct.
Disconnect two bolts that secure the air cleaner and remove the air cleaner.
Torque: 7~9 lb-ft (1.0~1.2kgf.m, 10~12 N.m)

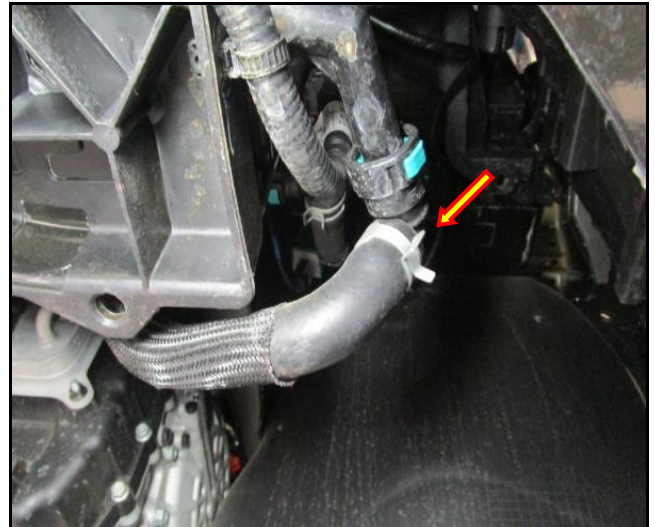
15. Loosen the cap on the reservoir.
Raise the vehicle on a hoist.
Remove the plastic undercover below the engine and transmission.
Locate the hose under the Hybrid radiator on the driver's side of the vehicle.
Remove the clamp and pull the hose off to drain the coolant from the reservoir.
NOTE: Save the coolant in a clean container.
Reinstall the hose and clamp.
Reinstall the undercover.

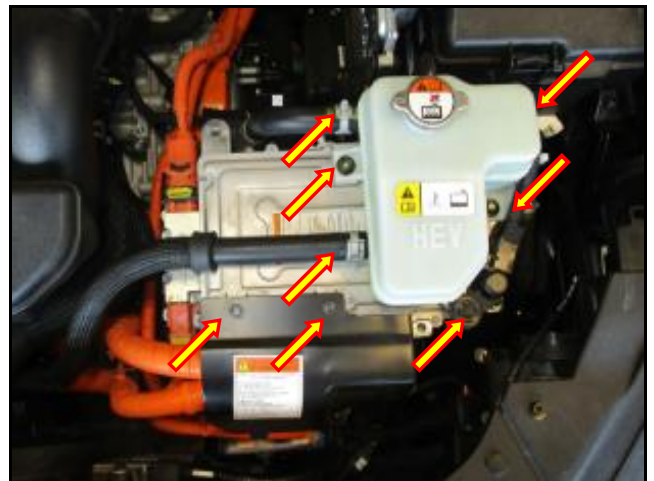
16. Remove two bolts to the HPCU protector and remove the cover.
Remove the clamps to the coolant hoses and remove the hoses.
Remove the ground cable.
Remove 2 bolts and 1 nut that secure the reservoir and remove the reservoir.

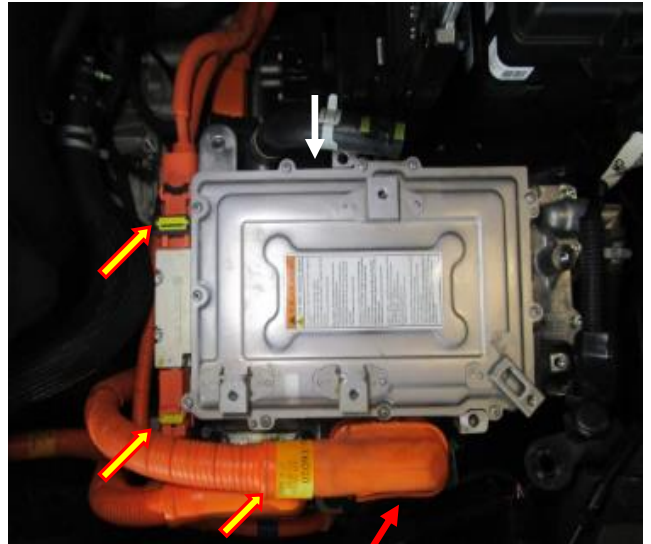
17. Remove the power cables:

- Yellow arrow: Pull out yellow tab, press tab
- Red arrow: Press black tab on latch
- White arrow: Press black tab

Remove 3 bolts and remove the HPCU.

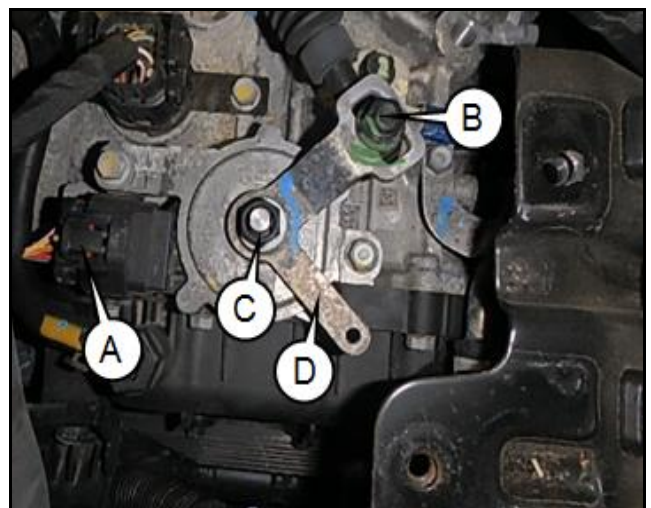
18. Disconnect the inhibitor switch connector (A)

Remove the shift cable mounting nut (B).

Remove the nut (C) and washer and remove the manual control lever (D).

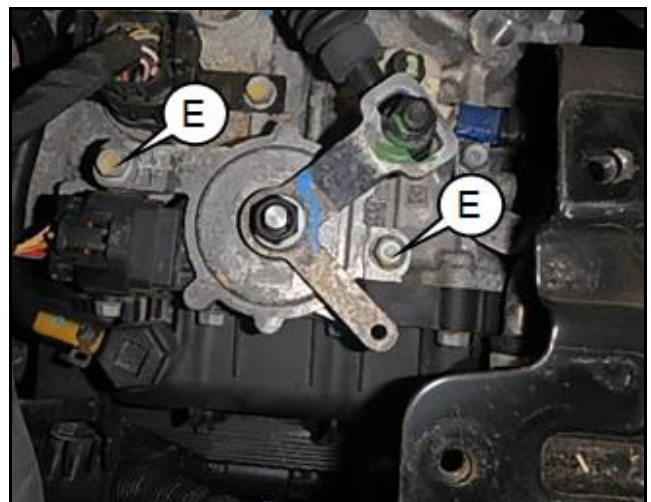
19. Remove 2 mounting bolts (E) and remove the inhibitor switch assembly.

Install the new inhibitor switch assembly to the transaxle and tighten the mounting bolts.

Torque: 7~9 lb-ft (1.0~1.2 kgf.m, 10~12 N.m)

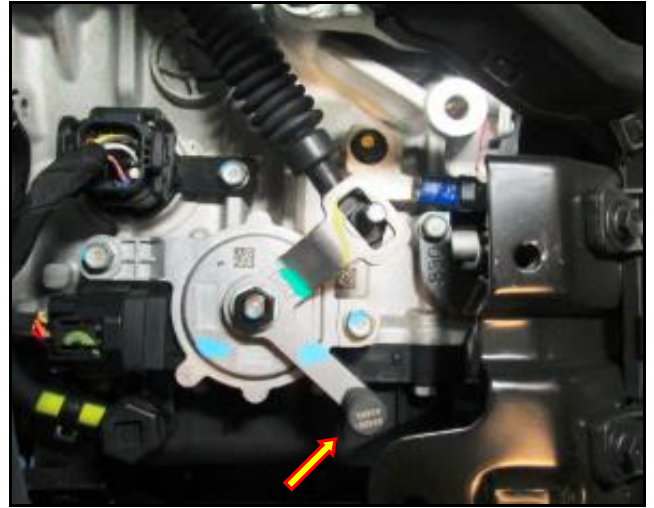
20. Install the manual control lever, washer and nut to the new inhibitor switch and tighten the nut.

Torque: 13~18 lb-ft (1.8~2.5 kgf.m/18~24 N.m)

Insert the **09480-A3800** guide pin or **5mm** bolt in the alignment hole before tightening the nut.

SST 09480-A3800, Inhibitor Switch Guide Pin.

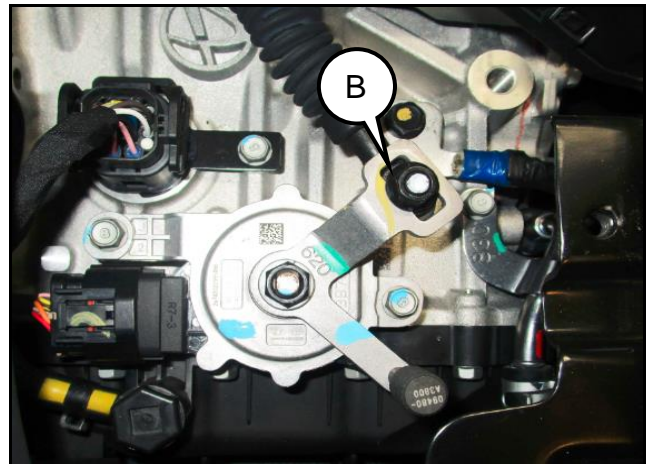
21. Confirm the shift lever is in the **N** position.

Install the shift cable nut and tighten the nut (B) to specification.

Torque: 6~9 lb-ft (0.8 ~ 1.2 kgf.m, 8~12 N.m)

Remove the SST or 5mm bolt from the alignment hole.

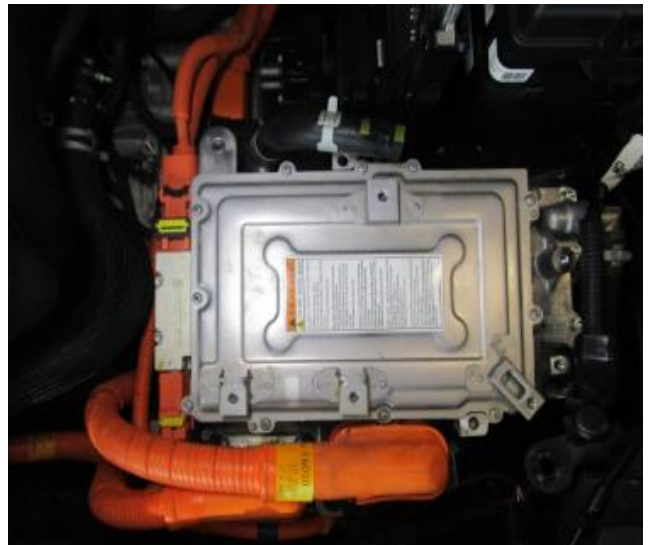
22. Install 3 bolts that secure the HPCU.

Torque: 14~22 lb-ft (2~3 kgf.m, 20~29 N.m)

Reconnect the power cables and ground wire.

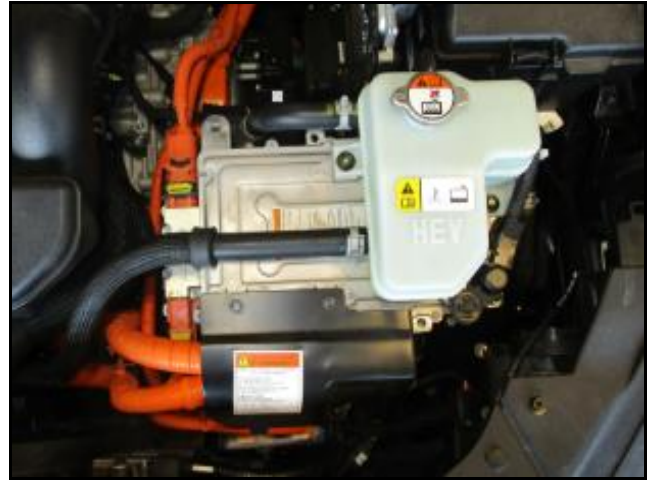
23. Install 2 bolts and 1 nut that secure the coolant reservoir.

Torque: 3~4 lb-ft (0.4~0.6 kgf.m, 4~6 N.m)

Reinstall the coolant reservoir and hoses.

Refill the coolant and perform air bleeding using GDS. Select **S/W Management, HEV Motor Control System** and **Electric Water Pump Control**.
