HYUNDAI Technical Service Bulletin	GROUP CAMPAIGN	NUMBER 17-01-058
	DATE OCTOBER , 2017	MODEL(S) SONATA 2.0T (LFa)
SUBJECT: AIR INTAKE HOSE REPLACEMENT (SERVICE CAMPAIGN T2K)

Description: Some Sonata 2.0T (LFa) vehicles may experience deterioration of the air inlet hose near the turbo inlet. This may cause an air rushing noise and may cause potential damage to the turbo charger.

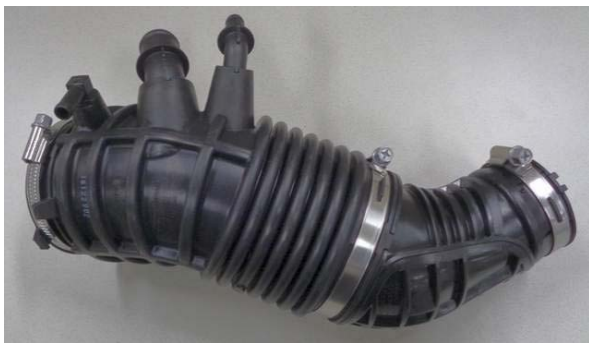
Part Name	Description	Part Number (OLD)	Part Number (NEW)
AIR INTAKE HOSE ASSEMBLY

28130-C1500 or 28130-C1501	28140-C1510QQH

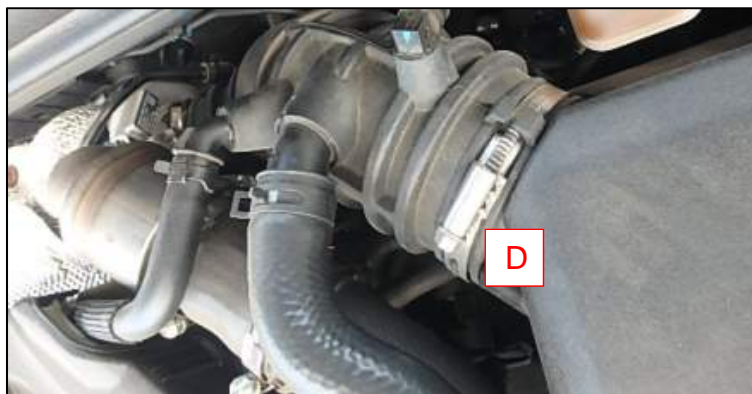
2. Using a 10mm socket or a screwdriver, loosen each hose clamp at the air cleaner (D) and the turbo inlet (E).

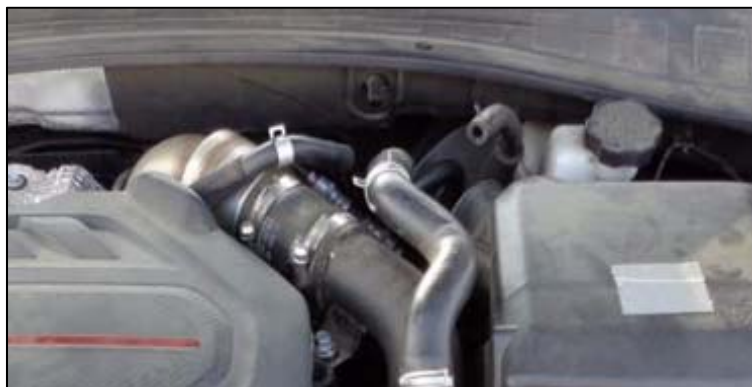
3. Disconnect the 3 hoses with clamps (A) (B) (C) from the air intake hose.

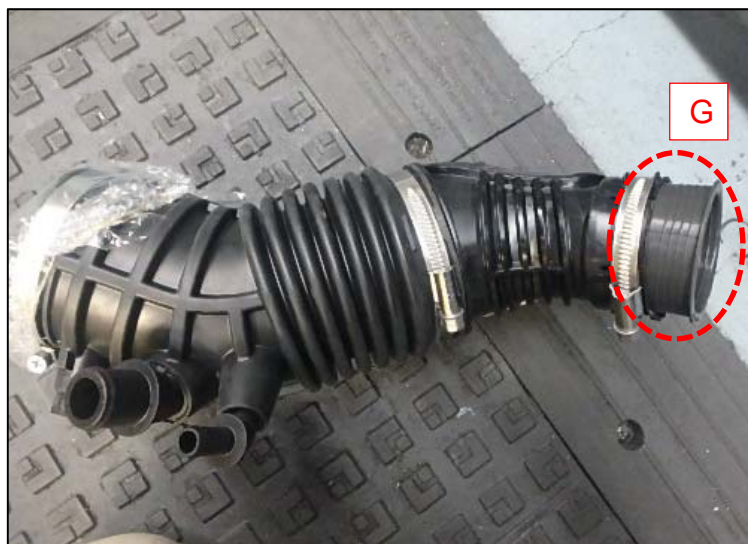
5. Remove the coupling sleeve (G) from the new air intake hose assembly and install onto the turbo inlet (H).
