GROUP  
BOD

MODEL  
2017MY  
Niro (DE)

NUMBER  
173

**SUBJECT:** OUTSIDE DOOR HANDLE COVER REPLACEMENT

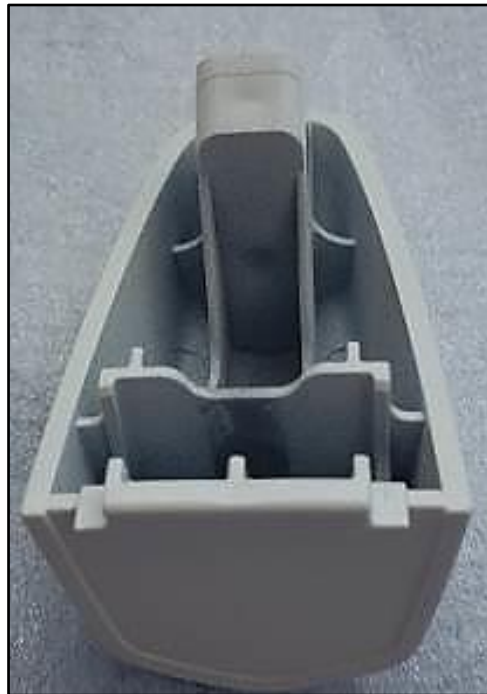
This bulletin provides the procedure to replace all three (3) outside door handle covers (all except the front driver's door) on some 2017MY Niro (DE) vehicles produced from November 1, 2016 through April 12, 2017, which may exhibit separation of the outside door handle cover.

**NOTE: Even if just one (1) door handle cover has separated, the dealer must order and replace all three (3) door handle covers at the same time (all except the front driver's door).**

To correct this concern, replace the door handle covers as outlined in this bulletin.

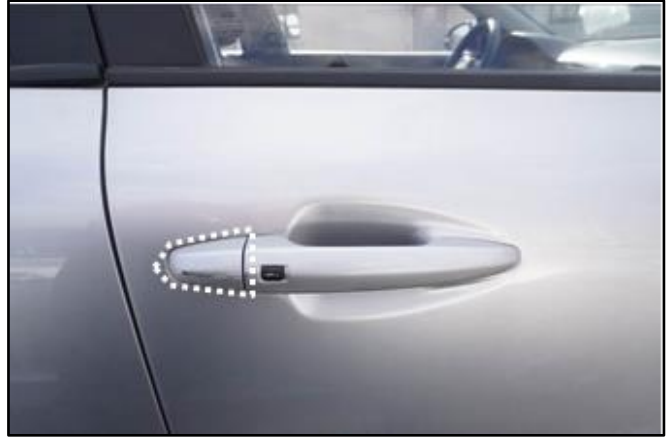
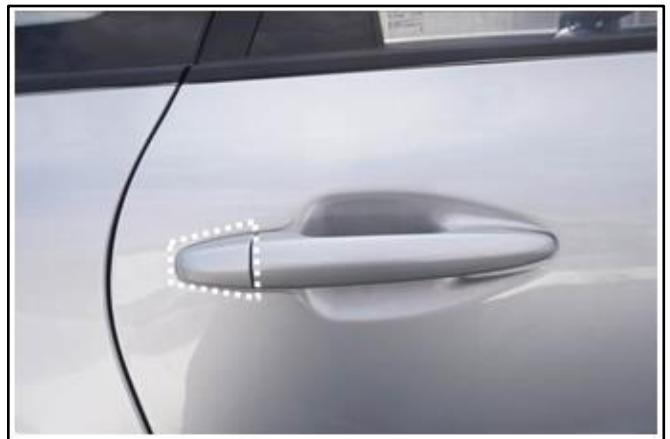
1. Remove the front RH outside door handle cover by referring to “Body (Interior and Exterior) → Front Door → Front Door Outside Handle → Repair procedures” chapters in the applicable workshop manual.
2. Remove the rear LH/RH outside door handle covers by referring to “Body (Interior and Exterior) → Rear Door → Rear Door Outside Handle → Repair procedures” chapters in the applicable workshop manual.
3. Install the three (3) new outside door handle covers in the reverse order of removal (excluding the driver’s door).

**Tightening torque:****2.9 - 4.3 lb·ft (3.9 - 5.9 N·m, 0.4 - 0.6 kgf·m)****\* NOTICE****Do not over torque as this may damage the cover and cause separation.**
