SERVICE BULLETIN

AT15-005i

2015 – 2017 QUEST; CVT JUDDER AND DTC P17F0 OR P17F1 STORED

APPLIED VEHICLES: 2015-2017 Quest (E52)

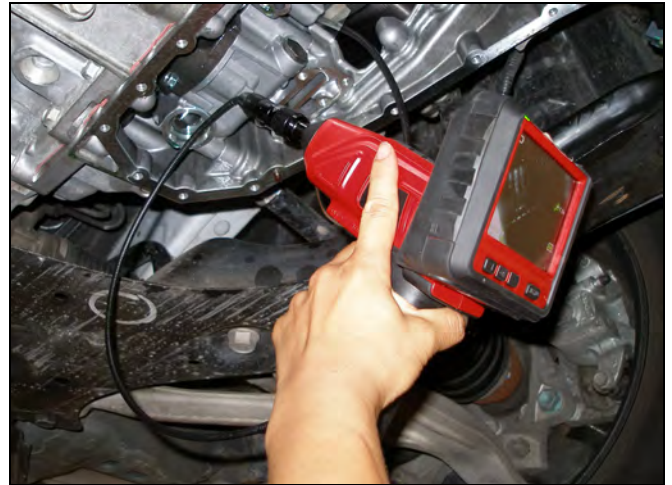
Figure 11

4c. Slowly and carefully turn the left front tire one full turn in the forward rotation to view all of the chain.

- Holding the borescope with one hand allows for turning the tire with the other hand (see Figure 11).

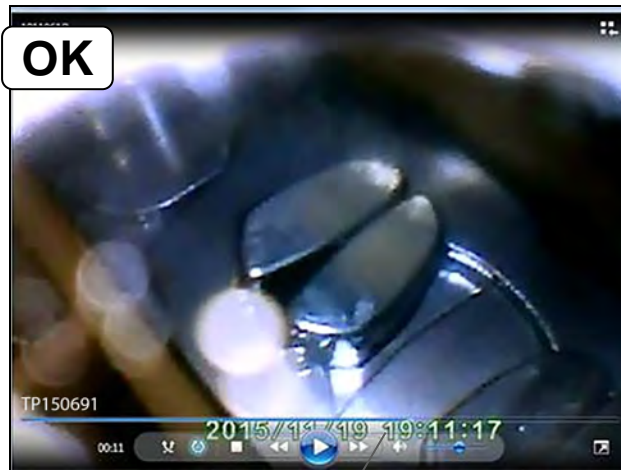
Pictures in Figure 16 and 17 were taken with borescope J-51951.

NOTE: Reference the pictures on page 13-15 for comparison.
