SERVICE BULLETIN

Classification: EL17-013	Reference: NTB17-109	Date: October 6, 2017
-----------------------------	-------------------------	--------------------------

2016 - 2017 TITAN AND TITAN XD; CLIMATE CONTROLLED HEATED AND COOLED SEATS POOR OR NO OPERATION

APPLIED VEHICLES: 2016 – 2017 Titan and Titan XD (A61)
Equipped with climate controlled seats.

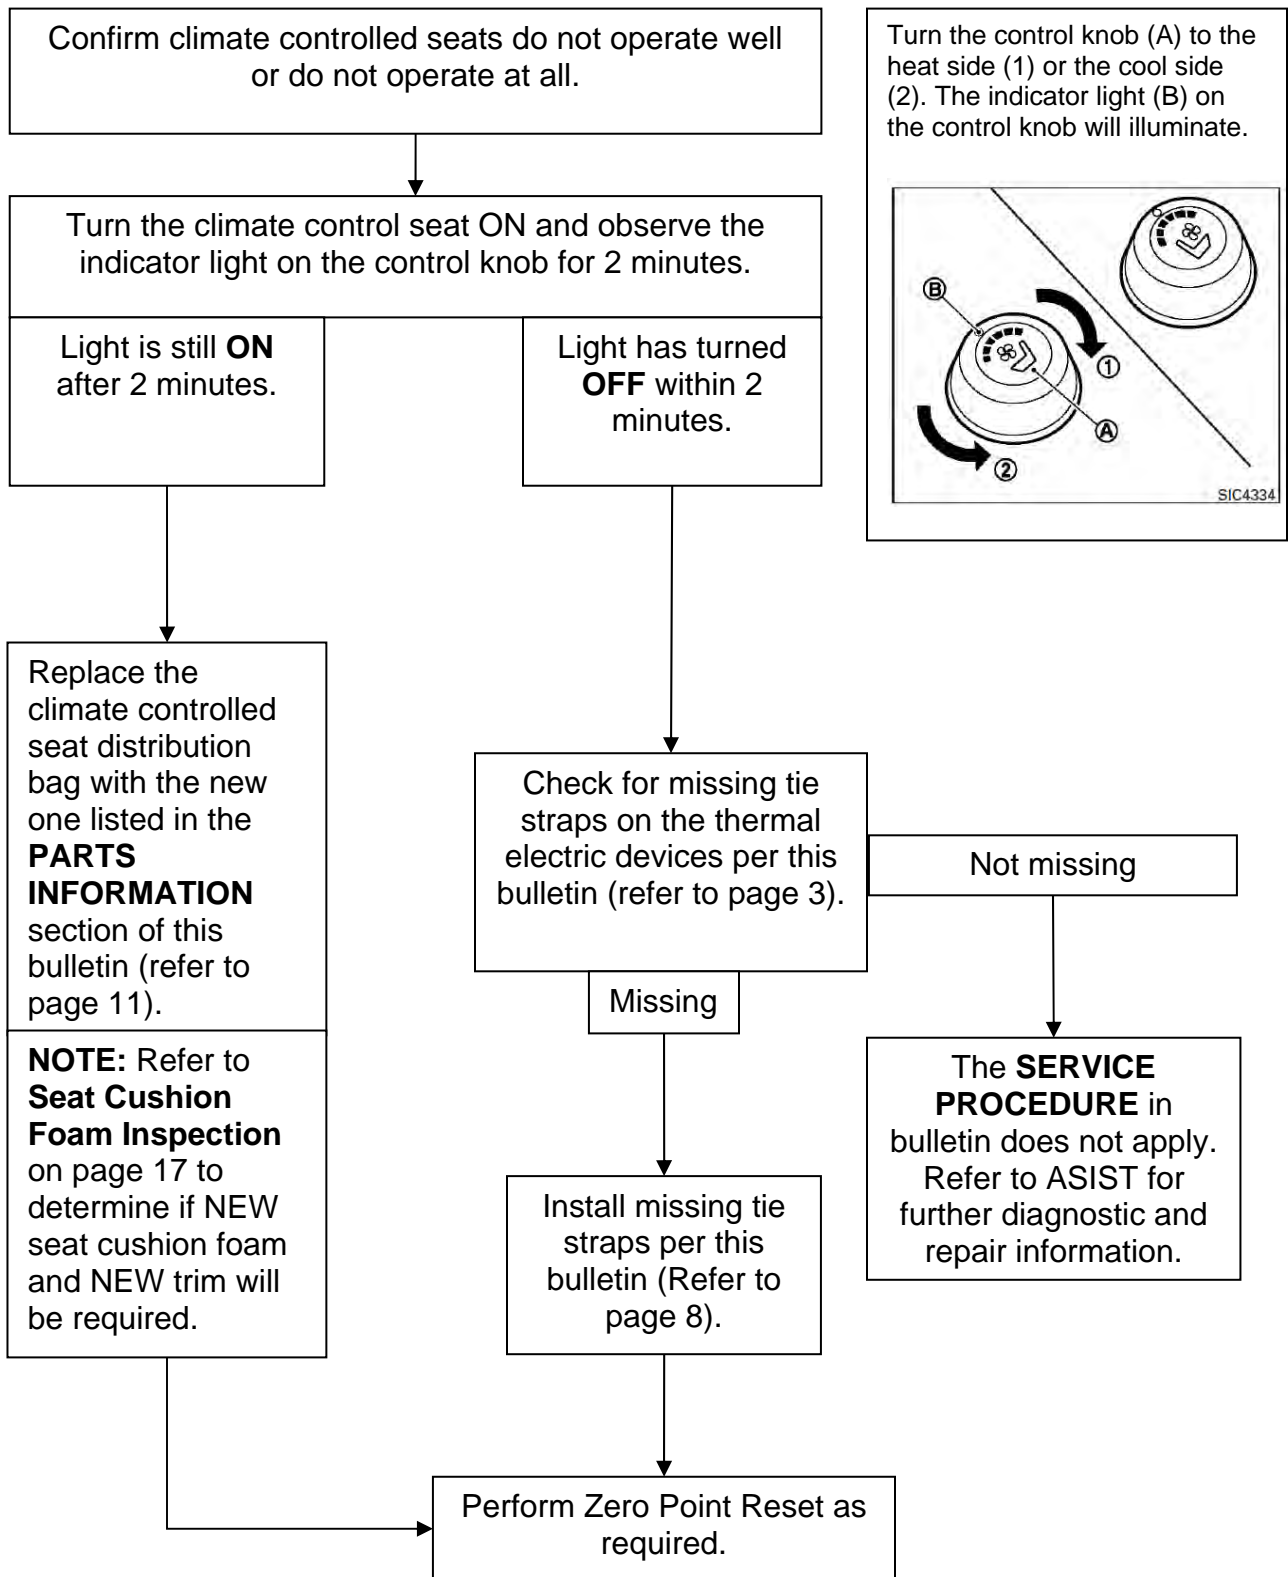
Refer to the Repair Overview flow chart on page 2.

NOTE: Perform repairs ONLY on seat(s) with a confirmed incident as described in Repair Overview.

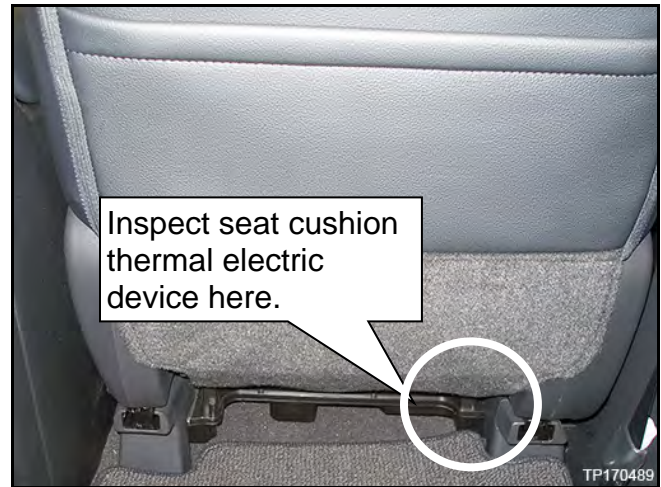
Figure 1

- Look for the thermal electric device under the seat in the area shown in Figure 1.

- Seat cushion thermal electric device as seen with the seat installed in the vehicle.
- Viewed from under the rear of the front seat.

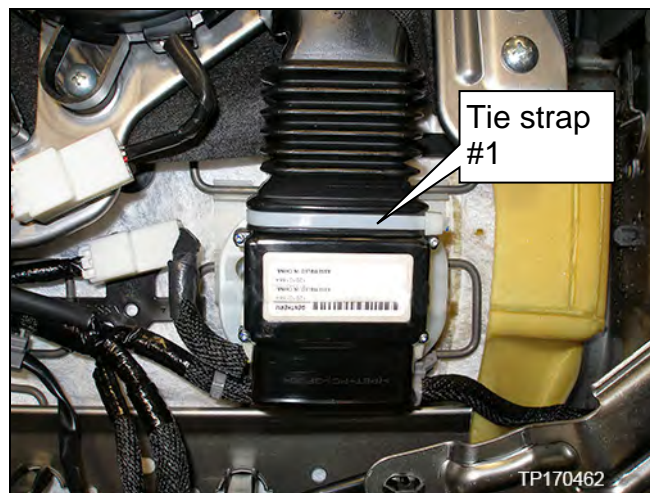
Figure 8

17. Install tie strap #1 around blower duct as shown in Figure 8.

- Use tie straps listed in the **PARTS INFORMATION** section of this bulletin.
- Cut excess tie strap material.

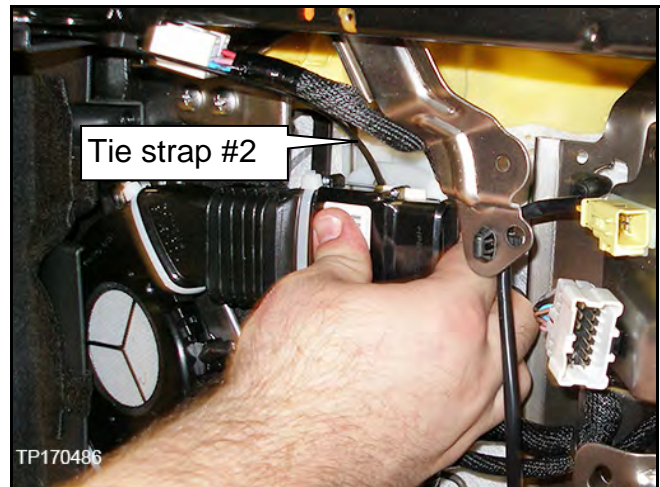
Figure 10

20. Secure thermal electric device into climate controlled seat distribution bag adapter.

- Squeeze the thermal electric device and the climate controlled seat distribution bag adapter together as shown in Figure 10.

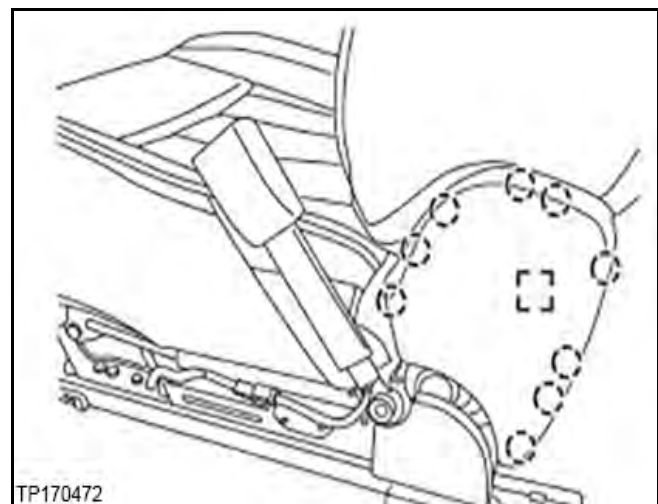
Figure 14

7. Remove the seat cushion outer finisher (LH).

- Release pawls and metal clip, then remove the seat cushion outer finisher.

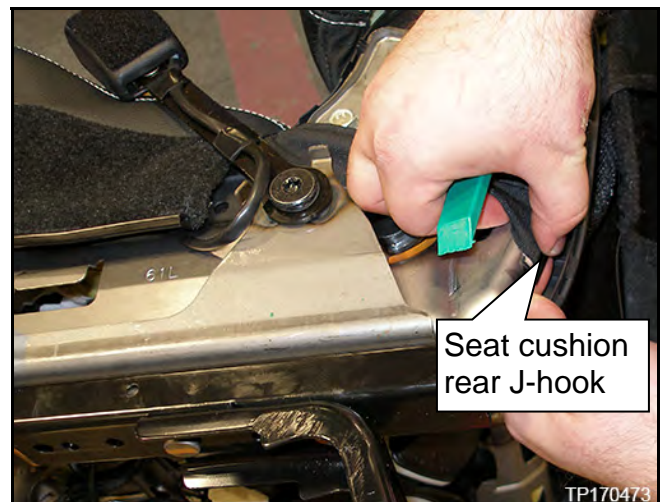
Figure 22

14. Release both seat cushion rear J-hooks from seat frame.

- Left and right side rear seat cushion J-hooks are similar.
- All seat cushion to seat frame connections have now been released.

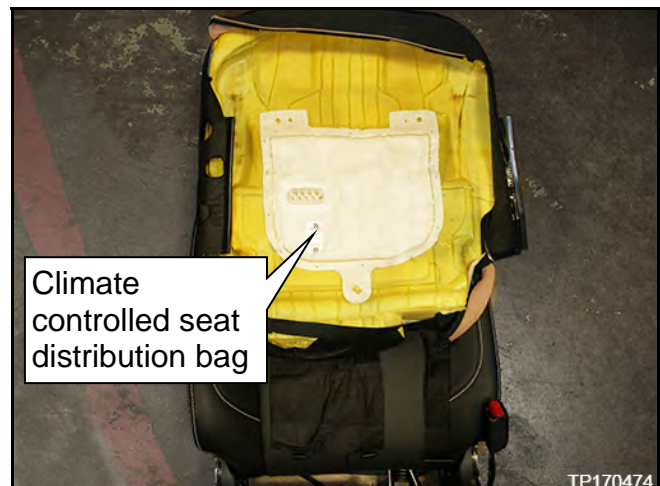
Figure 23

15. Remove seat cushion from seat frame.

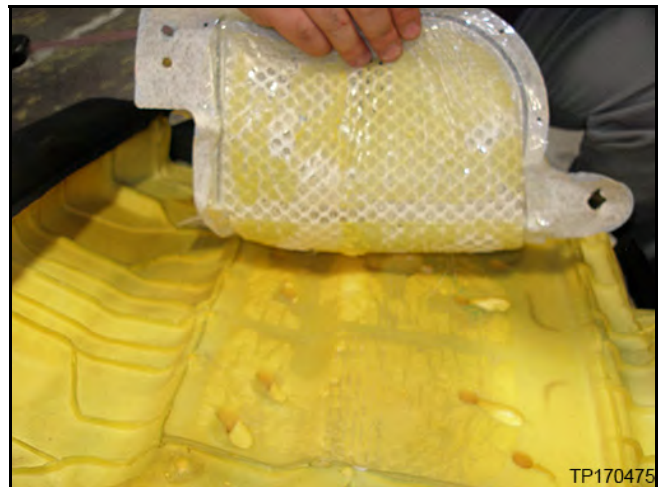
Figure 24

16. Remove climate controlled seat distribution bag from seat cushion foam.

- Climate controlled seat distribution bag will be attached to seat cushion foam with adhesive but can be removed by pulling away from seat cushion foam as shown in Figure 24.

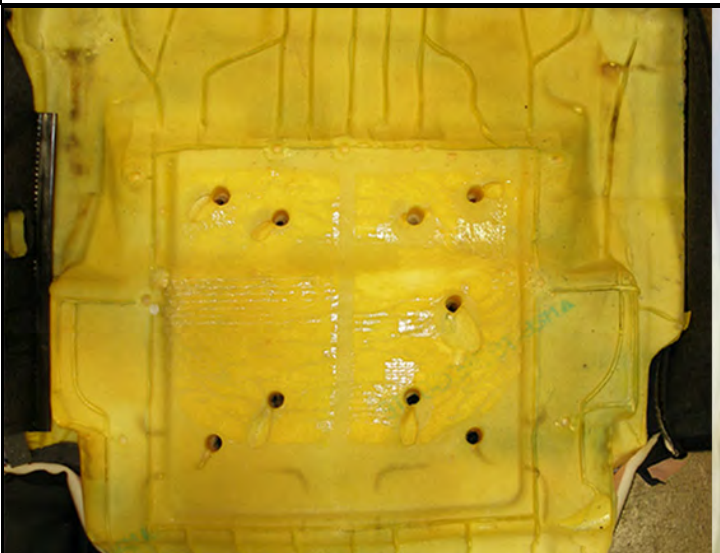
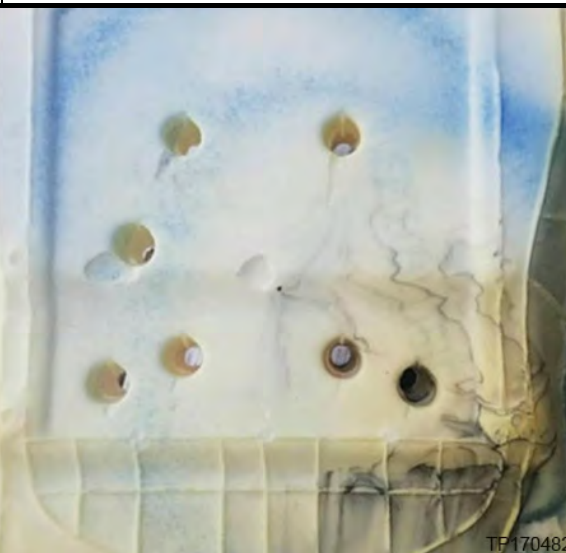
Figure 27

EXAMPLE	EXAMPLE
<p>All 2016 models and any 2017 models built on or before 1N6(*)A1(*)(*)HN 536160 will have the Old style seat cushion foam with 9 small holes and WILL require replacement.</p>	<p>All vehicles built after 1N6(*)A1(*)(*)HN 536160 should be equipped with the New style seat cushion foam with 7 large cone shaped holes and will NOT require replacement.</p>

20. If vehicle is equipped with old style seat cushion foam it must be replaced using new seat cushion foam and new seat trim listed in the **PARTS INFORMATION** section of this bulletin.

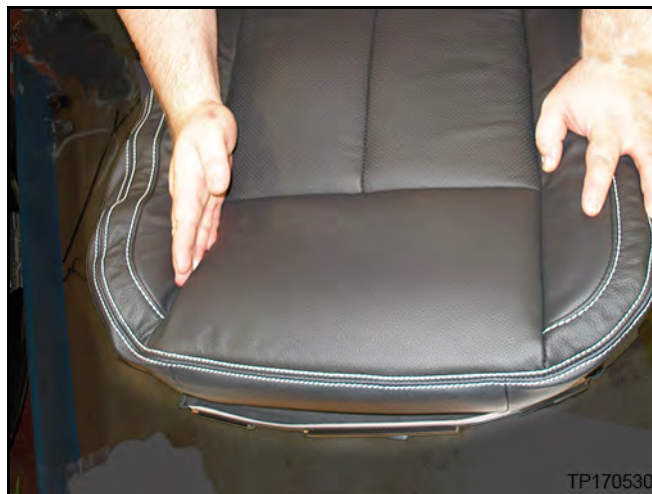
Figure 32

24. Wrap seat trim over seat cushion and apply pressure to secure Velcro strips.
