SERVICE BULLETIN

Classification: BT17-019	Reference: NTB17-110	Date: October 17, 2017
-----------------------------	-------------------------	---------------------------

2004 - 2015 TITAN; VIBRATION AT 40 – 50 MPH

APPLIED VEHICLES: 2004 – 2015 Titan (A60)

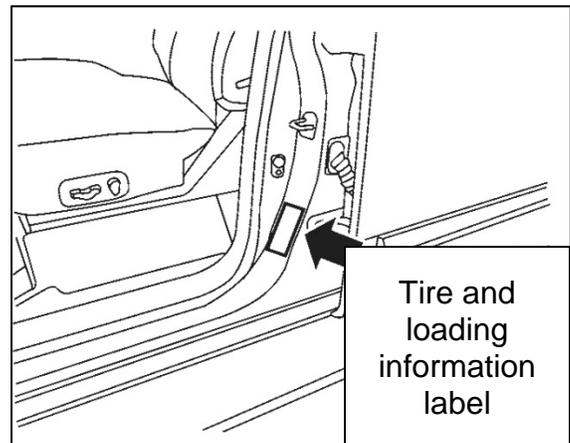
Figure A

The vehicle is equipped with the correct tires as shown on the TIRE AND LOADING INFORMATION LABEL on the driver side body side outer panel (B-pillar), (see Figure A).

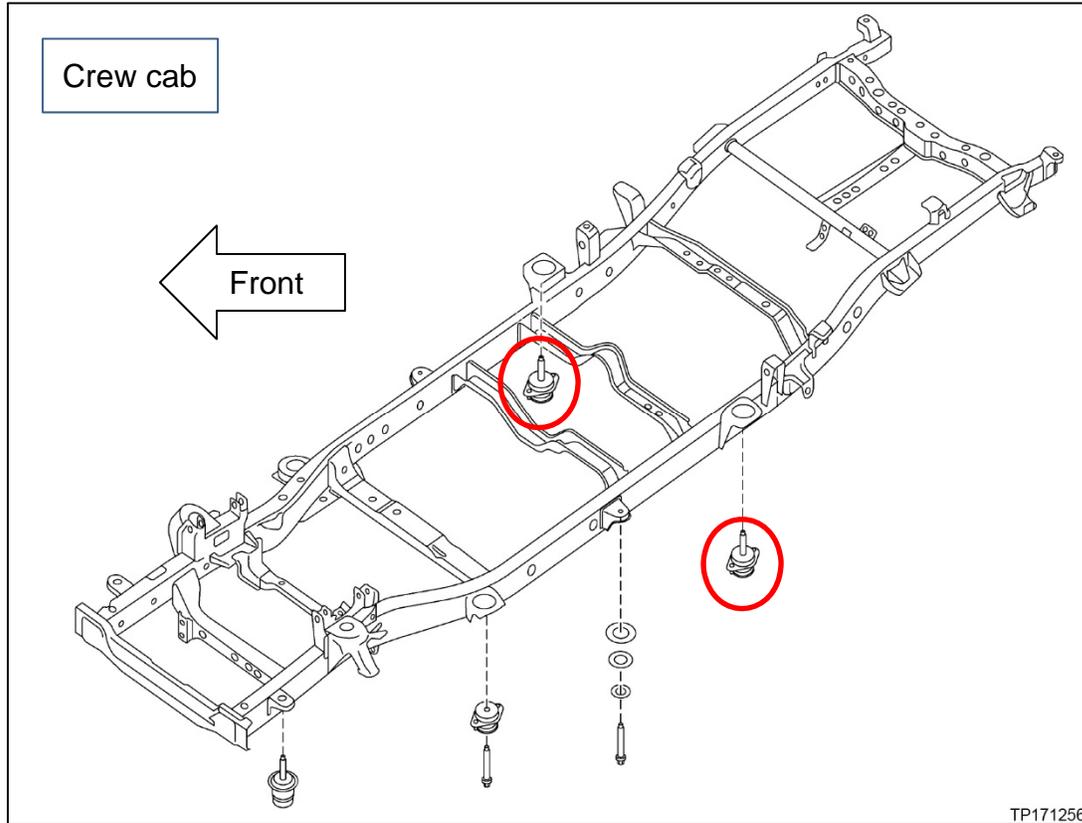
1. Locate the 2 rearmost cab body mounts that will be replaced.

NOTE: Figure 1 shows Crew cab and Figure 2 shows King cab locations in red.

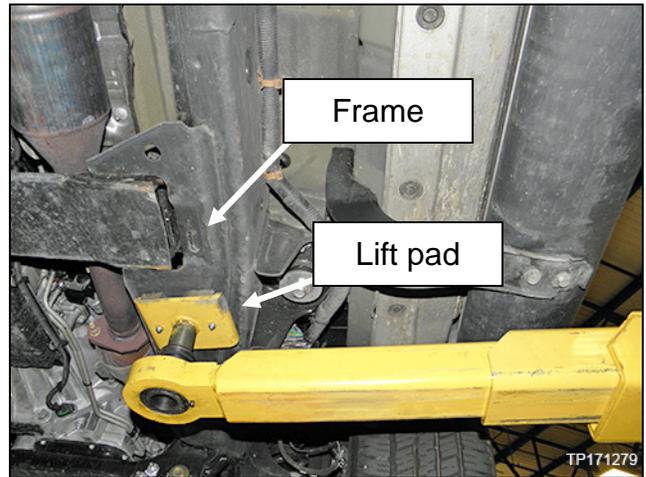
Figure 3

2. Raise vehicle on lift with lift pads placed on the frame as shown in Figure 3.

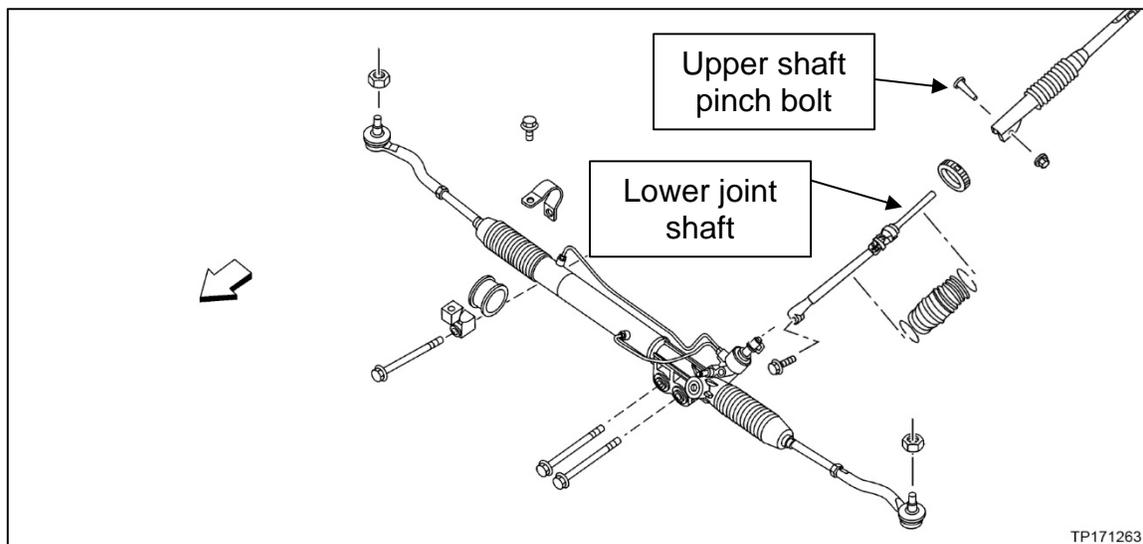
Figure 4

4. Remove steering column upper shaft pinch bolt shown in Figure 4.
5. Separate the upper shaft from the lower joint shaft.

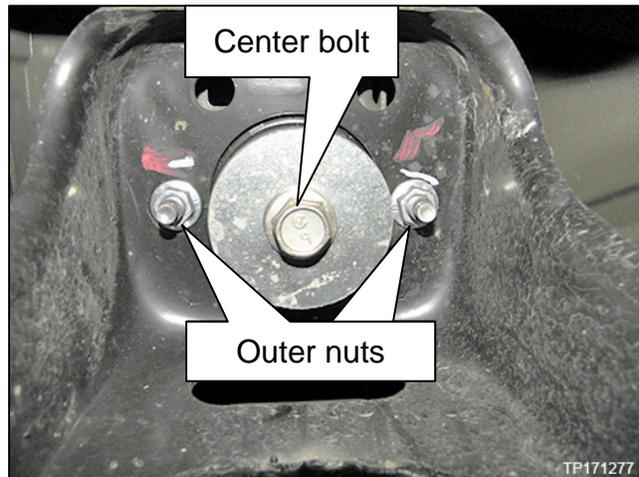
Figure 5

7. Remove the left and right side rearmost **CAB** body mount center bolt and outer nuts.

NOTE: The **OLD** outer bolts are installed from the top. The **NEW** outer bolts will be installed from the bottom.

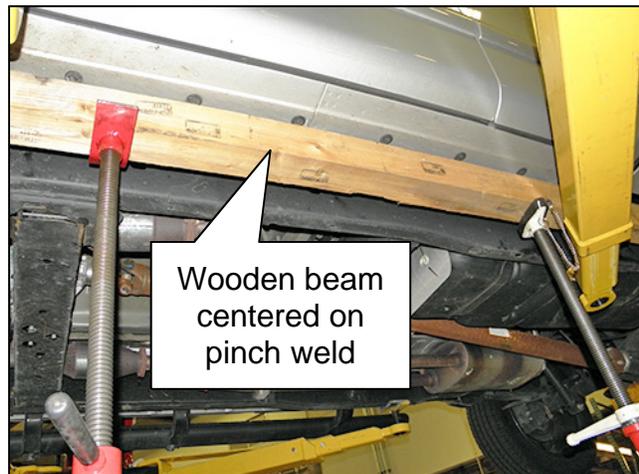
Figure 6

10. Remove rearmost cab body mount.

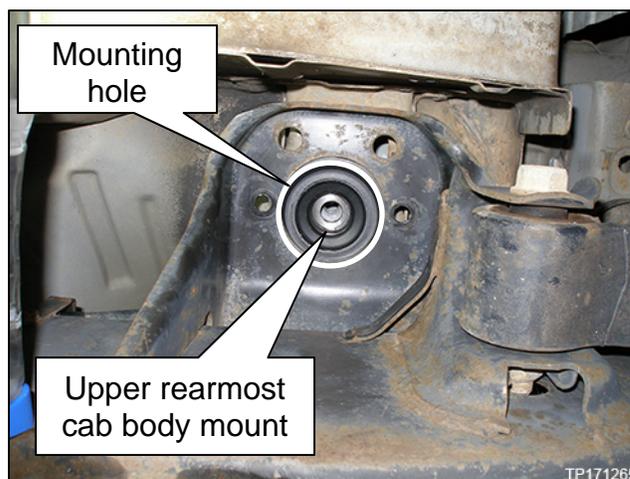
Figure 7

12. Position the new upper rearmost cab body mount in the center of the mounting hole.

13. Temporarily lower the pole jacks to prevent the upper rearmost cab body mount from moving.

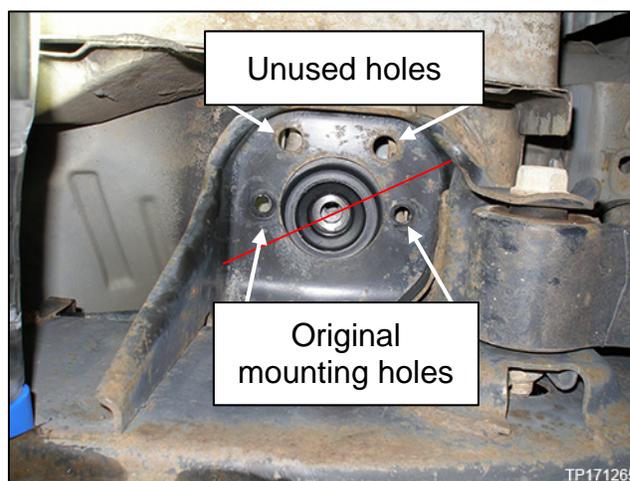
Figure 8

14. Using a straight edge or equivalent, draw a line approximately half way between original rearmost cab body mount hole and unused hole along edge of frame.

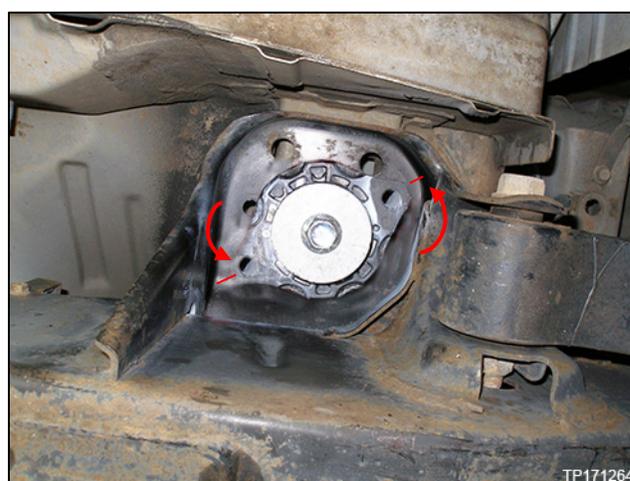
Figure 9

15. Install the NEW lower rearmost cab body mount center bolt.

16. Orient (rotate) the rearmost cab body mount holes to align with the line created in Step 14.

17. Hand tighten the center bolt.

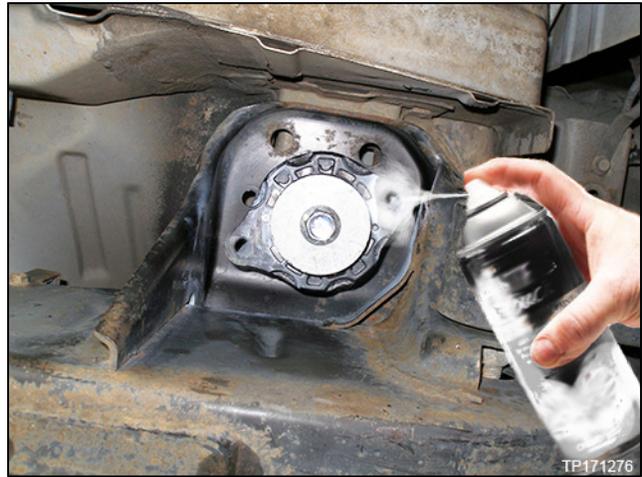
Figure 10

18. Use spray paint through the holes of the new rearmost cab body mount to mark the locations where the new holes will be drilled.

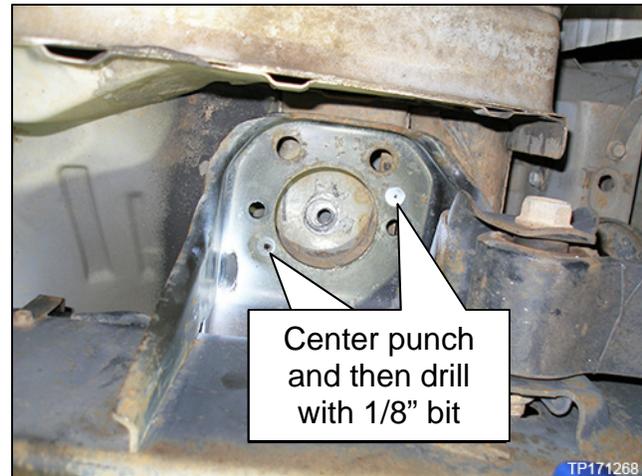
Figure 11

21. Use a center punch on the center of the marks to aid in drilling the new holes.

22. Use a 1/8" drill bit to drill a pilot hole in the center of the new hole locations.

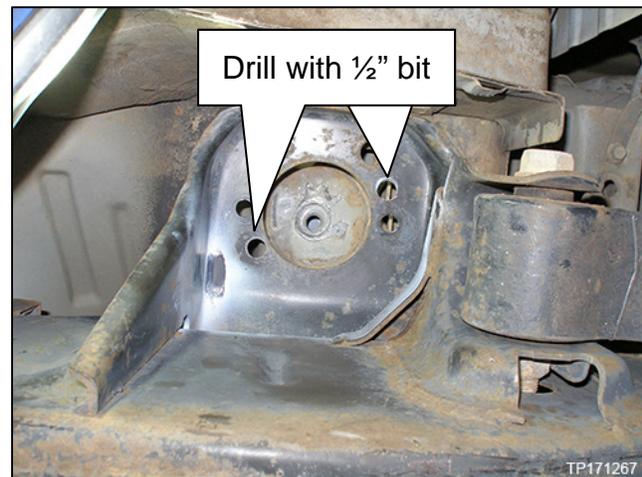
Figure 12

23. Drill the final hole using a 1/2" drill bit.

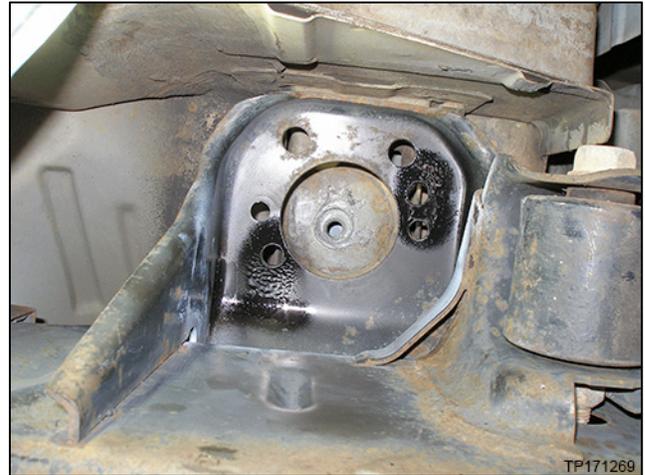
Figure 13

24. Apply zinc rich primer to protect bare metal.

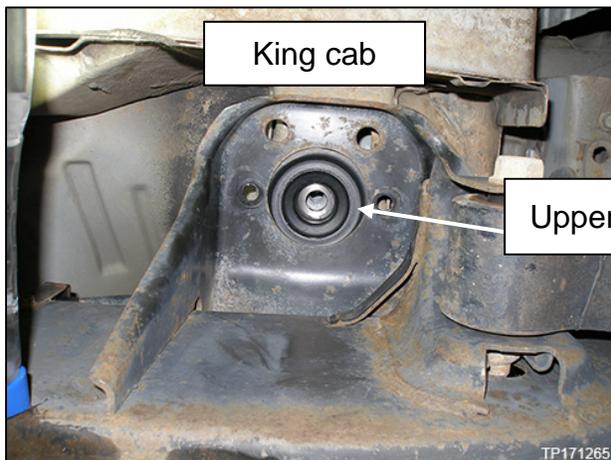
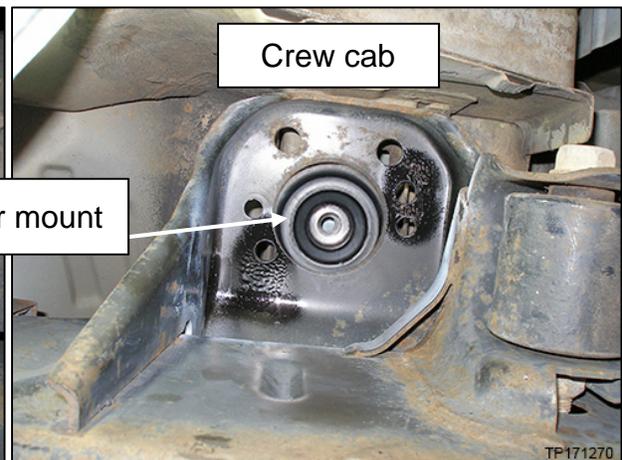
25. Install the new upper rearmost cab body mount.

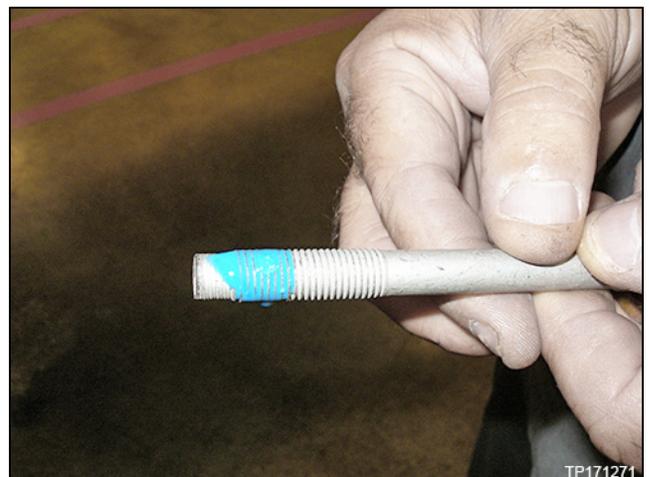
Figure 16

26. Add Loctite® 243™ medium strength threadlocking adhesive or equivalent to the new outer bolts.

- Threadlocking adhesive is listed in the **Parts Information** section of this bulletin.
- The center bolt does not require threadlocking adhesive.

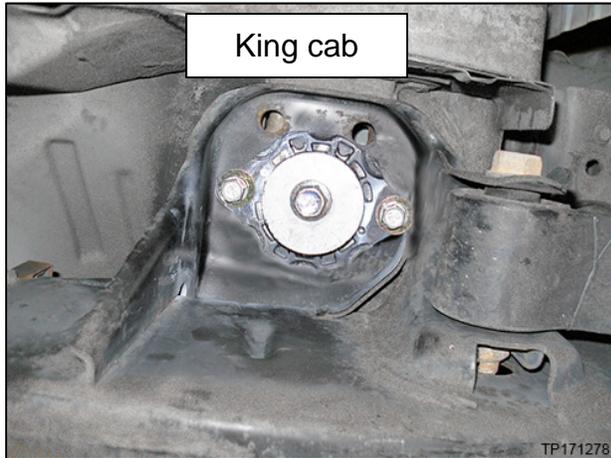
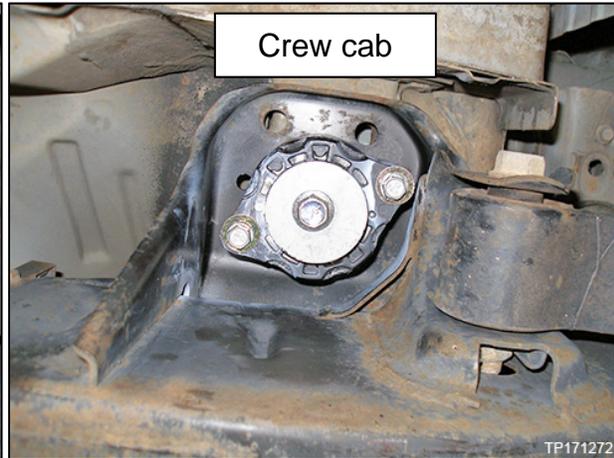
27. Install new lower rearmost cab body mount bolts and nuts.

- Leave the center bolt 3-4 turns loose.

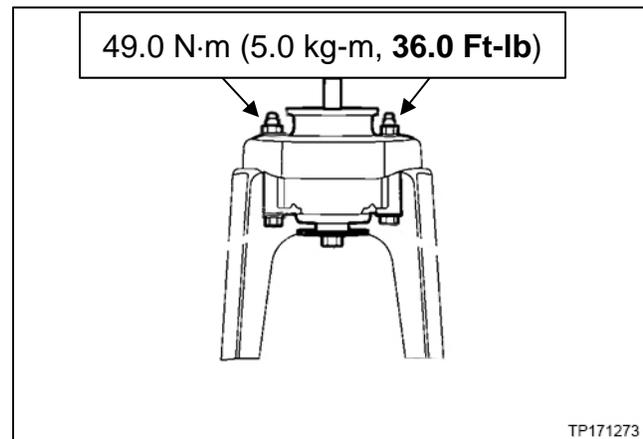
Figure 19

29. Torque the new rearmost cab body mount **outer** bolts to the specifications shown in Figure 19.

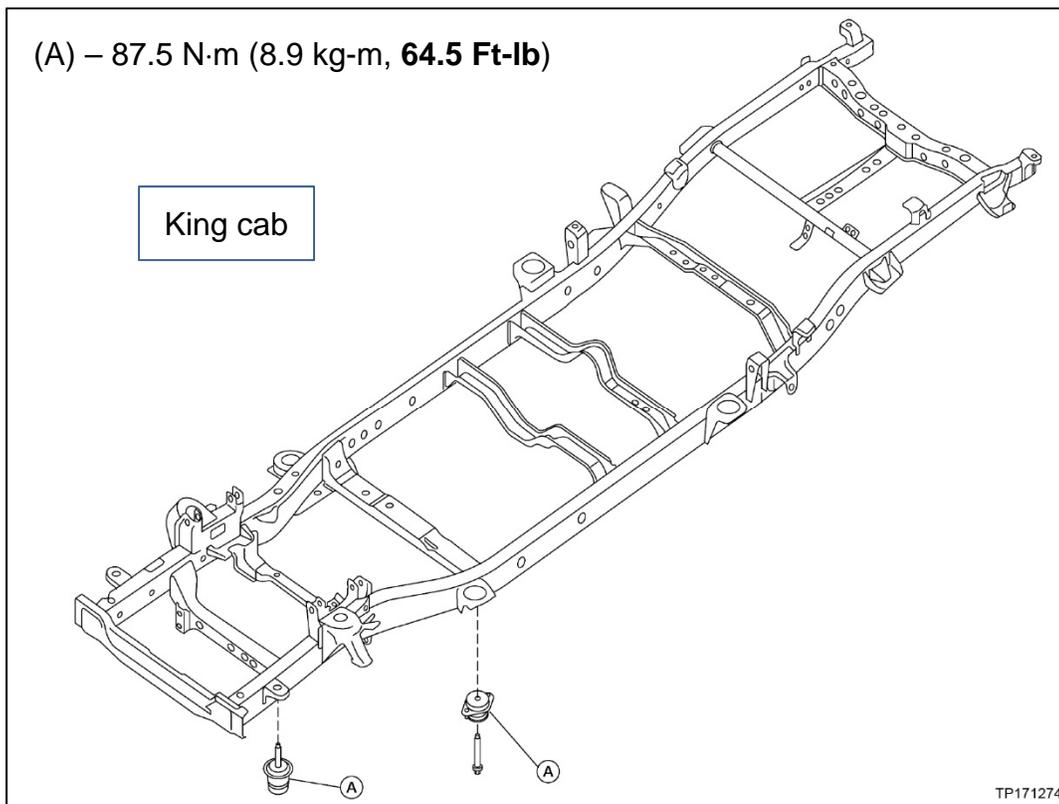
31. Torque the all body mount **center** bolts as shown in Figure 20 for King cab, and Figure 21 for Crew cab.
