# QUALITY ACTION

## CAMPAIGN BULLETIN Radiator Fan Dealer Inventory

Reference: PM700

## PM700 – SENTRA (B17) COOLING FAN BLADE

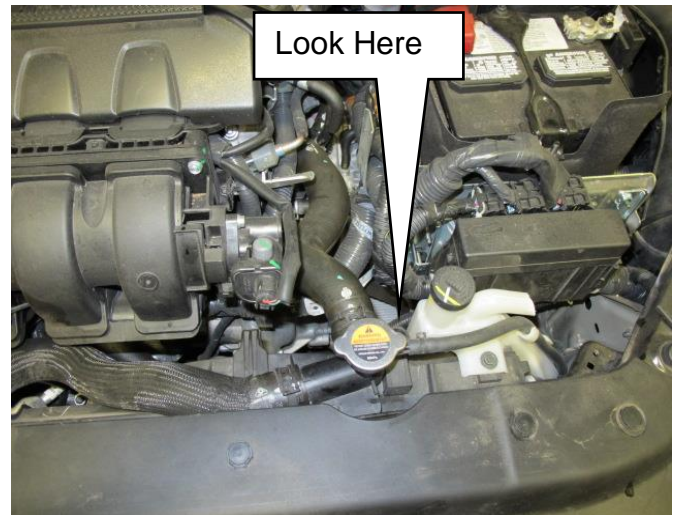
Figure 1

1. Drive vehicle into the shop and pull up to an available lift. Prepare vehicle to raise but do not lift at this time.
2. Turn the ignition OFF and remove the key from the inside of the vehicle.
3. Open the hood and support with the prop rod.
4. Locate the engine cooling fan blade date code (Refer to Figures 1 & 2).
  - Inspect the backside (engine side) of the fan blades (Refer to Figure 2).
  - Rotate the fan blades by hand until the fan blade date code is located.
  - Use of a shop light or flashlight may help to locate the fan blade date.
  - The fan blade date code could be marked in blue, yellow or white china marker.

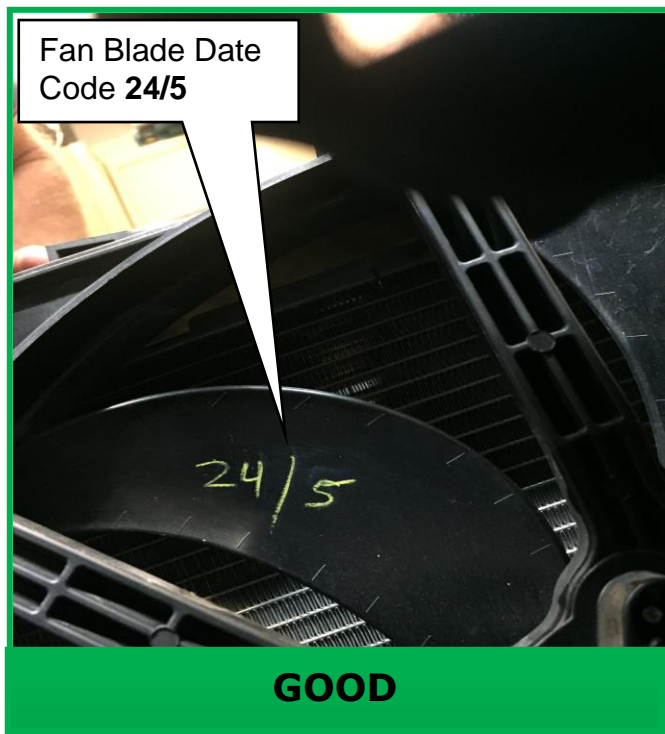
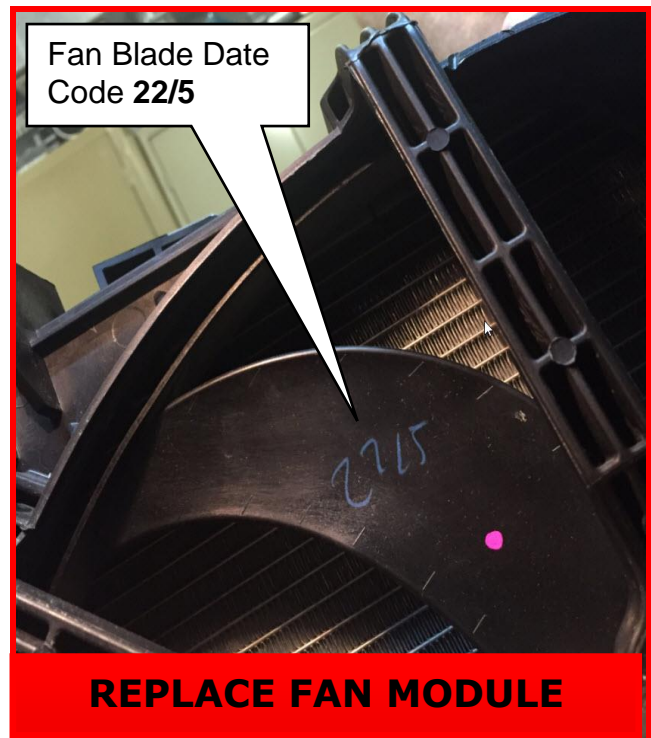
Figure 3

- Fan blade date code will be in (Day/Month) format:  
EXAMPLE: 24/5 = May 24<sup>th</sup>

6. Is the fan blade date code "**22/5**" (**May 22<sup>nd</sup>**)? (Refer to Figure 3)

- If **NO**, submit a warranty claim using op code PM7000 (see Claims Information). The repair is complete.
- If **YES**, or if **UNREADABLE** then proceed to Step 7 to replace the engine cooling fan shroud and motor assembly.

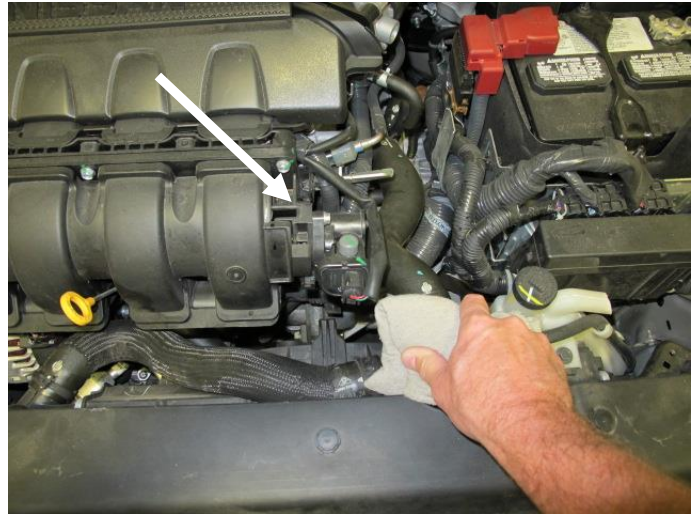
Figure 4

7. Make sure vehicle engine is cool and remove radiator cap (Refer to Figure 4).

Do not remove the radiator cap when the engine is hot. Serious burns could occur from high pressure engine coolant escaping from the radiator. Wrap a thick cloth around the cap. Slowly turn it a quarter turn to allow built-up pressure to escape. Carefully remove the cap by turning it all the way.

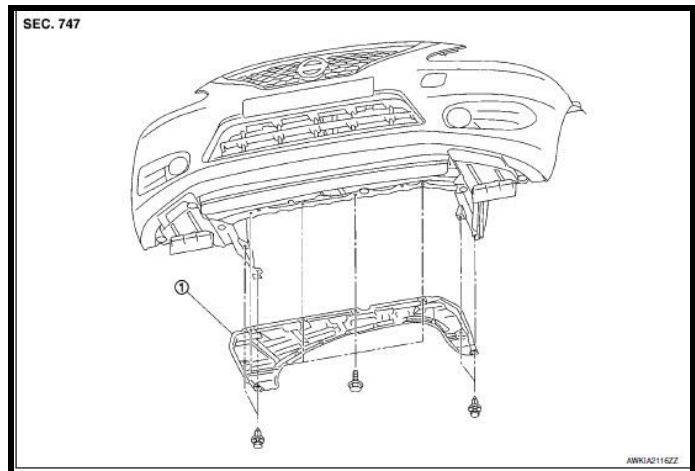
Figure 5

8. Disconnect the negative battery cable.
9. Using a suitable lift, raise the vehicle to gain access to the underside of the vehicle.
10. Remove front undercover to gain access to the lower radiator area (Refer to Figure 5).
  - Remove (4) 10 mm bolts.
  - Remove (4) retainer clips.

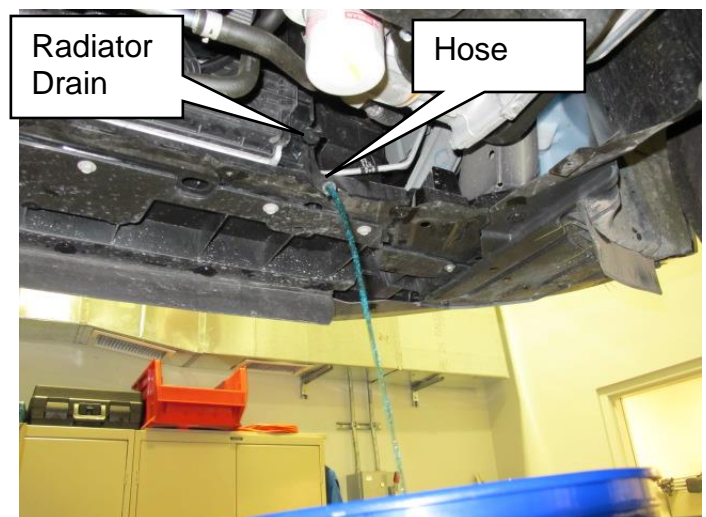
Figure 6

11. Partially drain the coolant from the radiator into a suitable clean drain pan (Refer to Figure 6).

**NOTE:** It may be helpful to attach a short piece of hose to the radiator drain plug to assist with directing the coolant into a drain pan.

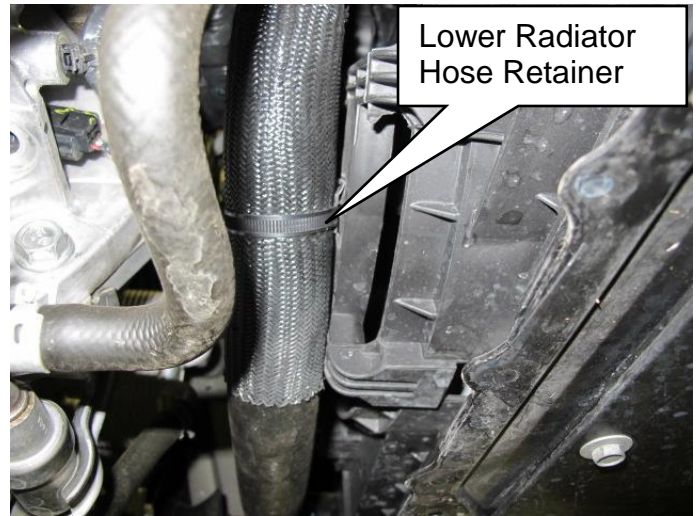
Figure 7

12. Disconnect the lower radiator hose retainer from the fan shroud and motor assembly (Refer to Figure 7).

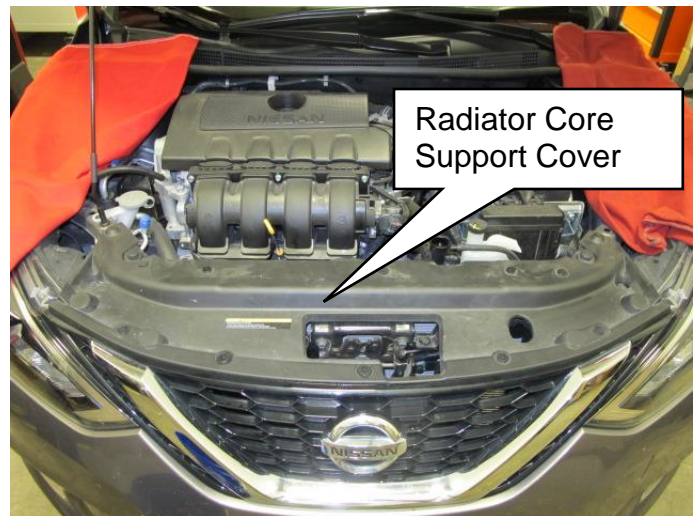
Figure 8

14. Remove the radiator core support cover (Refer to Figure 8).

- Remove (12) retainer clips.

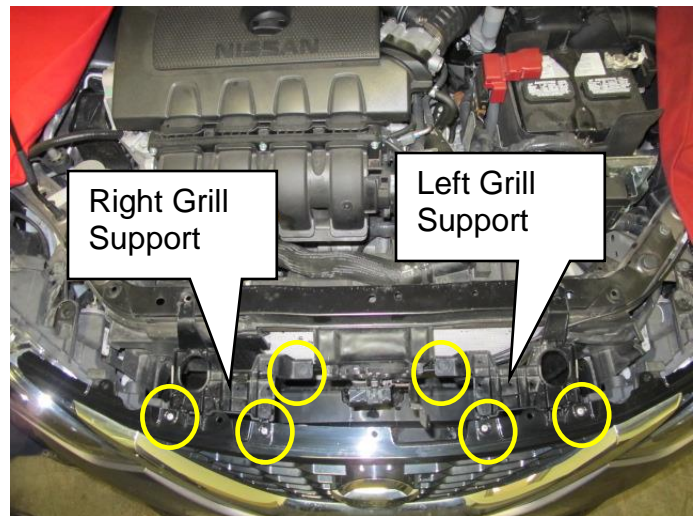
Figure 9

15. Remove the left and right grill supports (Refer to Figure 9).

- Remove (1) retaining clip per grill support (total of 2 clips).
- Remove (2) screws per grill support (total of 4 screws).
- Gently unclip the grill supports from the grill.

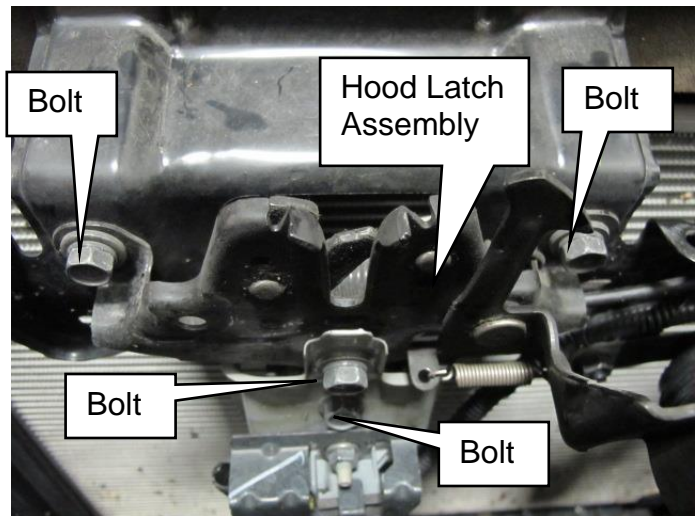
Figure 10

16. Remove the hood latch assembly from the radiator core support (Refer to Figure 10).

- Remove the (4) retaining bolts.
- Leave the hood latch cable attached.
- Bolt torque 22 N.m (2.2 kg-m, **16 ft-lb**)

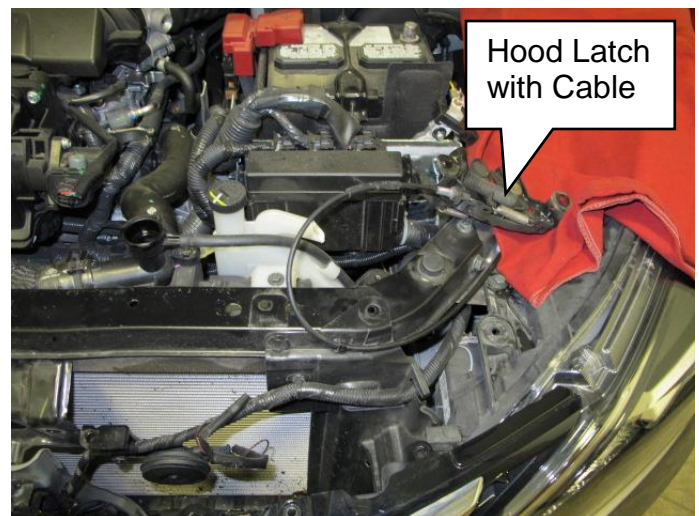
Figure 11

17. Gently position the hood latch w/cable attached to the right side as shown in Figure 11.

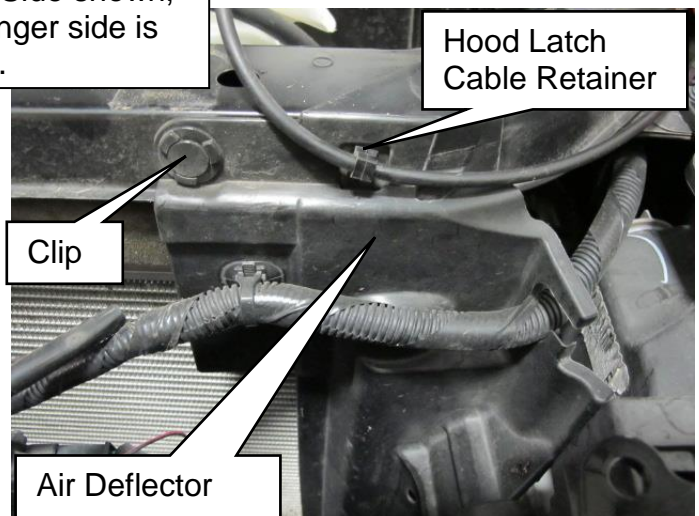
Figure 12

18. Remove the clips from the air deflectors on the front of the radiator core support and release the hood cable retainer. Refer to Figures 12.

Driver Side shown,  
Passenger side is  
similar.

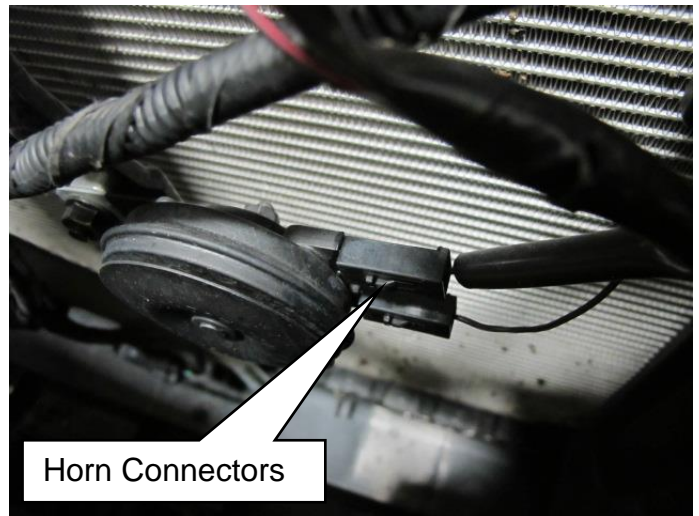
Figure 13

19. Disconnect the (2) horn connectors  
(Refer to Figure 13).

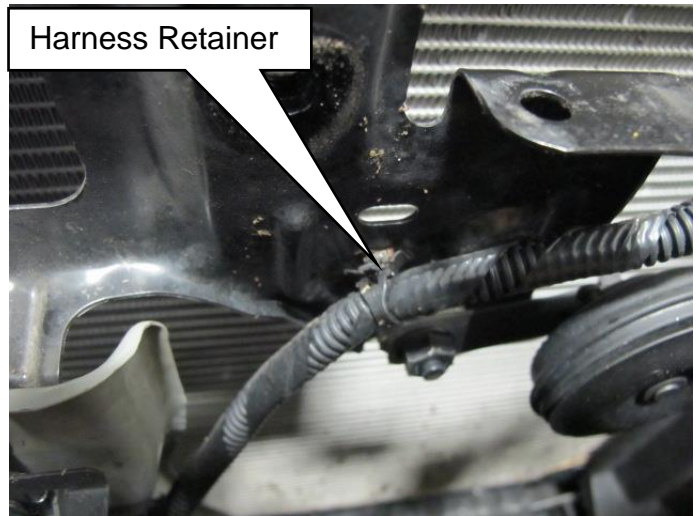
Figure 14

20. Unclip the crash zone sensor harness retainer from the front of the core support (Refer to Figure 14).

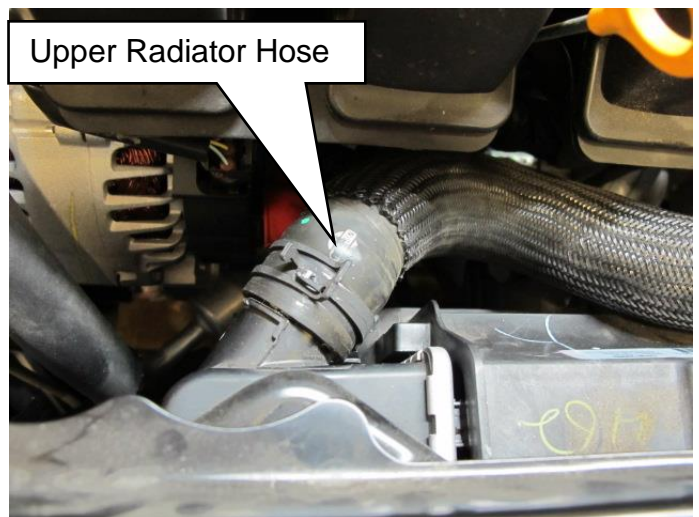
Figure 15

21. Disconnect the upper radiator hose from the radiator (Refer to Figure 15).

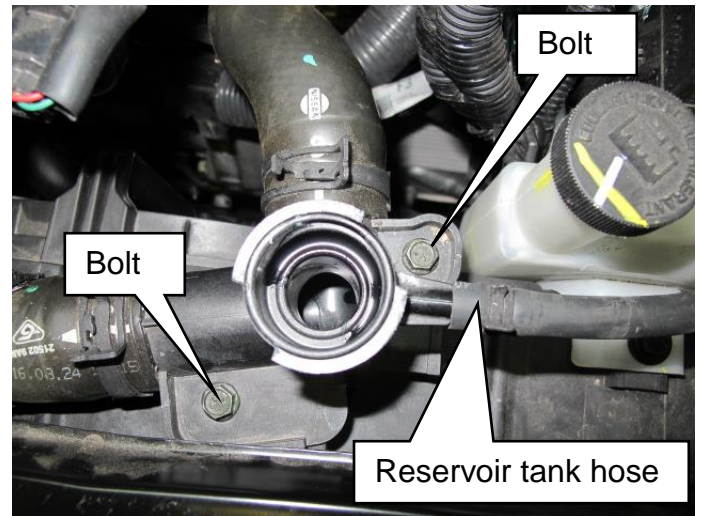
Figure 16

22. Disconnect the reservoir tank hose from the filler neck and the (2) filler neck 10 mm retaining bolts (Refer to Figure 16).

- Bolt torque 8.0 N.m (0.82 kg-m, **71 in-lb**)

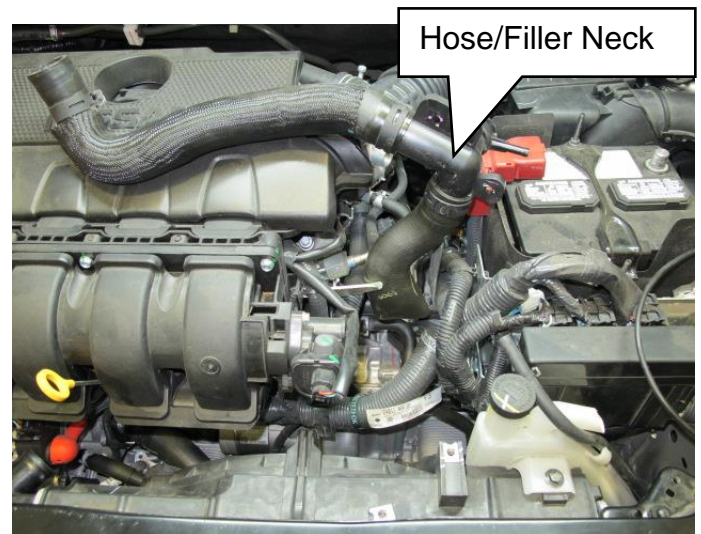
Figure 17

23. Position the upper radiator hose/filler neck assembly out-of-the way as shown in Figure 17.

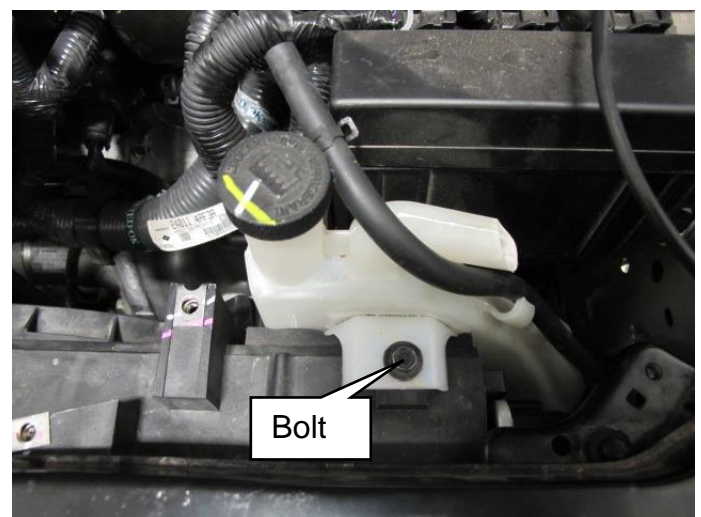
Figure 18

24. Remove reservoir tank (Refer to Figure 18).

- Remove (1) 10 mm retaining bolt.
- Pull straight up to disengage lower tab from cooling fan module.
- Bolt torque 8.0 N.m (0.82 kg-m, **71 in-lb**)

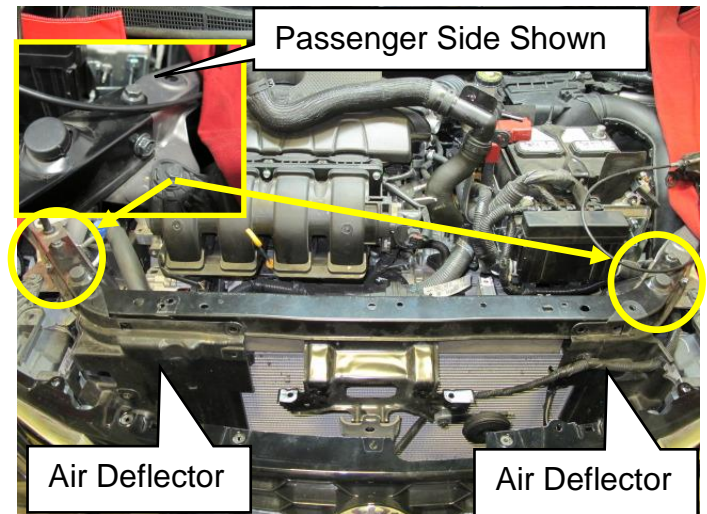
Figure 19

25. Remove the radiator core support (Refer to Figure 19).

- Remove (4) 12 mm retaining bolts.
- Carefully lift up to remove.
- Bolt Torque 24.5 N.m (2.5 kg-m, **18 ft-lb**)

**NOTE:** Use care not to damage the air deflectors during removal.

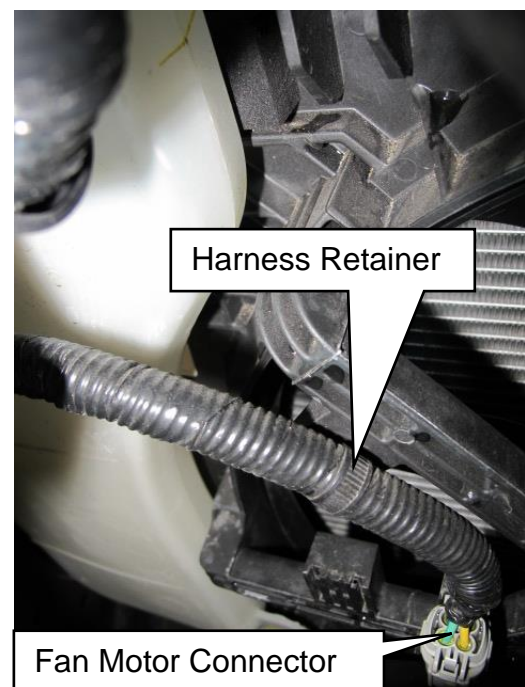
Figure 20

26. Disconnect the cooling fan motor connector and unclip the harness retainer from the fan shroud and motor assembly (Refer to Figure 20).

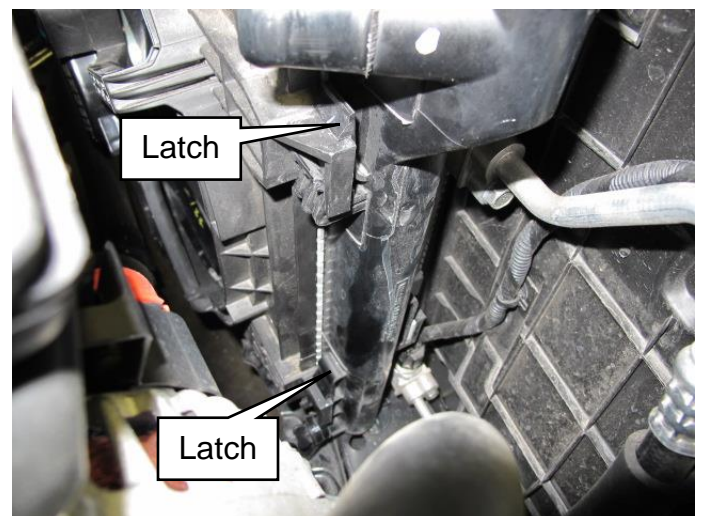
Figure 21

27. Remove the fan shroud and motor assembly (Refer to Figure 21).

- Push in (4) retaining latches (2 on each side) to release the fan shroud and motor assembly from the radiator.
- Gently pull the fan shroud and motor assembly straight up to remove it from the vehicle.

**CAUTION: Excessive force on the retaining latches could cause them to be damaged.**

28. Install the NEW fan shroud and motor assembly.

- Verify all (4) locking tabs are correctly seated and latched in the radiator assembly.

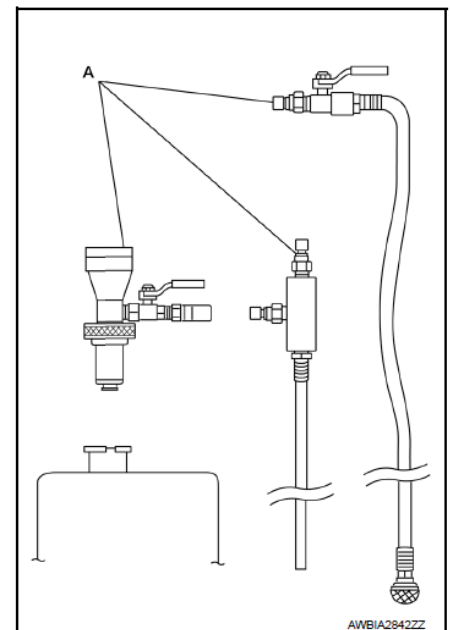
Figure 22

32. Fill the cooling system with coolant previously drained using Tool (A), following the manufacturing instructions included with the tool (Figure 22).

Tool number (A): KV991J0070 (J-45695-A)

- Use Recommended Coolant or Equivalent
- The compressed air supply must be equipped with an air dryer.
