TECHNICAL INSTRUCTIONS

LIMITED SERVICE CAMPAIGN H0T

REAR WHEEL ARCH SEALER GAP

CERTAIN 2018 CAMRY

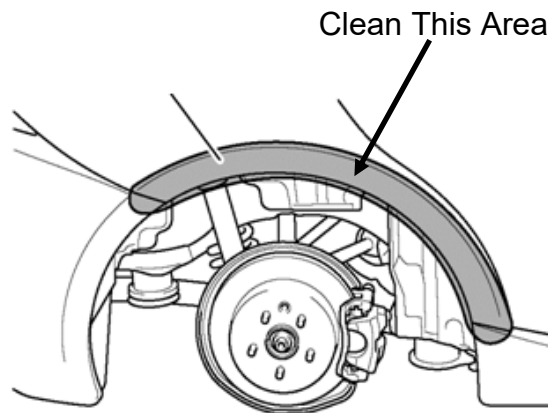
2. CLEAN WHEEL ARCH
 - a. Using water and a cloth, clean the inside edge of the wheel well in the area as shaded below.

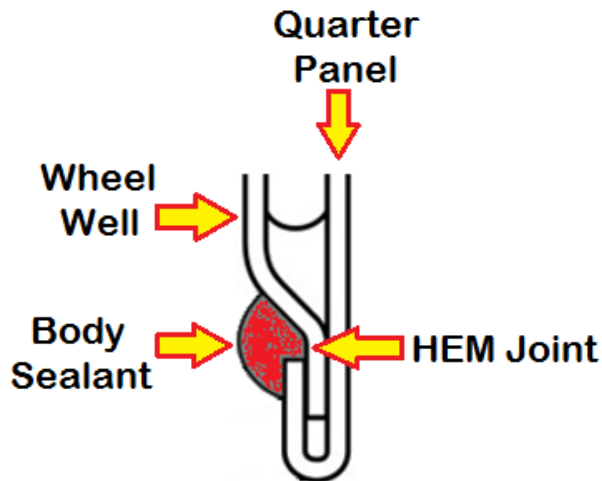
3. INSPECT WHEEL WELL BODY SEALANT

- a. Using a light, visually inspect the body sealant application along the inner wheel well. The sealant should thoroughly cover the hem joint of the quarter panel and wheel well. Identify any areas that the sealant fails to thoroughly cover the hem joint. In some cases, it may be necessary to use your fingernail to feel for the edge of the exposed quarter panel.

Note: Take your time when inspecting the wheel arch. It can be difficult to find misapplied sealant.

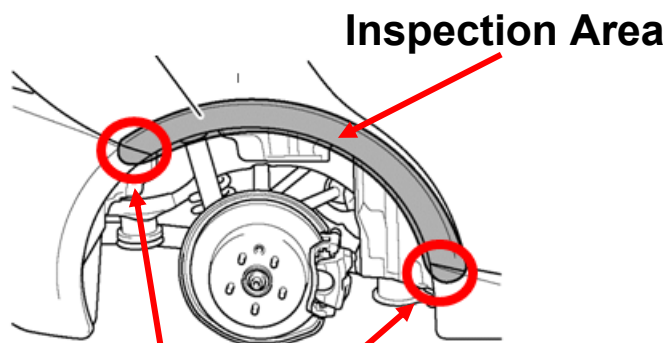
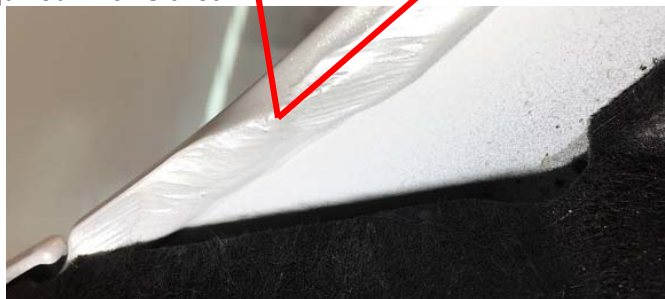
Note: The area shaded in gray below needs to be inspected. The two areas at the end of the wheel arch (circled in red below) does NOT need to be inspected. This area has a different application process that is not affected by this issue.

Inspection NOT required in this area

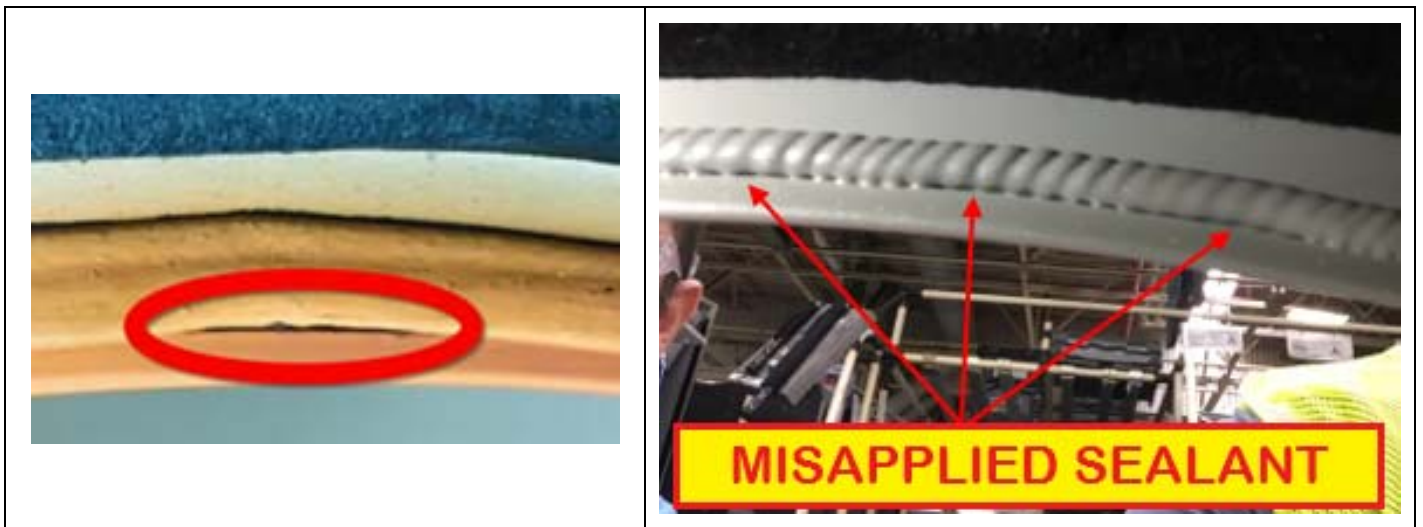
Examples of misapplied sealant:

INSPECTION CRITERIA:

OK

NG

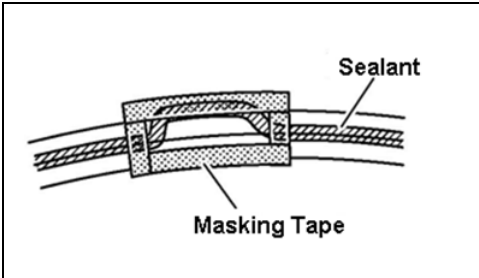
1. CLEAN THE AFFECTED AREAS

- a. Using a degreaser, thoroughly clean ALL the affected areas that were found to have improper sealant application.

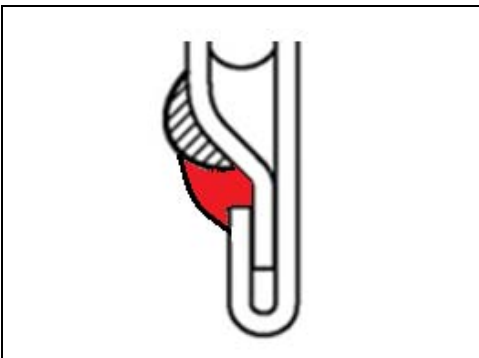
2. APPLY TAPE

- a. Apply masking tape around all 4 edges of the affected areas to prevent the sealant from getting onto unaffected areas of the body panels.

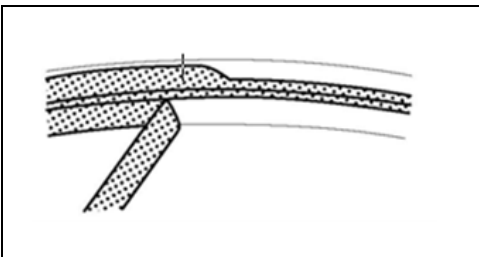
3. APPLY SEAM SEALER

- a. Apply seam sealer to the affected areas. Use a spatula to spread the seam sealer into place as shown in red.
Standard: 3M Flexiclear Body Seam Sealer 08405
