November 10, 2017

07659 Version 1

Product Update: 2018 Odyssey Rear Power Window Switches

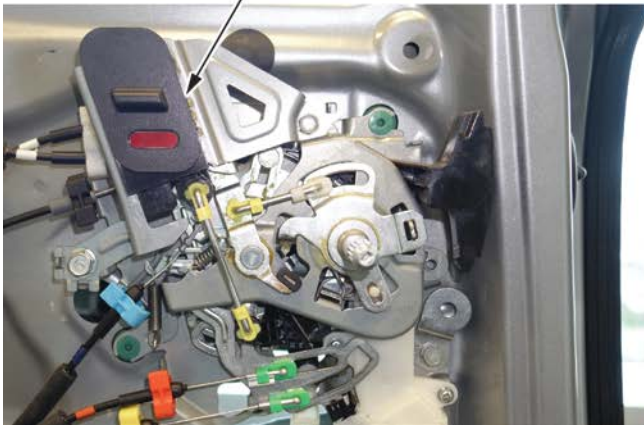
Door lock slider in proper position.

7. Make sure the door inner lock slider properly engages the bracket. If it is disengaged, disconnect the rod from the slider, reinstall the slider, then reconnect the rod.

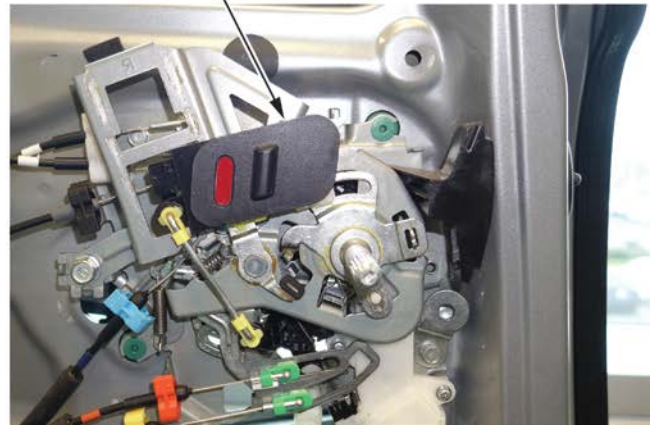
Door lock slider is disengaged.
