## Reach Driver's Seat Pedestal Welds Campaign Directive

**Situation:** Insufficient welds on the driver's seat pedestal.

**Corrective Action Summary:** Inspect and replace pedestal as necessary.

**Document Part Number:** 03103361-D004EN

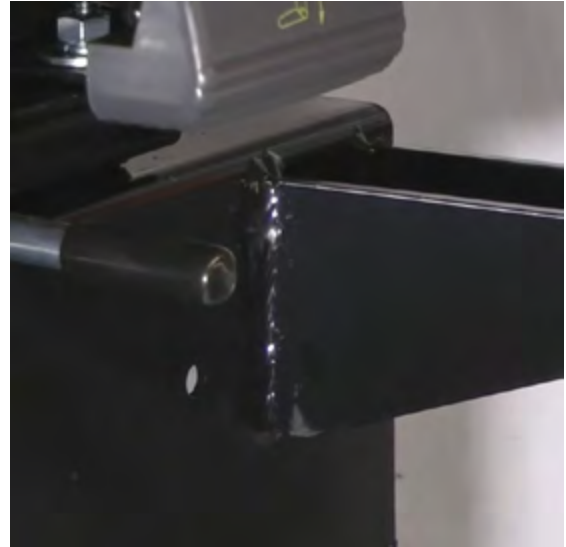
1. Read and understand all the instructions before starting the repair.
2. Visually inspect the inboard and outboard seat belt mounting bracket welds on the driver's seat pedestal where they meet the base. If there is full length continuous weld on both sides at all the joints with no cracks or break at all the joints, no further action is required. If any of the joints do NOT have a continuous length of weld on both sides or have welds that are cracked or broken, replace the pedestal.

*An example of a good continuous weld*

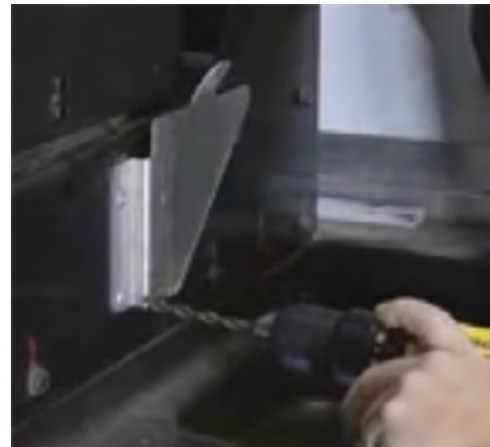
*Waste basket retainer*

1. Remove waste basket retainer by punching the stems out of the blind fasteners and drilling off the heads using an F (or 1/4") drill bit. Set retainer aside for reuse.
2. Remove the seat belts from the base. Discard the nuts and bolts but keep all washers and spacers for reuse.

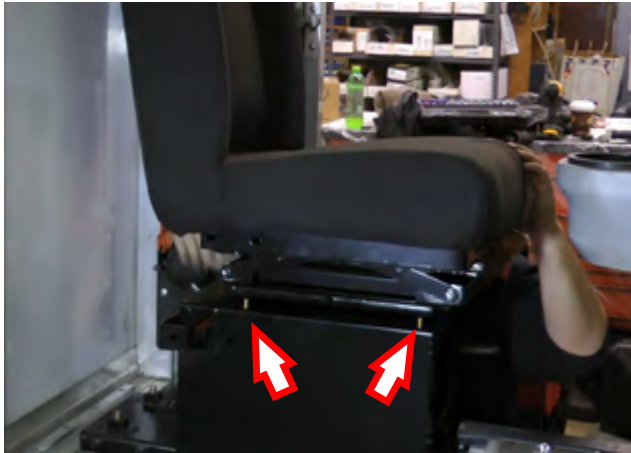
*Seat fasteners*

3. Remove the seat from the pedestal. Keep the nuts and washers for installation.
4. Remove and discard the (8) bolts along the bottom of the pedestal. Remove and discard the pedestal.

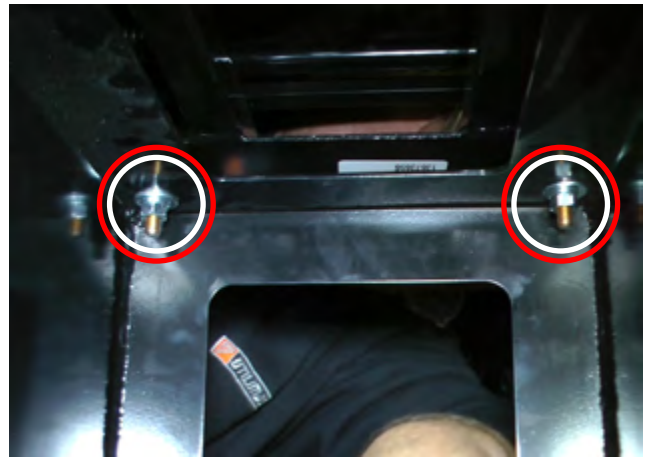
*Seat fasteners (view from below)*

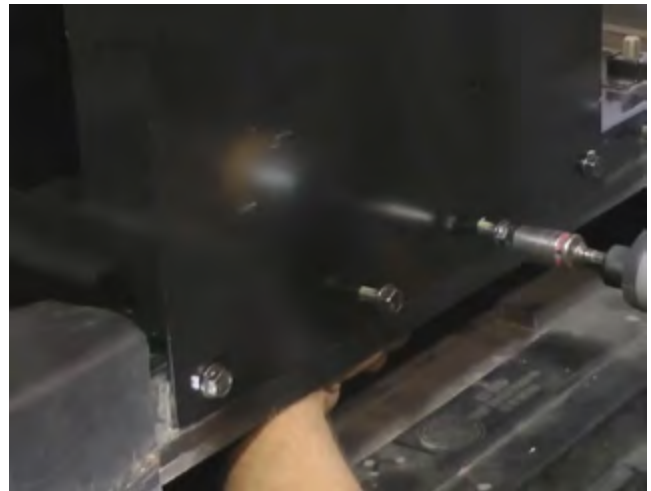
*Pedestal bolts*

1. Install the replacement pedestal with (8) M8-1.25 bolts.

**If the seat was installed as an aftermarket upgrade, (2) M8-1.25 nuts are also required. Remove the battery cover to install nuts.**

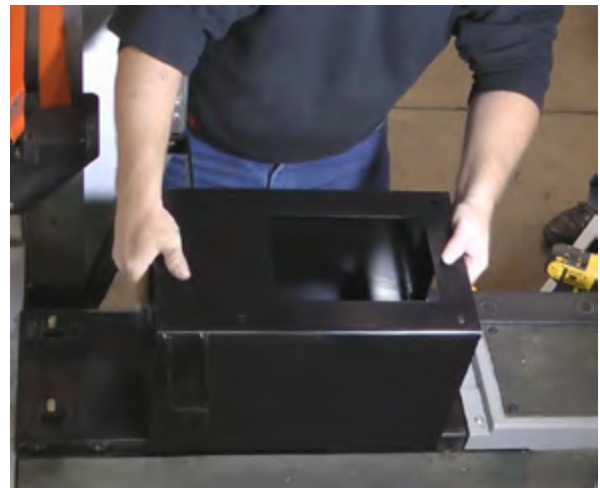
*Remove and discard pedestal*

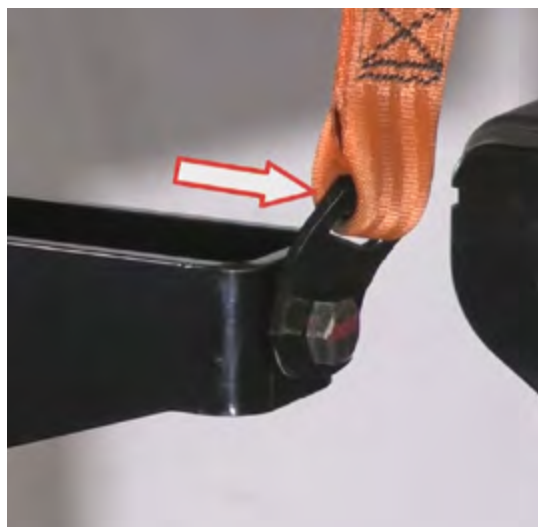
*Seatbelt bracket bends outboard*

2. Assemble the seat belt bracket on the outboard side by placing new bolt and nut, seat belt bracket, and reuse spacer and washers in sequence. Confirm the bracket bends toward the outboard side.
3. Assemble the seat belt catch with new bolt and nut, reuse washers, and spacers in sequence on the inboard side.
4. Torque to 39–45 ft•lbs.
5. Reuse fasteners to attach the seat to the pedestal.
6. Torque to 10–12 ft•lbs
7. Install waste basket retainer using (2) blind fasteners.
8. Install waste basket.
9. Test the operation of seat and seat belt.

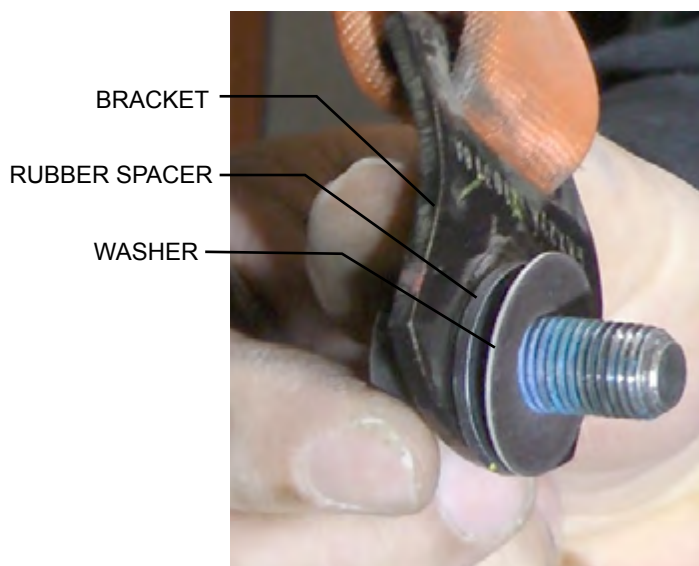
*Seat belt bracket assembly (nut not shown)*

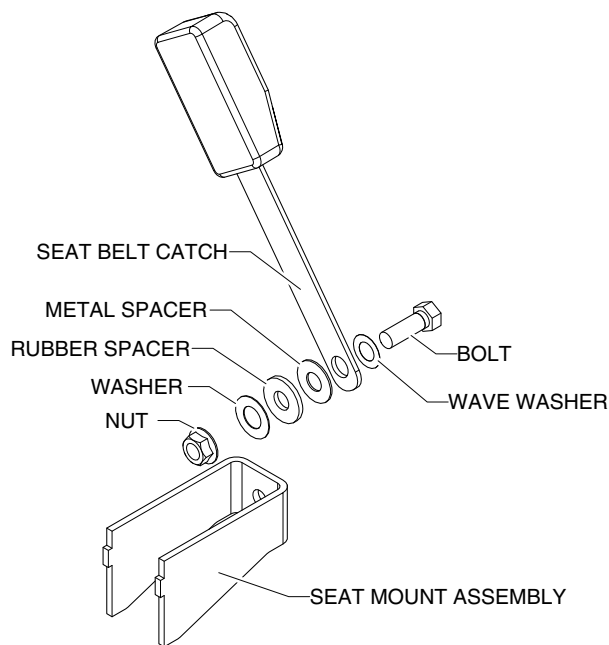
*Seat belt catch assembly*

Seat belt catch assembly requires installation of washers and spacers in a specific order.

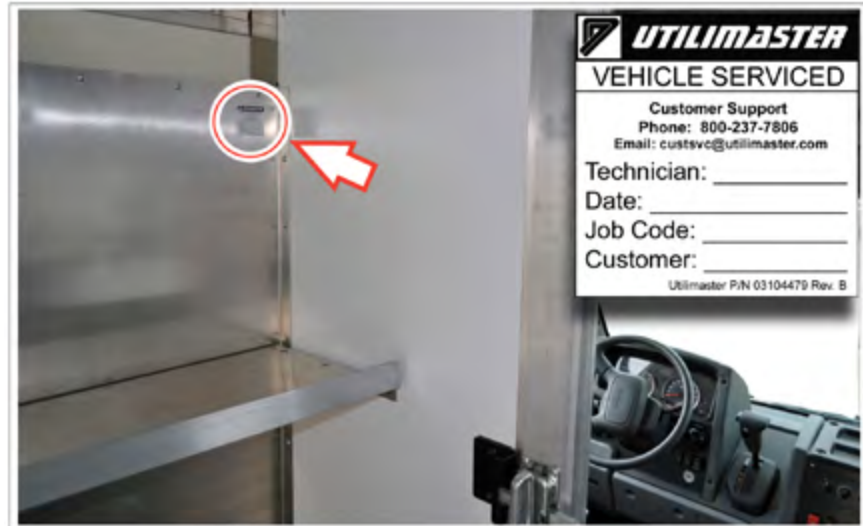
*Service decal on driver's door pocket (cargo side)*

10. Use Job Code 13-P8-35-LV for inspection only or 13-P8-A4-LV for pedestal replacement to complete the SERVICED decal.
11. Adhere the decal to the upper right-hand corner of the driver's door pocket panel or sidewall next to the bulkhead wall. Do NOT cover any previously applied decals.
