# ***Airstream Service Bulletin***

Bulletin Number: 173

Product Line: 2018 30' & 33' Airstream Classic Travel Trailers

Subject: Alde Connector

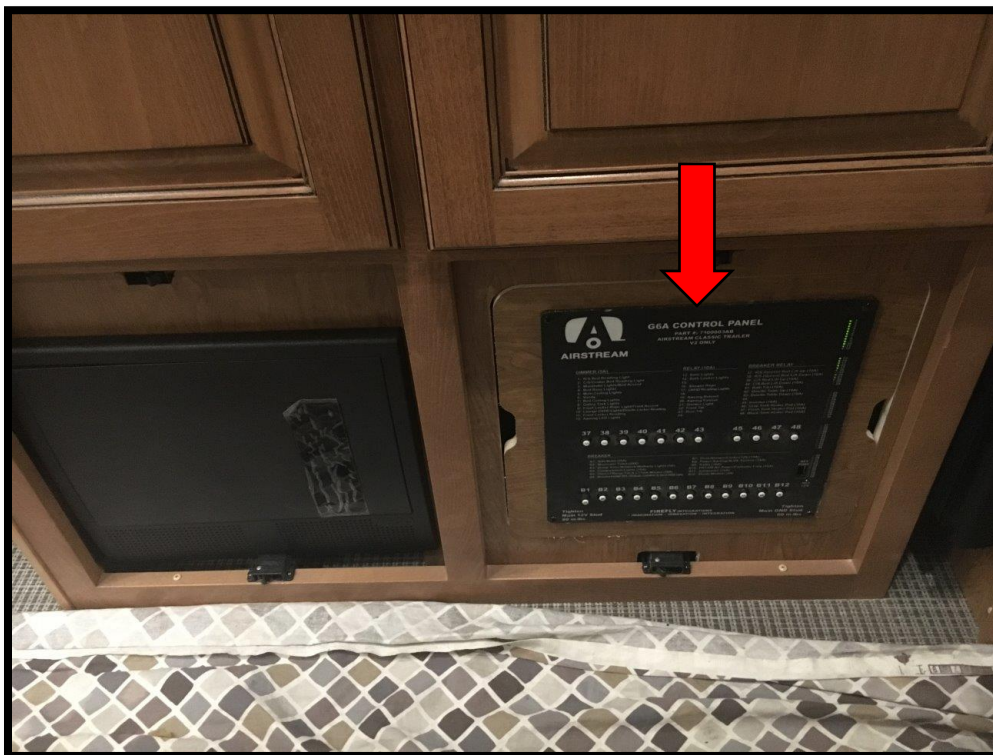
**Step 1:** Locate the 6G panel in the coach. It will be located behind a false panel under the wardrobe on the right side on both 30' and 33' models:

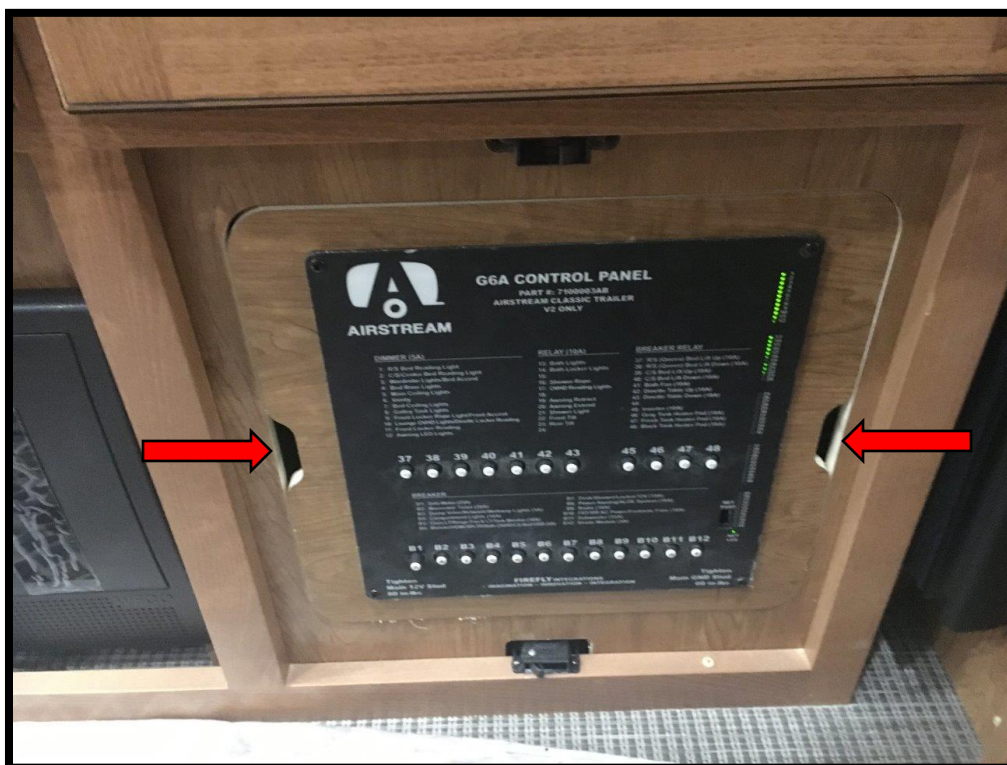
**Step 2:** Remove the G6 panel. The panel is held in by 2 catches and can be removed by pulling out on the wood panel from the 2 cut-outs on either side.

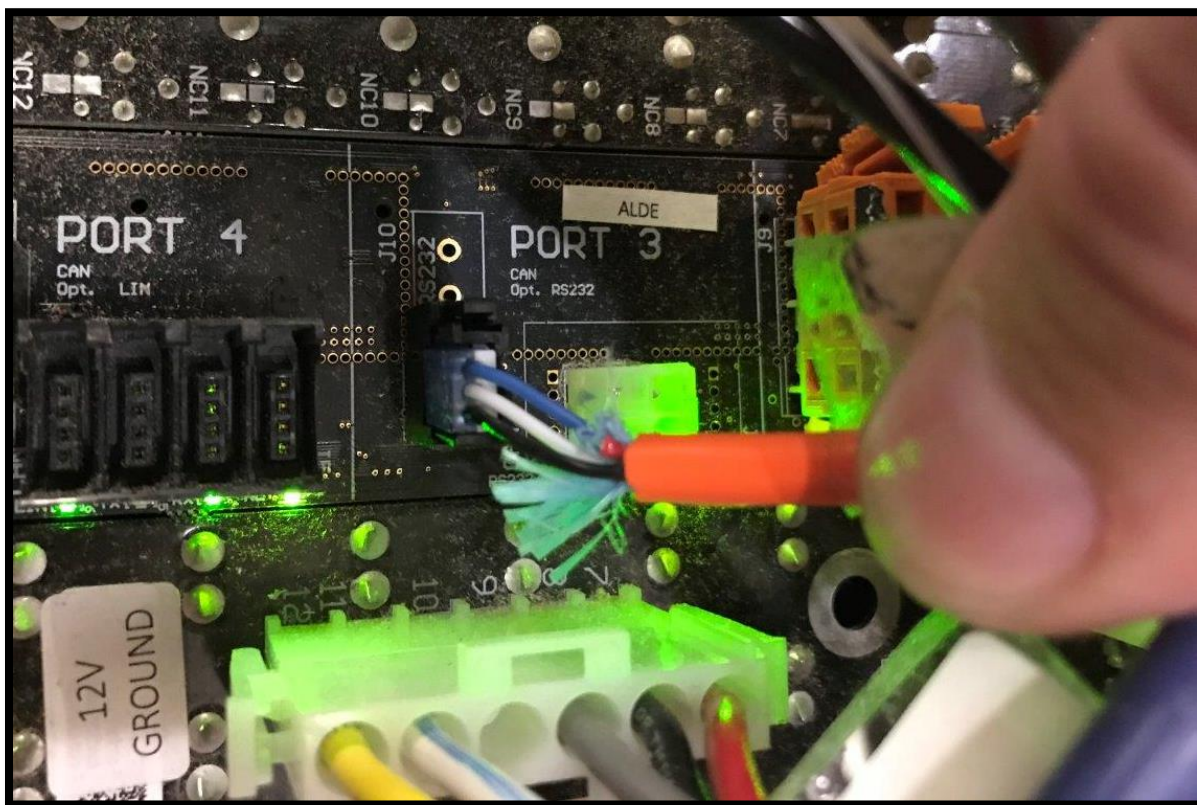
**Step 3:** Verify the wiring sequence on port 3 of the G6 panel. It should be wired as pictured below, with the blue wire closest to the clip, white in the middle and black furthest away from the clip:
