## Technical Information Bulletin

**34-061**

Gliders built without J1587 Data Bus Connector

Glider chassis built from 6/26/2017 through 9/29/2017.

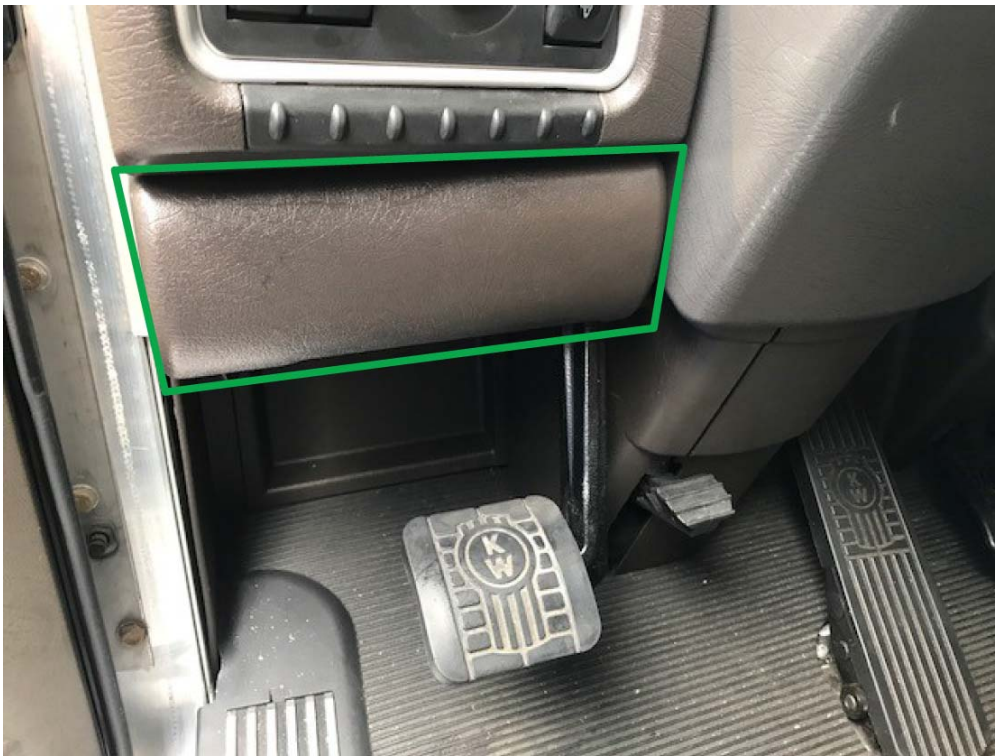
1. Remove the lower left-side under dash panel.

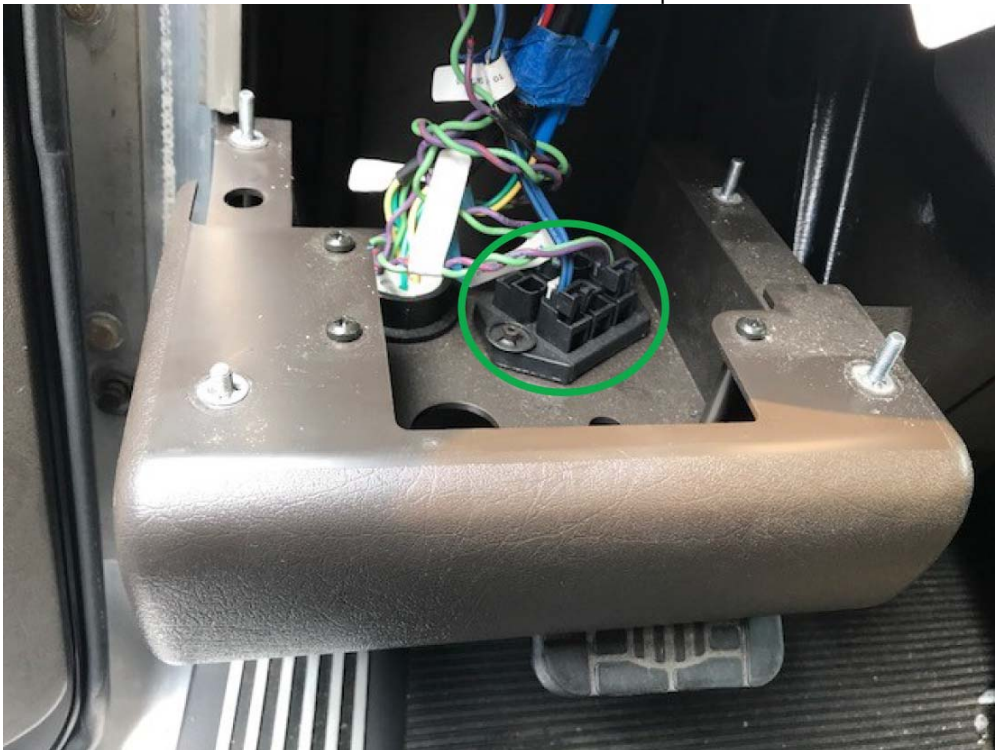
2. Place the J1587 connector over the studs and then install the push nuts.

3. Connect any open data cable to any receptacle in the J1587 data bus connector.
