TA0021: Front Wheel Skid Spacer for 2018 Touring

Reference	TA0021
Last Modified	2017-08-31
Models	2018: FLHP, FLHR, FLHRC, FLHRXS, FLHTCU, FLHTK, FLHTK ANV, FLHTK SHRINE, FLHTKL, FLHTKSE, FLHTKSE ANV, FLHTP, FLHX, FLHX ANV, FLHXS, FLHXS ANX, FLHXSE, FLTRU, FLTRX, FLTRXS, FLTRXSE
Category	Chassis
Markets	U.S. market is affected.
Vehicles Affected	2018 Touring, CVO Touring and Police
Symptoms	Front fender damage caused by shipping spacer.

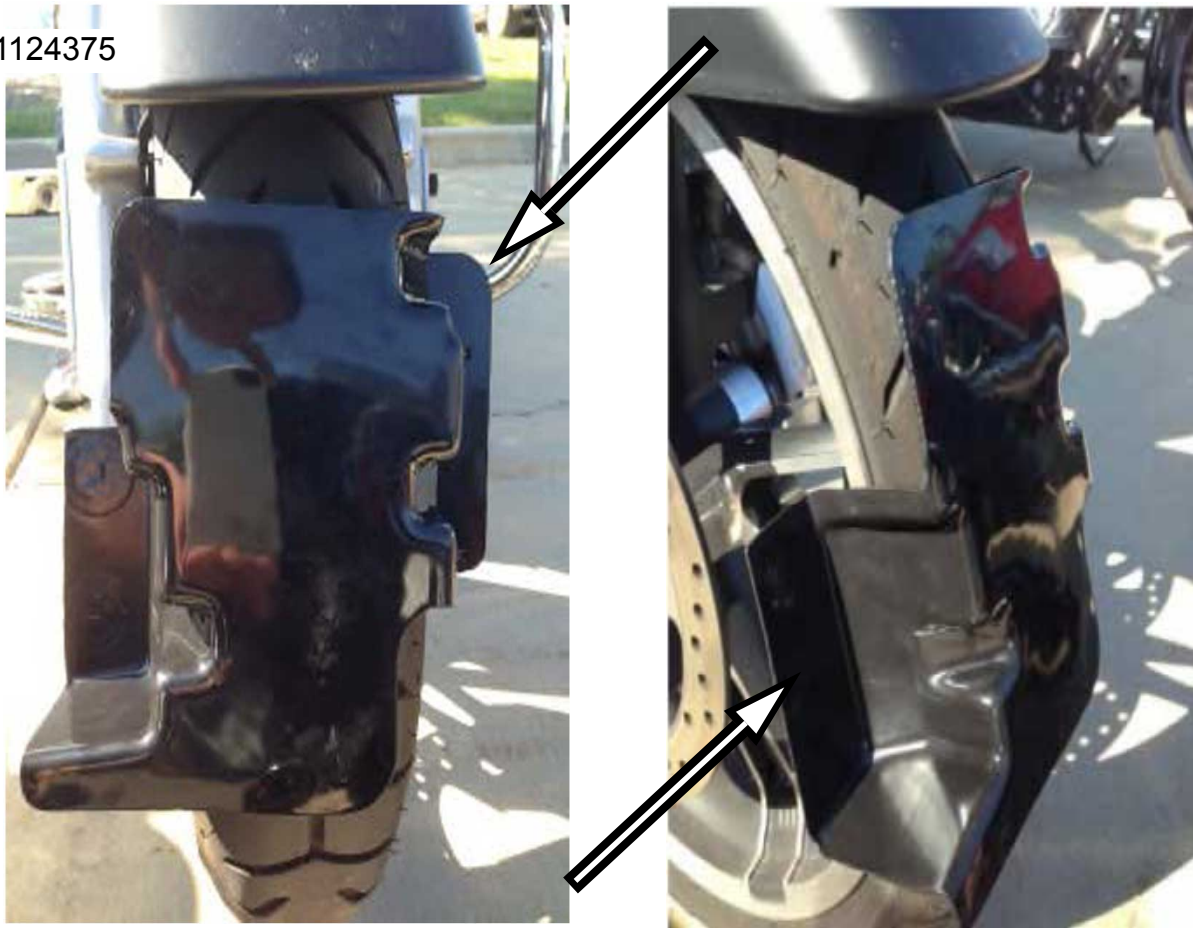
Figure 1. Front Wheel Skid Spacer

See Figure 1. A spacer was added to the shipping skid for the front tire of 2018 Touring, CVO Touring and Touring Police vehicles. The spacer is used to chock the tire in the skid correctly. This avoids shipping strap contact and possible damage to the front fender.

The spacer is not intended to remain attached to the front tire. This may damage the front fender as the motorcycle is removed from the skid.
