<b>HYUNDAI</b> <b>Technical Service Bulletin</b>	GROUP <b>CAMPAIGN</b>	NUMBER <b>17-01-064</b>
	DATE <b>NOVEMBER, 2017</b>	MODEL <b>SANTA FE SPORT (AN) SONATA (LFA)</b>
<b>SUBJECT:</b>	<b>INHIBITOR SWITCH REPLACEMENT (SERVICE CAMPAIGN T2M)</b>

**Description:** This bulletin describes the service procedure to replace the inhibitor switch. A possible symptom is Diagnostic Trouble Code P0705 (Transmission Range Sensor Circuit).

2017~18	Santa Fe Sport (AN)
2017	Sonata (LFA)

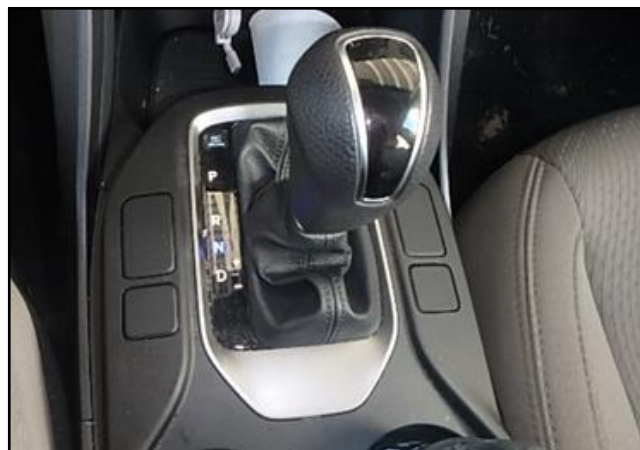
1. Apply the parking brake.  
Turn the ignition to the **ON** position and move the shift lever to the **N** position.  
Turn the ignition switch to the **OFF** position.

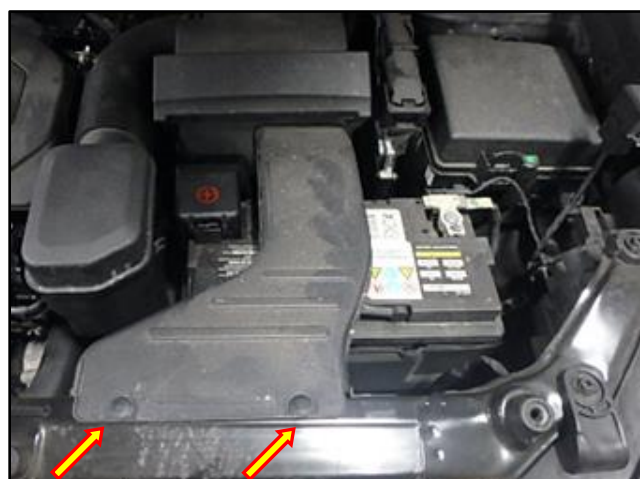
2. Open the hood and remove the plastic tabs and remove the air duct.

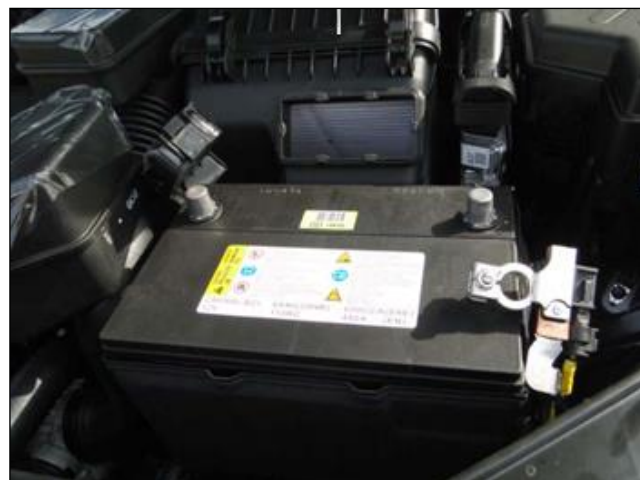
3. Remove the negative and positive battery cables.  
Remove the battery hold down bolt and remove the battery.  
**Torque: 7~9 lb-ft (1.0~1.2 kgf.m, 10~12 N.m)**

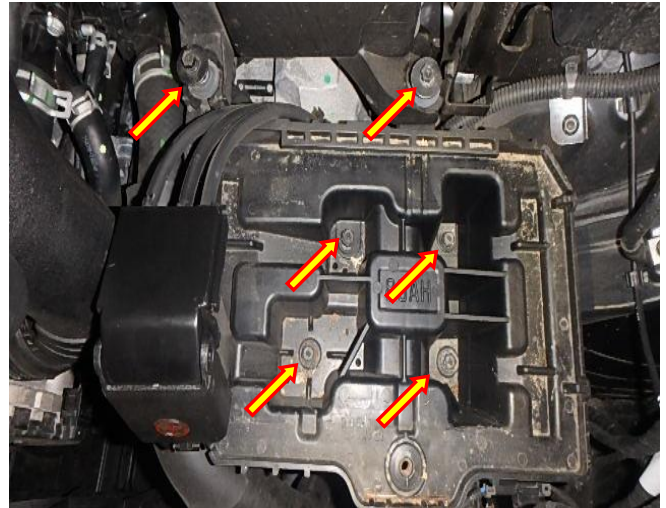
4. Remove 2 bolts to the air cleaner and remove the air cleaner.

Remove 4 bolts to the battery tray and remove the battery tray.

**Torque: 7~9 lb-ft (1.0~1.2 kgf.m, 10~12 N.m)**

Move the battery tray aside to gain access to the inhibitor switch.

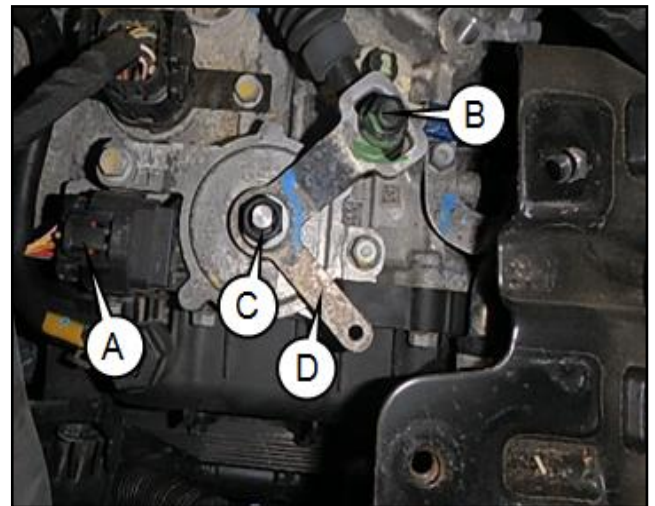
5. Disconnect the inhibitor switch connector (A)  
Remove the shift cable mounting nut (B).  
Remove the nut (C) and washer and remove the manual control lever (D).

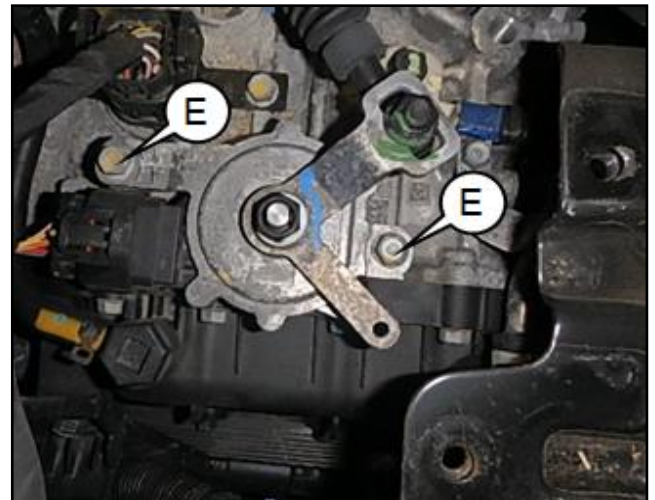
6. Remove 2 mounting bolts (E) and remove the inhibitor switch assembly.

Install the new inhibitor switch assembly to the transaxle and tighten the mounting bolts.

**Torque: 7~9 lb-ft (1.0~1.2 kgf.m, 10~12 N.m)**

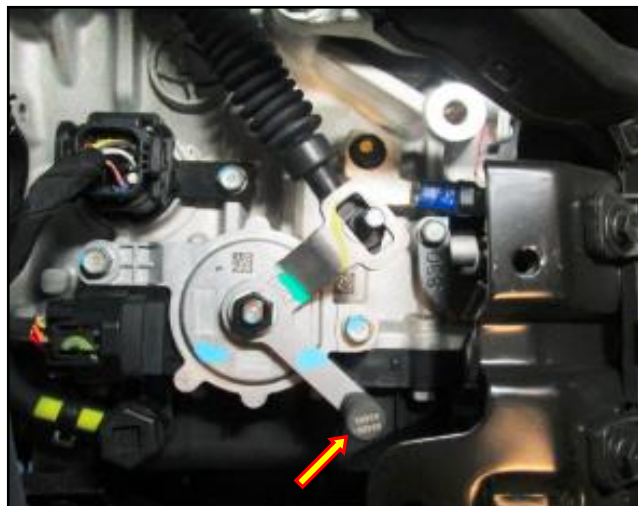
7. Install the manual control lever, washer and nut to the new inhibitor switch and tighten the nut.

**Torque: 13~18 lb-ft (1.8~2.5 kgf.m/18~24 N.m)**

Insert the **09480-A3800** guide pin or **5mm** bolt in the alignment hole before tightening the nut.

**SST 09480-A3800**, Inhibitor Switch Guide Pin.

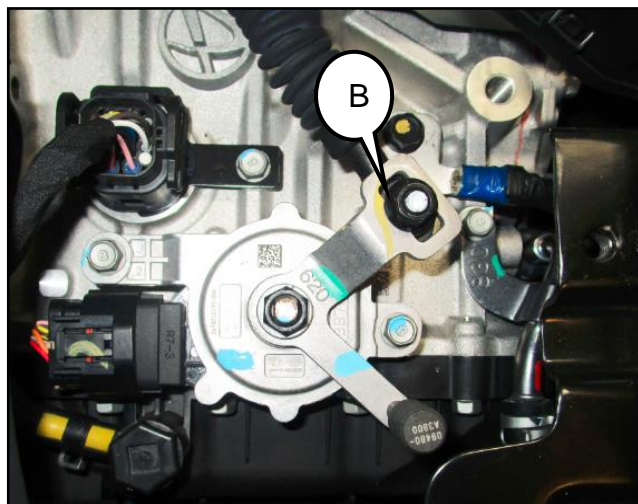
8. Confirm the shift lever is in the **N** position.

Install the shift cable nut and tighten the nut (B) to specification.

**Torque: 6~9 lb-ft (0.8 ~ 1.2 kgf.m, 8~12 N.m)**

Remove the SST or 5mm bolt from the alignment hole.
